**NEW GOLD RAINY RIVER MINE  
APPENDIX K  
EXCEEDANCE LETTERS  
SUBMITTED TO MECP**

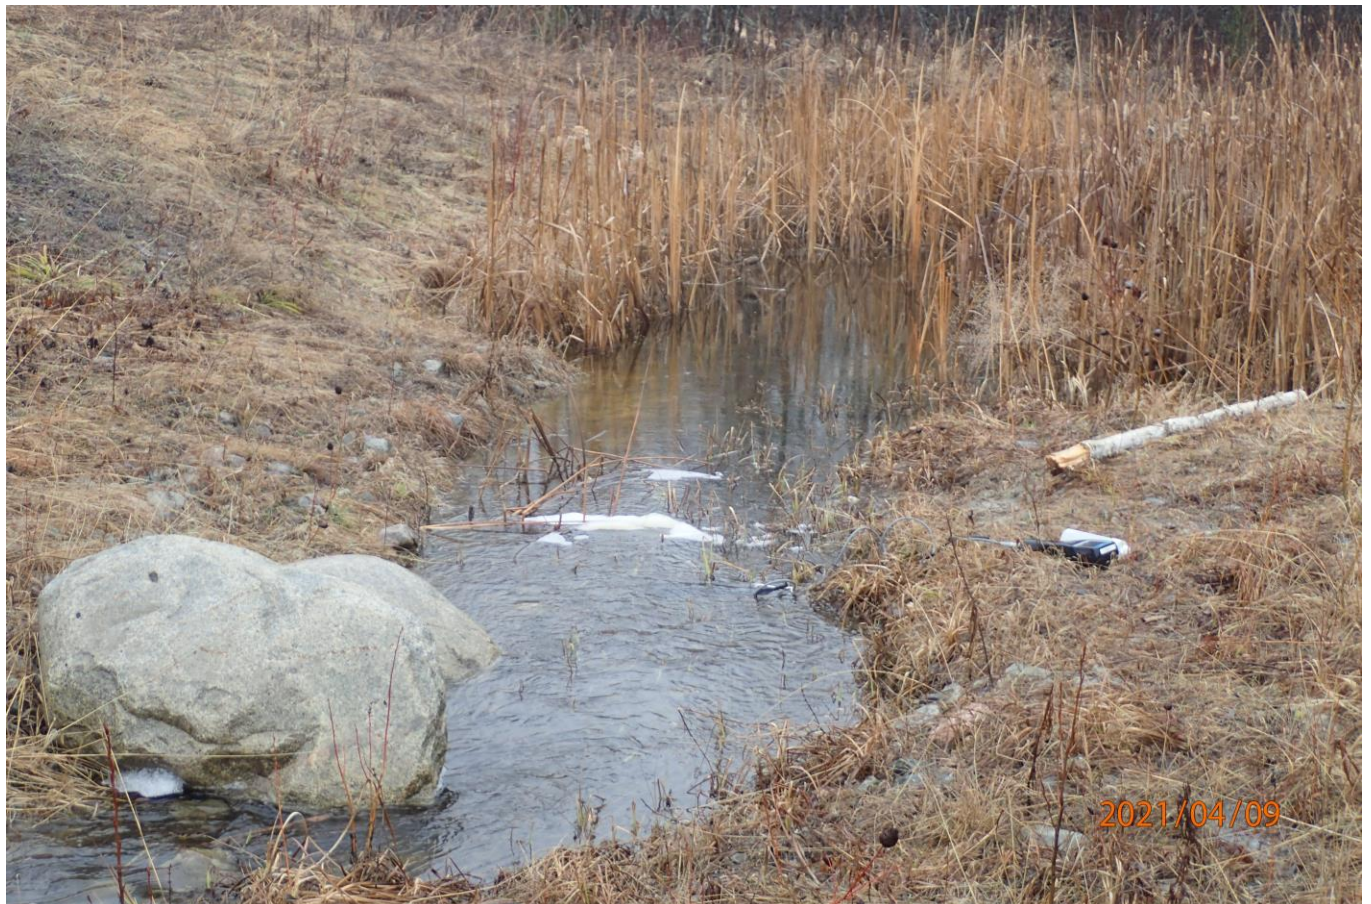
Photo 1: Teeple Diversion at the location of the fish kill (water quality meter and sample bottle present)

An estimated 500 dead minnows (mainly Brook Stickleback) were found in the last pool and riffle in the Teeple Diversion. Several other pools were inspected, and dead fish were not found anywhere else. Clark Diversion and West Creek Diversions were also inspected, and no dead fish were found in those structures nor in any of the associated ponds.

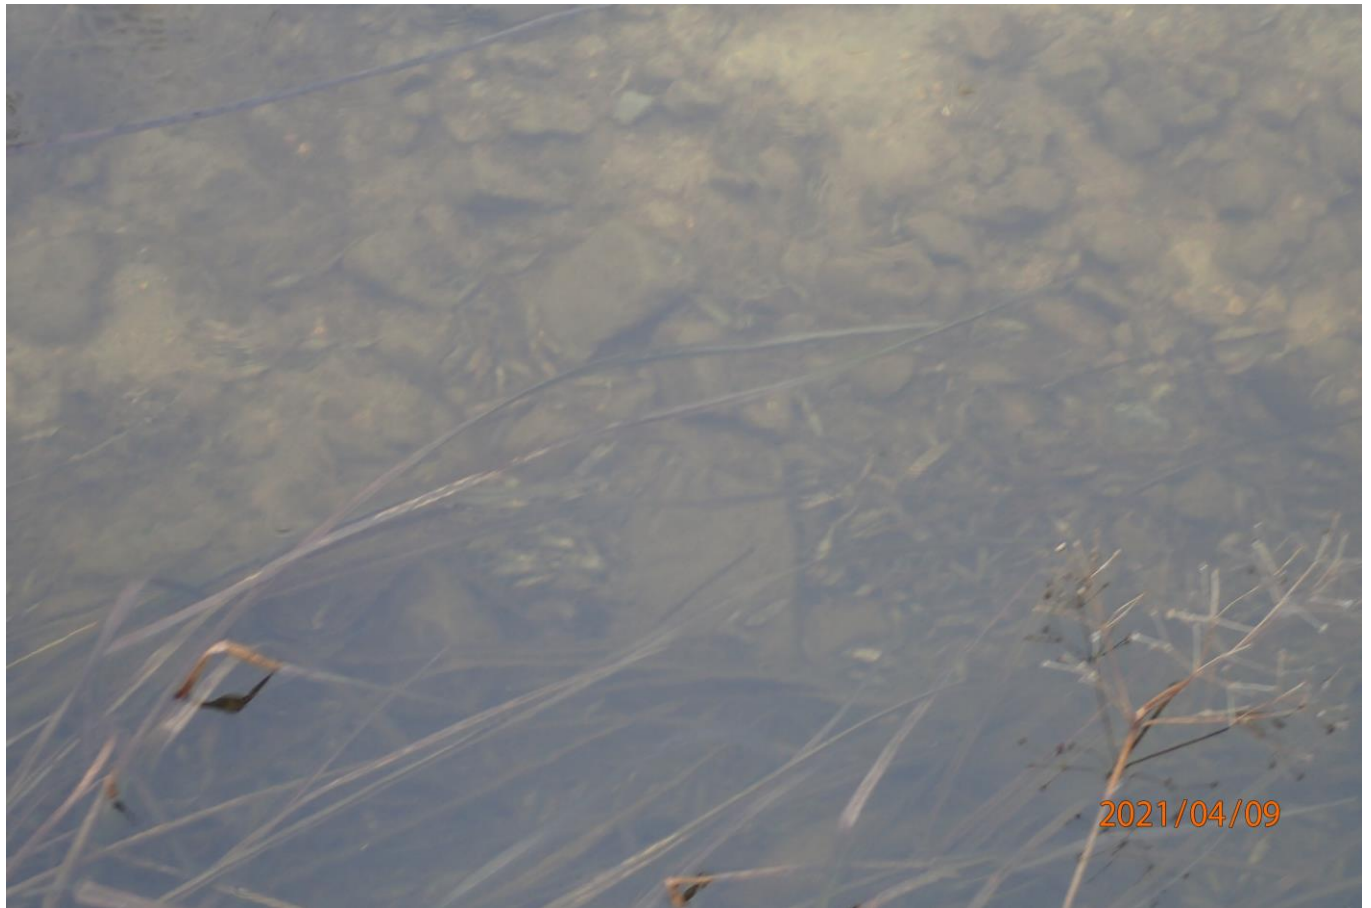
Photo 2: Dead fish on bottom of pool in Teeple Diversion.

Currently the most likely explanation for the fish kill is anoxic shock due to large numbers of fish being present in the diversion and low flow conditions prior to the rain. The number of fish competing for oxygen plus the waste they would be producing can cause stress in fish and lead to a fish kill. No effluent discharges or site runoff enters Teeple or upstream Clark Creek systems, essentially, they are outside the influence of Rainy River Mine however they were constructed by New Gold to regulator specifications.

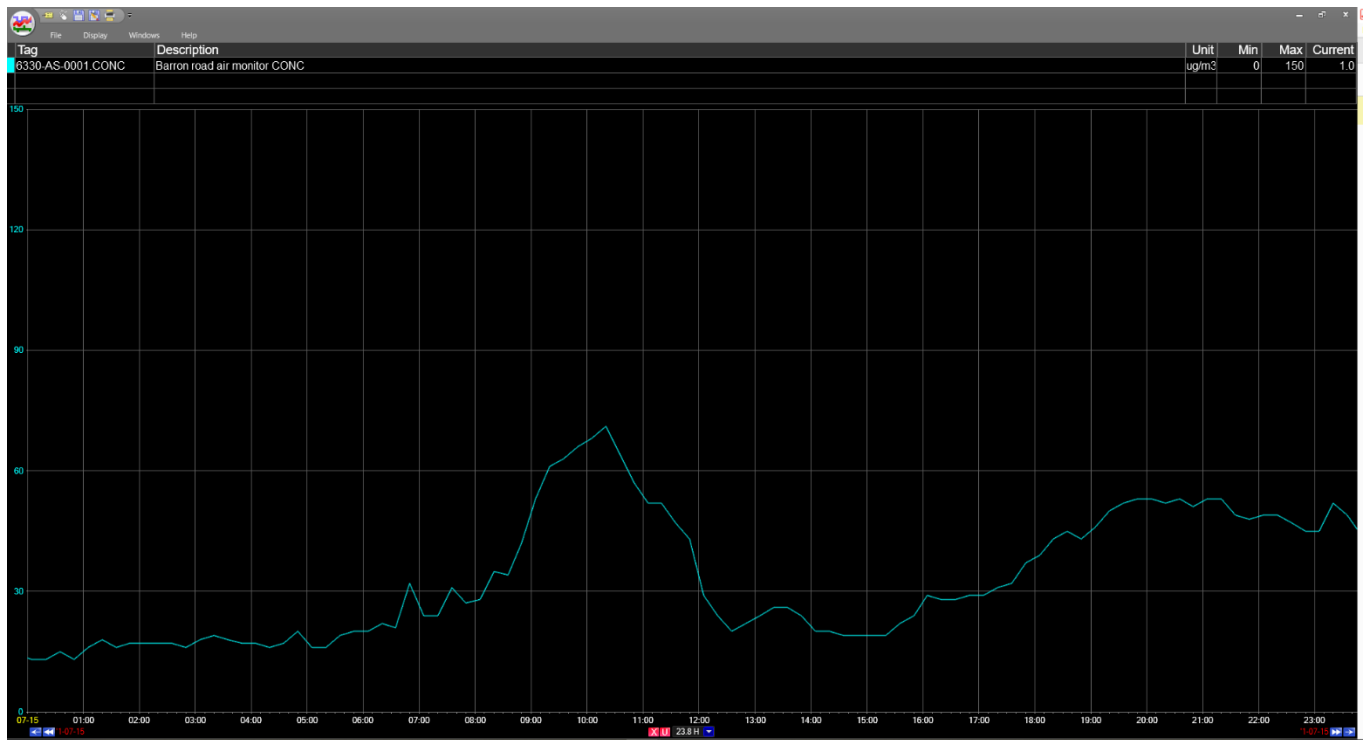
The cause of the exceedance is due to the increased smoke in the area from local wildfires. The other two PQ200 units at RRM also measured very high readings that day (97% and 99%). Below I have also attached the E-Sampler readings for the day which show consistently elevated total suspended particulate readings over the 24 hours from July 15, 2021.

Figure 1 Barron Site E-Sampler readings for July 15, 2021 (ug/m3)

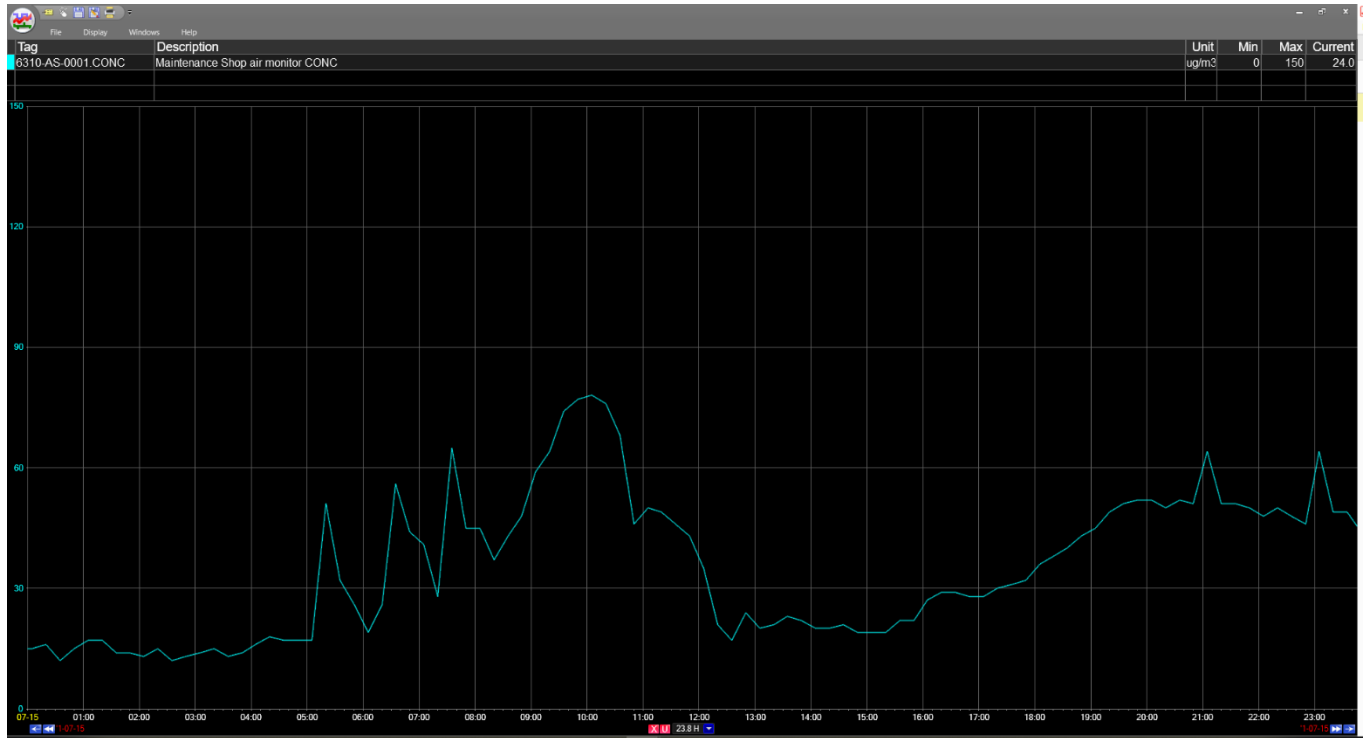
Figure 2 Gallinger Road E-Sampler readings from July 15, 2021 (ug/m3)

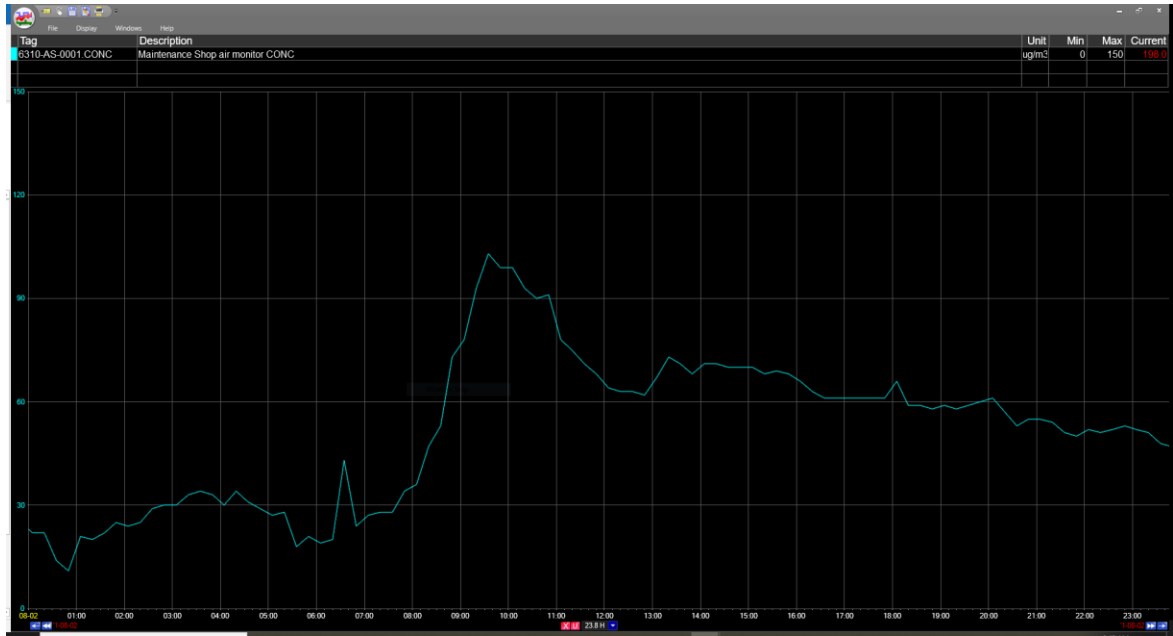
The cause of the exceedance is due to the increased smoke in the area from local wildfires. The third air quality station, Tait Road Monitoring Station, also reported a high sample reading of 53.38  $\mu\text{g}/\text{m}^3$  but was deemed to be an invalid sample due to exceeding the total volume limit. Below I have also attached the E-Sampler readings for the day which show consistently elevated total suspended particulate readings over the 24 hours as well as an Air Quality Advisory for International Falls for August 2, 2021. I have also included the Coarse Ore Stockpile height during those 24 hours.

Figure 2 Gallinger Road E-Sampler readings from August 2, 2021 ( $\mu\text{g}/\text{m}^3$ )

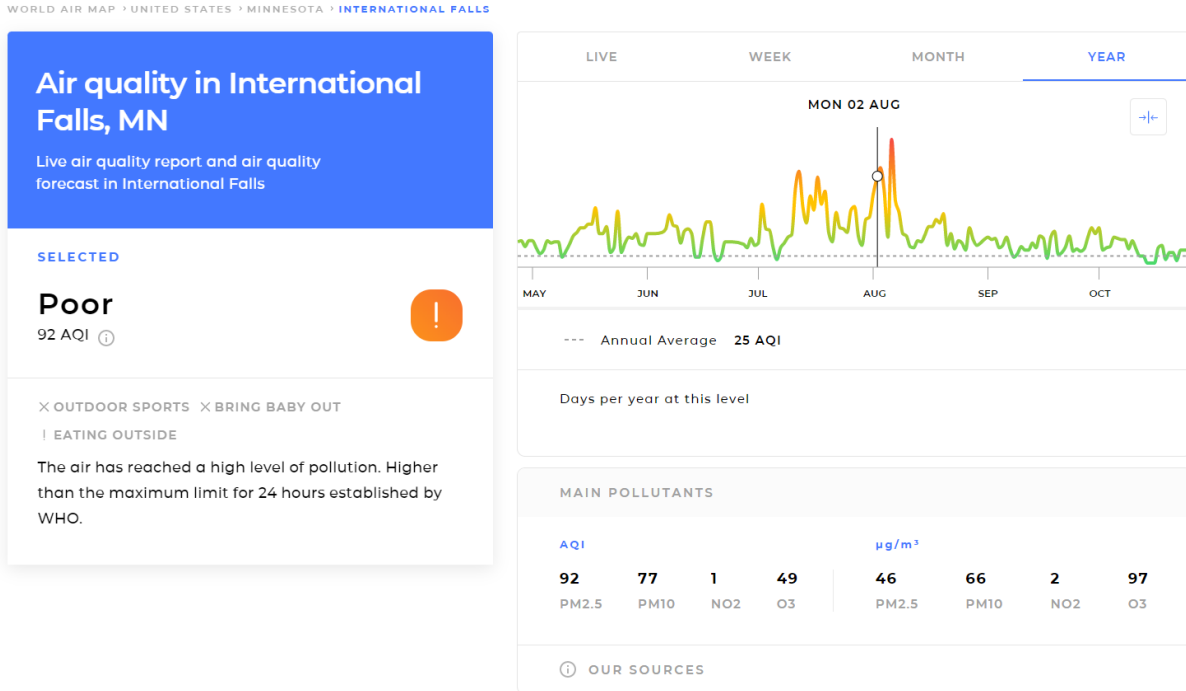
Figure 4 Air Quality advisory for International Falls, MN for August 2, 2021.

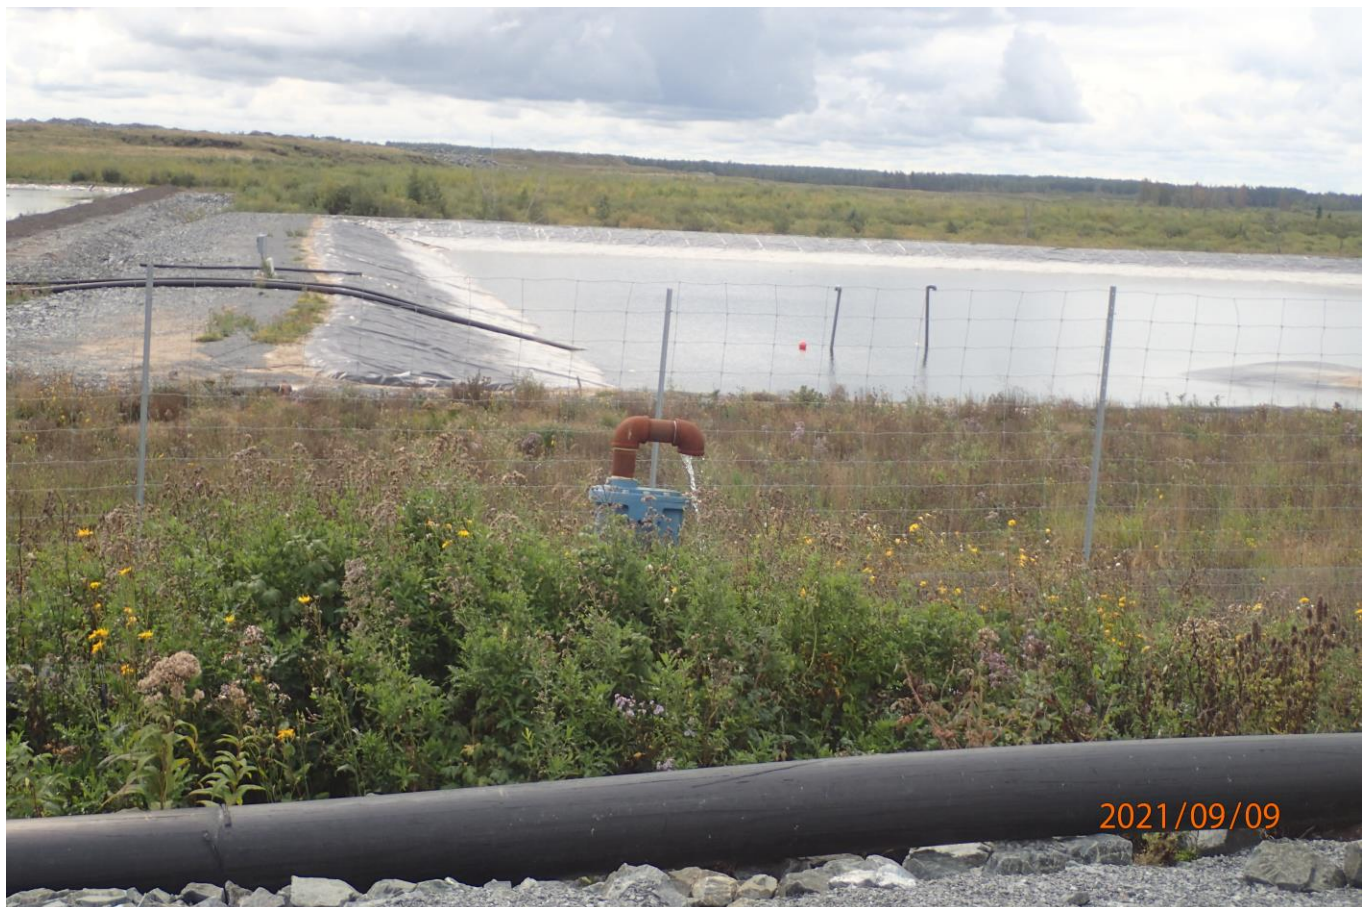
Photo 1: Leaking valve.

The bucket test indicated a total loss of 33.6 m<sup>3</sup> of water, if we assume the leak started immediately after the valve was last observed functioning at 10 am, the previous day, by New Gold Environment staff during water level checks. Given the

No cleanup was attempted for this event as it would have caused more harm than good to the surrounding environment. To prevent this from reoccurring a different style of valve will be selected or an isolation valve will be added.

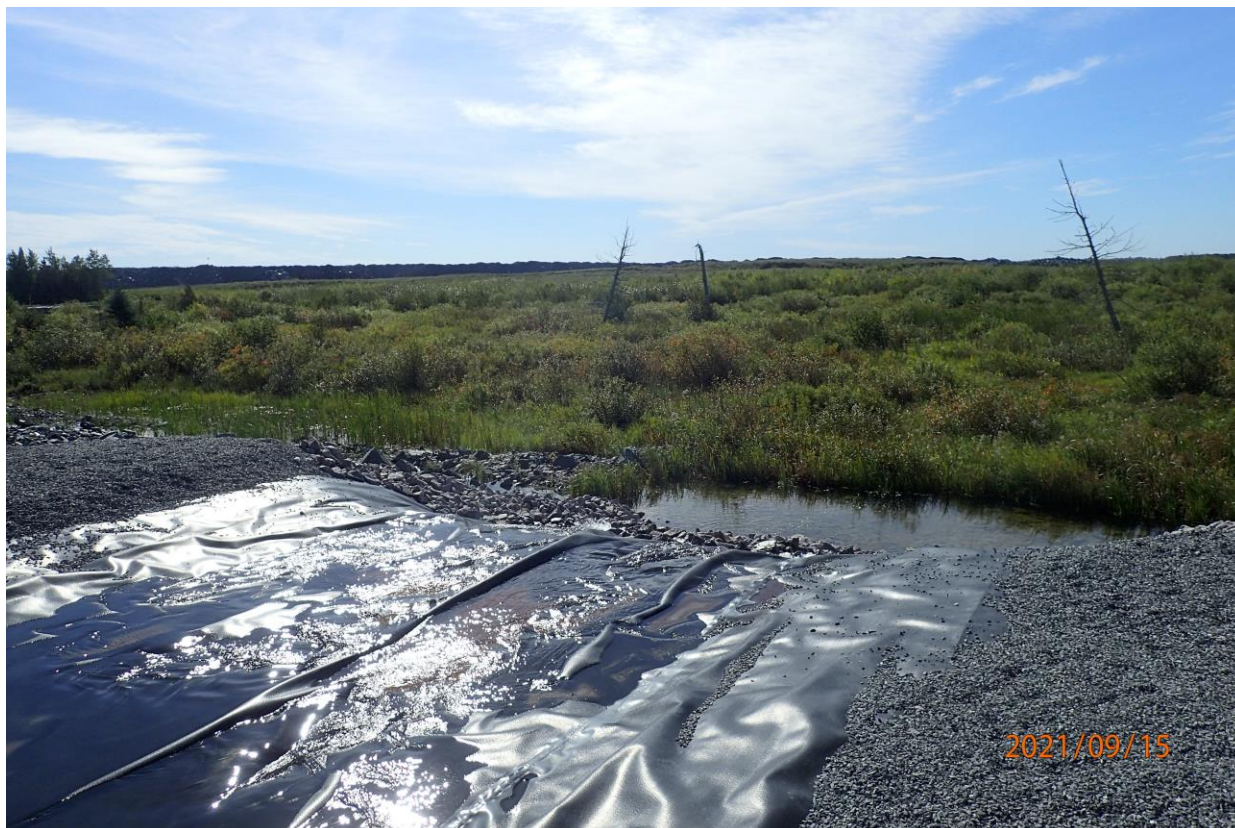
Photo 1: Outflow Basin emergency spillway active.

The volume of water lost is estimated to be 21,000 m<sup>3</sup> of treated mine effluent and would have made it to fish bearing waters in Loslo Creek and the Pinewood River. The primary reasons for this occurrence are that the pump sending water from OB to WMP lost prime and the level indicator for OB was not calibrated correctly. Please refer to the screen shot below from PARCView for greater detail and timeline.

As mentioned in the table above, sensors have been recalibrated, additional personnel are being assigned responsibility, the requirement for visual observations and documentation has been made clear and cameras will be added in this location in an effort to ensure this does not reoccur.
