Red Mountain Geophysical Baseline

Red Mountain Geophysical Base Line

Final Report

March 29, 2017

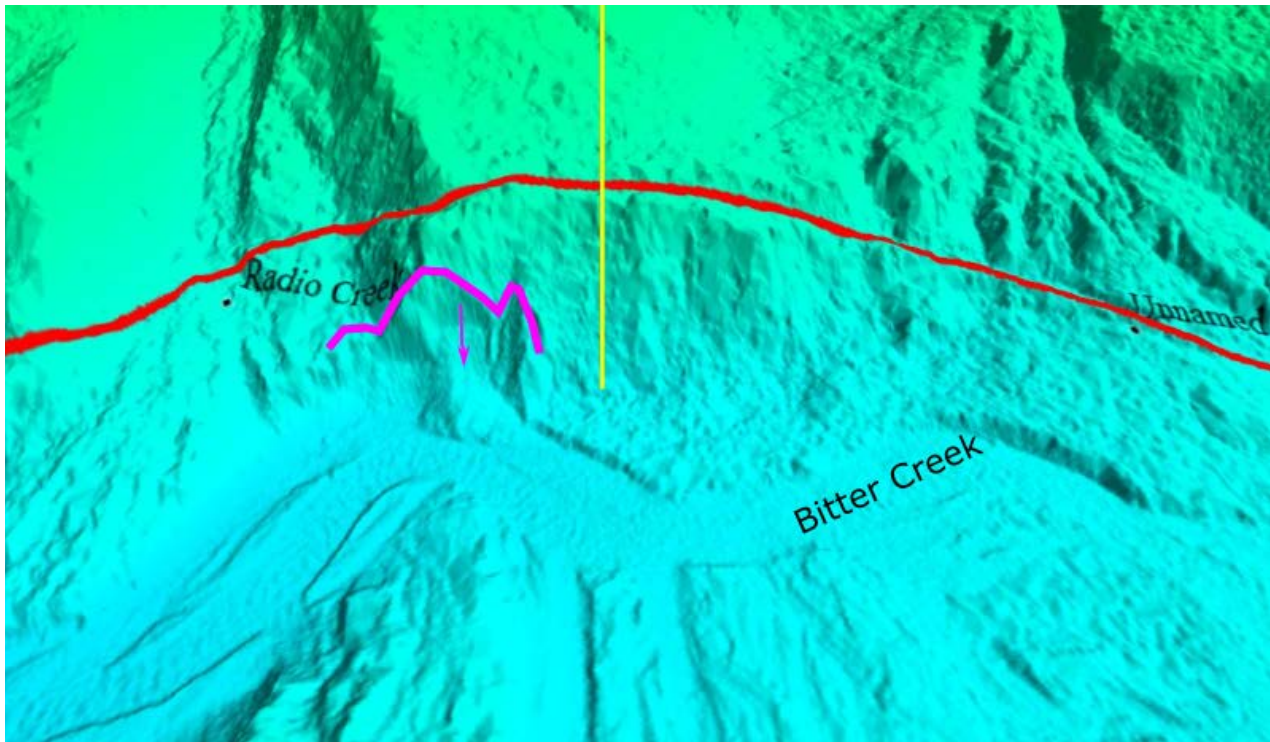
- › There appear to be undercut slopes along Bitter Creek below the proposed road at Radio Creek (Figure 3-1);

Figure 3-1: Radio creek slumping (pink arrow denotes direction of movement)

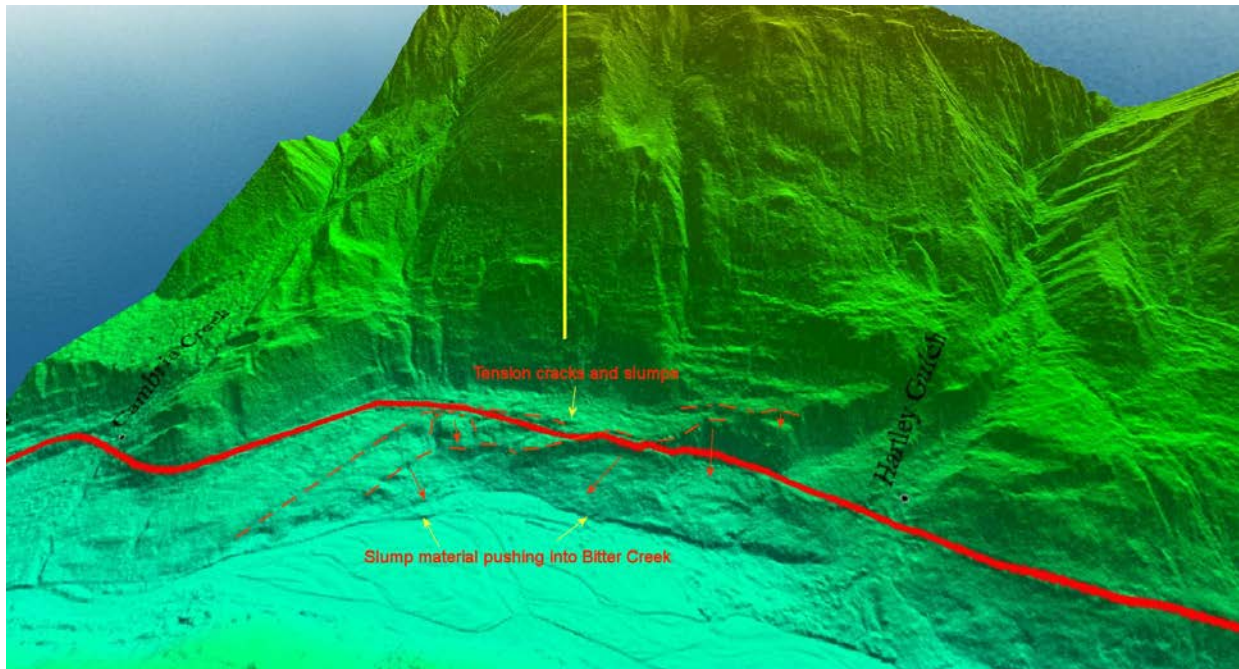
- › Tension crack and slumping features appear to exist at the road between Cambria Creek and Hartley Gulch (Figure 3-2);

Figure 3-2: Appearance of tension crack and slumping between Cambria Creek and Hartley Gulch (Note: red arrows denote direction of movement; thick red line denotes access road).

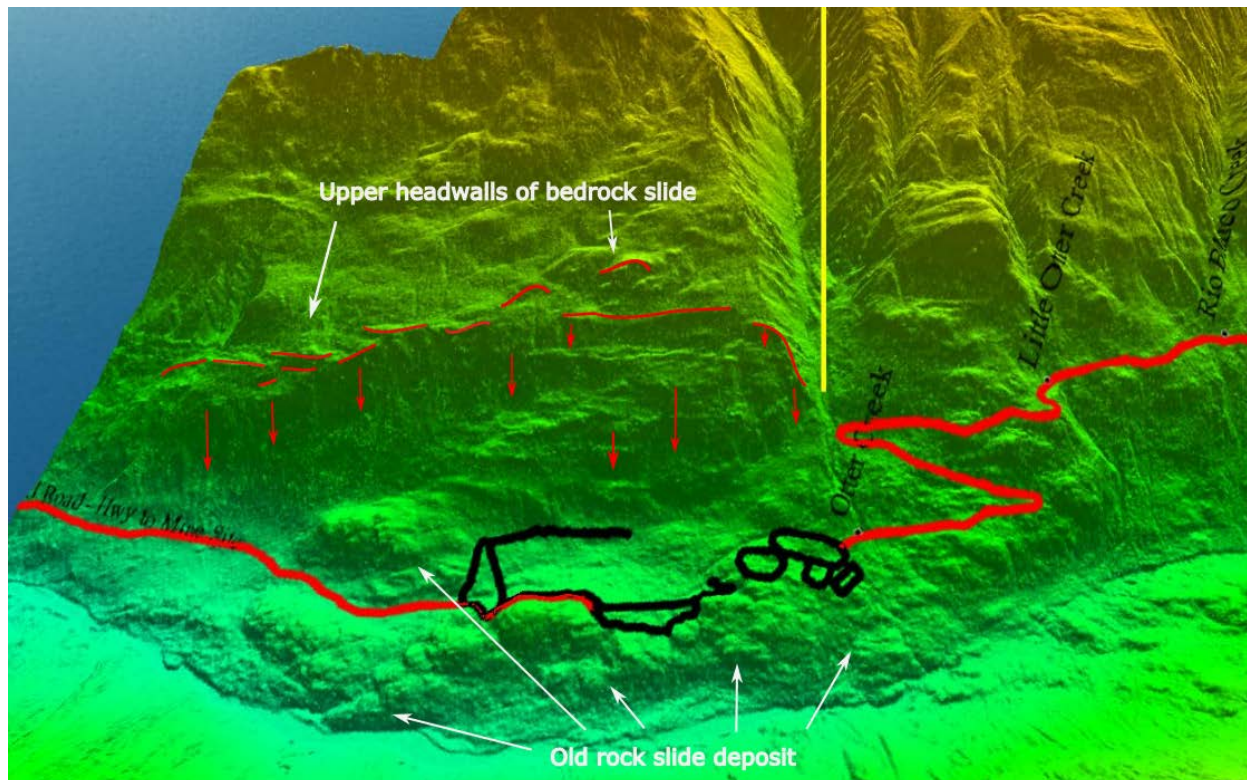
- › LiDAR imagery shows the potential existence of a possibly pre-glacial, rotational rock slide (slump). The potential slide is evidenced by possible redirection of the Bitter Creek channel below the Bromley Humps and valley walls, dropped blocks and possible tension cracks upslope of the Bromley humps (Figure 3-3). Till and glacial striae, found along the proposed road at field location WP-73 (Figure 3-4 and Figure 3-5), indicate that this potential feature is likely pre-glacial. The material (bedrock, either in-situ or a displaced block/mass) is resting at valley bottom and is more than likely dormant. Core data provided to SNC-Lavalin, taken from recent drilling within the Bromley Humps area conducted by others, describe high fracture density, numerous broken and sheared and brecciated zones, and some slickensided joint faces. These descriptions indicate past deformation of the rock, which could have resulted from mountain building processes, glacial ice advances and recessions, rock sliding, or a combination of these processes. Engineering designs of the surface facilities in this area should evaluate the stability and activity of this site (at the north valley headwall and within the Bromley Humps).

Figure 3-3: Possible bedrock displacement above Bitter Creek and the proposed road and infrastructure near Otter Creek (Note: red arrows denote direction of potential original slide movement from headwalls; white arrows denote the potential deposition zone; thick red and black lines denote access road and infrastructure, respectively).

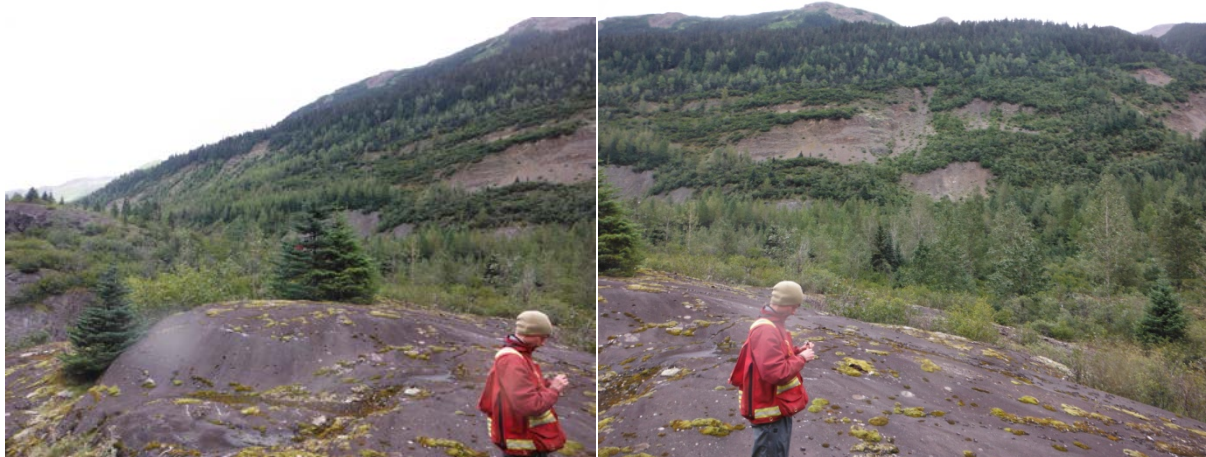
Figure 3-5: Photos from WP-73 facing north-northeast towards Otter Mountain. Showing rotational surficial slides on the slopes of Otter Mountain on the right of the photograph and fluted and striations on rock trending roughly southeast to northwest.

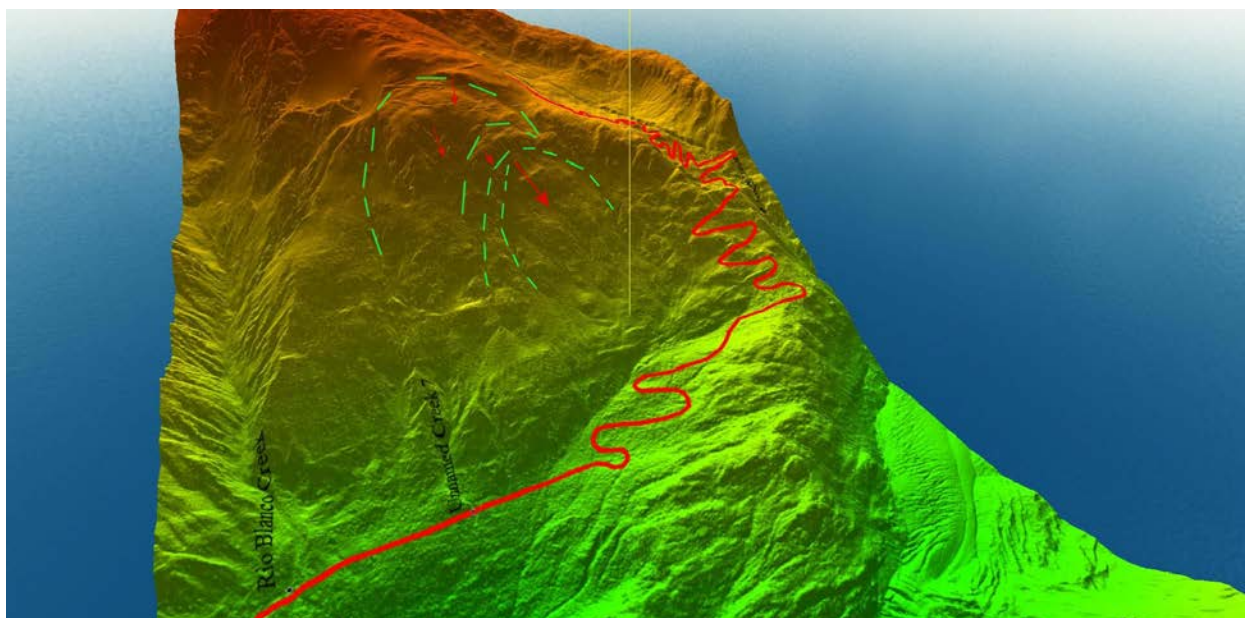
- › Inactive (KCC, 1994) and potentially active bedrock rotational slides (slumping) at Red Mountain (Figure 3-6). The Red Mountain slide appears to be dormant upslope but may be more active down slope and as such, should be assessed to determine active state.

Figure 3-6: Inactive and potentially active bedrock rotational slide at Red Mountain
(Note: red arrows denote direction of movement; red line denotes access road).

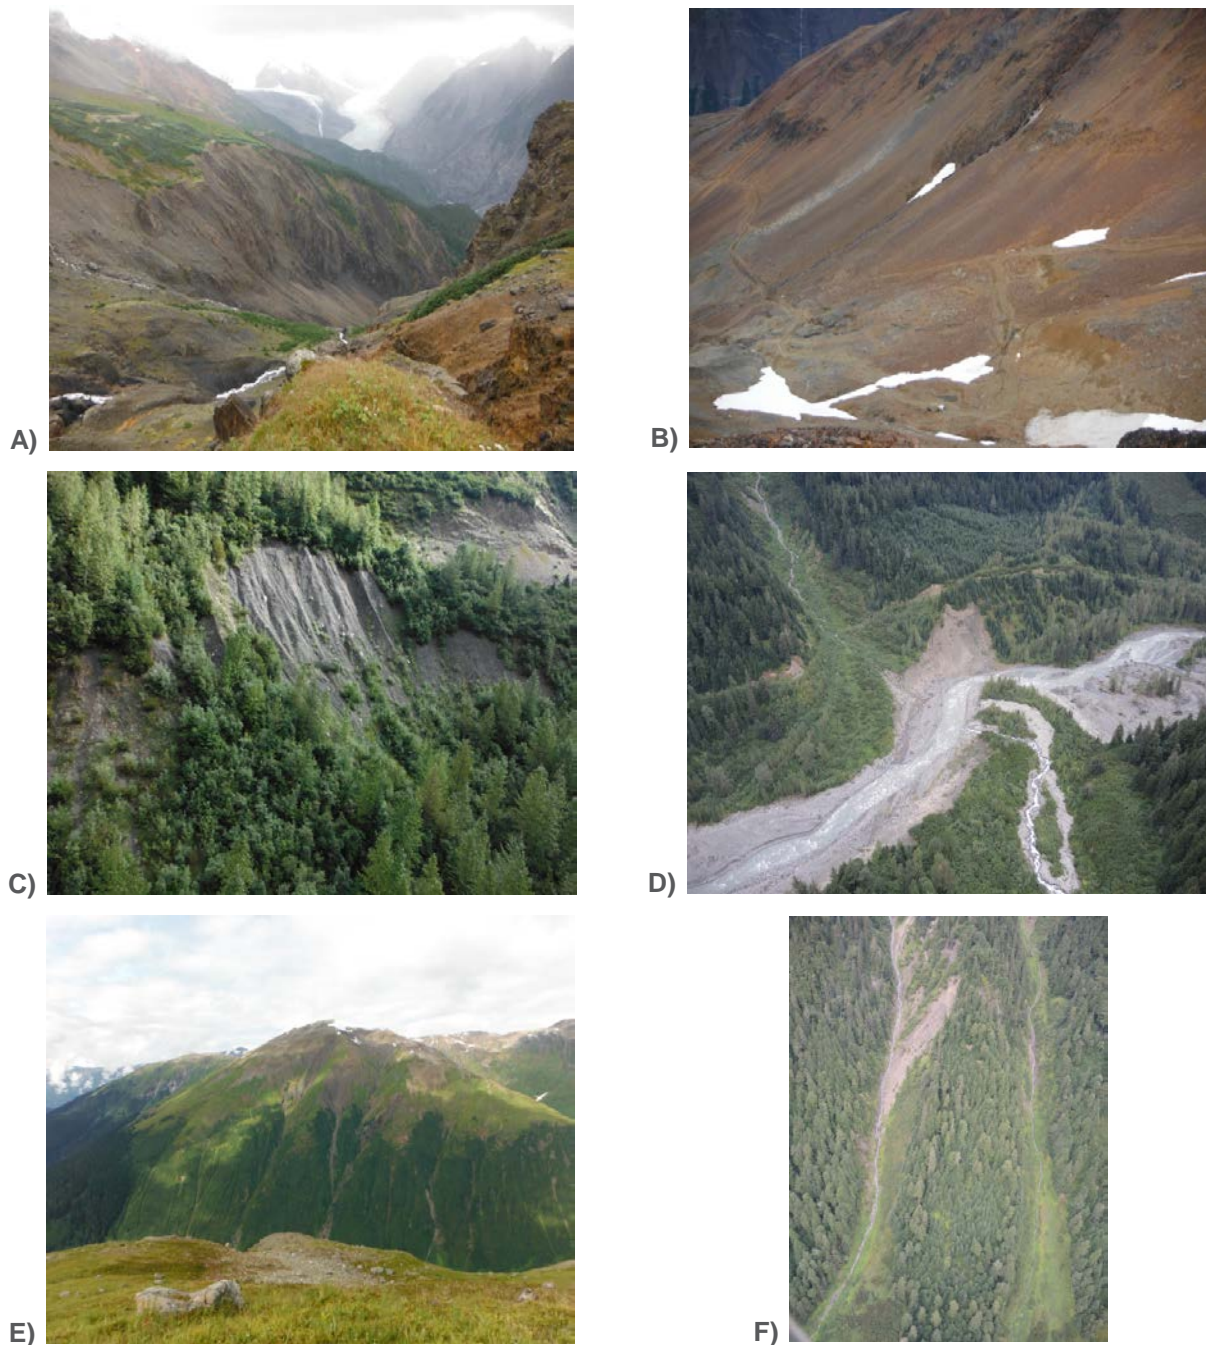
Debris flows have the greatest runout distance of any rapid mass movement observed in the GeoRSA. The source areas are primarily located at high elevations within the steep mountain creek watersheds on the steep valley sides and in the channels where loose debris has accumulated (Figure 3-7A). Entrained material is transported through the major channels, and deposited in the lower valley on fans (Figure 3-7D, E, and F). Debris flows are therefore anticipated to impact the access road at crossings of these creeks and fans. Due to the high volume of sediment supply and availability, many of these watersheds are transport-limited, and debris flows may occur when critical climatic thresholds are exceeded (Jakob, 2005). Where debris flow activity is located in close proximity to permanently occupied structures, such as the Otter Creek fan near the TSF, further investigation and mitigation plans are warranted.

Figure 3-7: Landslides and Avalanches in the GeoRSA. A) Rock fall and debris flow source accumulation in Otter Creek; B) Rock fall in Goldslide Creek cirque above the access road; C) Debris falls in gullied till above the proposed TSF; D) Debris flow fan and rotational slide at Radio Creek; E) Mixed major and minor avalanche tracks and debris flow channels in the Roosevelt Creek watershed; F) Debris fall and debris flow channel with major avalanche tracks Unnamed Creeks 5 and 6.

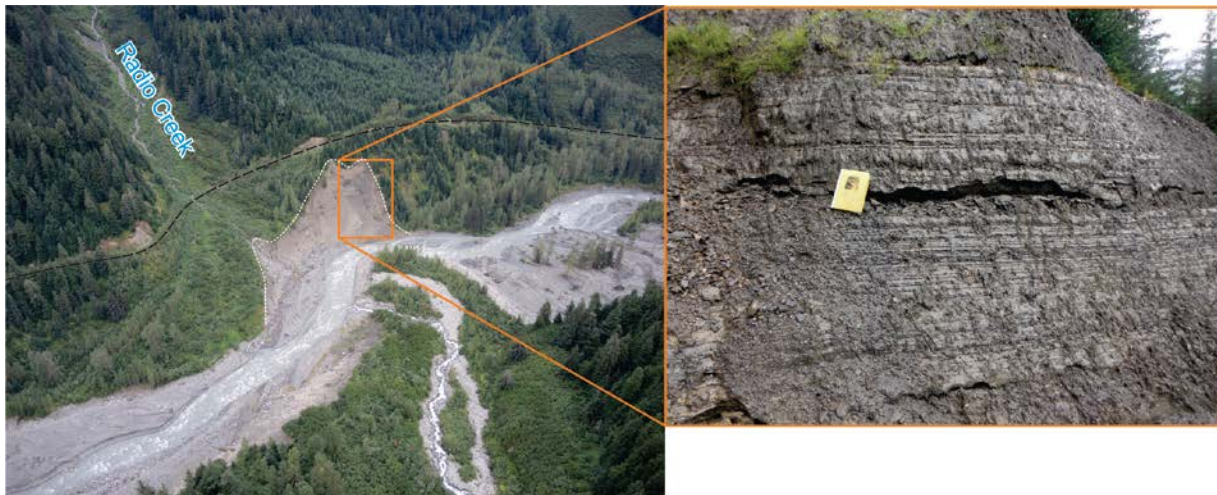
The valley widens to an active floodplain approximately 250 m across in this reach and the stream gradient lessens to approximately 2.1 %. Bitter Creek is joined by Roosevelt Creek, and the input of sediment contributes to the aggradational nature of the reach. At station 10+700, there is a slight constriction where the Swarm Creek fan extends into Bitter Creek, deflecting the channel into the right bank. Between 1994 and 2013, channel migration into the right bank has ranged between 10 and 20 m in several locations. From station 10+700 to 12+000, lateral erosion into softer glaciolacustrine banks is creating slope instabilities adjacent to the road (for example, at 10+800 in Appendix I-003 and Figure 6-2).

Figure 6-2: Bitter Creek bank failure in glaciolacustrine deposit, near Radio Creek (station 10+800). The headscarp is shown in white; dashed line shows approximate access road route.

Lateral erosion is presently undermining the pre-existing road where the proposed access road is slated to be built. This is apparent where the Bitter Creek channel is directed around the Swarm Creek fan toward the right bank at Radio Creek. This is triggering a failure in glaciolacustrine material as the toe of the slope is removed (Figure 6-2). As northward channel migration is expected to continue, this failure may retrogress toward the proposed access road as material is removed by the river. Additionally, at station 11+800, the main channel has shifted into the right bank by 50 m which has washed out a section of the previous road. Steep upper slopes confine the channel in this reach, which leaves little flexibility to set the road back from the erosive channel.

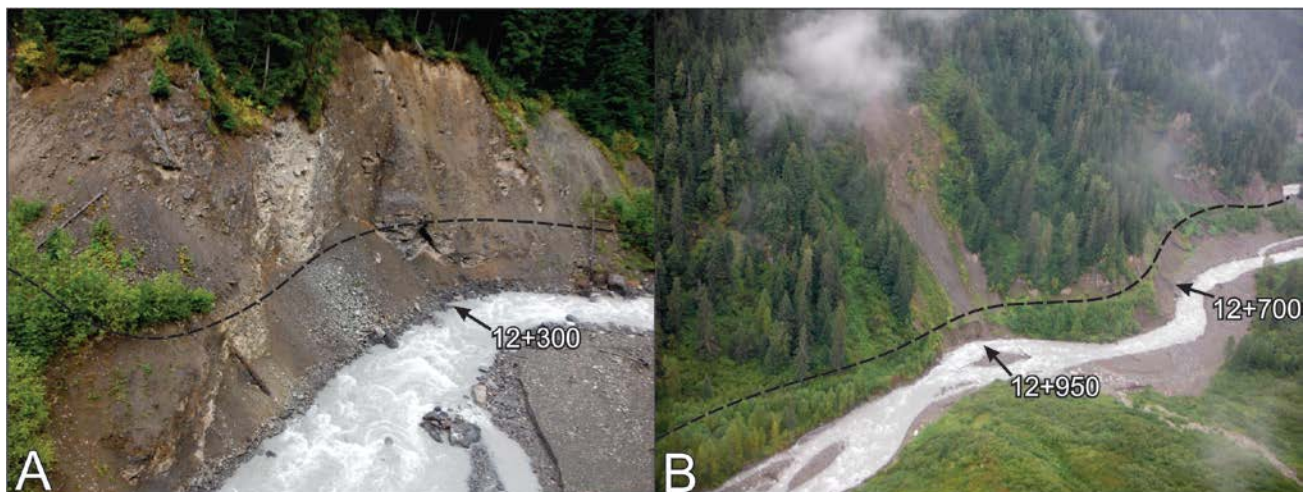
Similar to the previous reach, lateral erosion is presently undermining the pre-existing road that the new access road will follow. The road has been undercut and washed out in several locations in this reach (near stations 12+300, 12+700, 12+950, and 13+600; Figure 6-3). At station 12+700, the proposed access road is within the main channel (see Appendix H-002). Natural fluvial processes will continue to erode laterally into the right bank and continue to undercut the access road unless protective measures are implemented. The steep confining hillslopes leave little flexibility to set the road back from the erosive channel.

Figure 6-3: Recent lateral erosion at A) Station 12+300; and B) 12+700 and 12+950. Black arrows denote direction of channel migration; dashed line shows approximate proposed access road route.

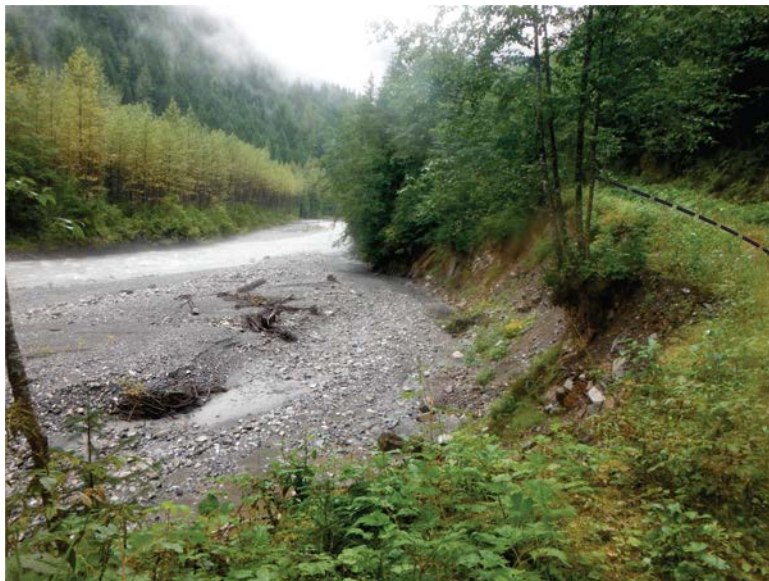
There are two locations where the main channel encroaches to within 10 m of the proposed access road: station 15+000 and 15+800 (Figure 6-4). Since 1972, Bitter Creek has eroded into the right bank by 10 m at 15+000 and by 30 m at 15+800. At these rates, washouts of the proposed access road may be expected within 31 and 14 years respectively.

Figure 6-4: Lateral erosion and washout near station 15+000. Dashed line shows previous access road.

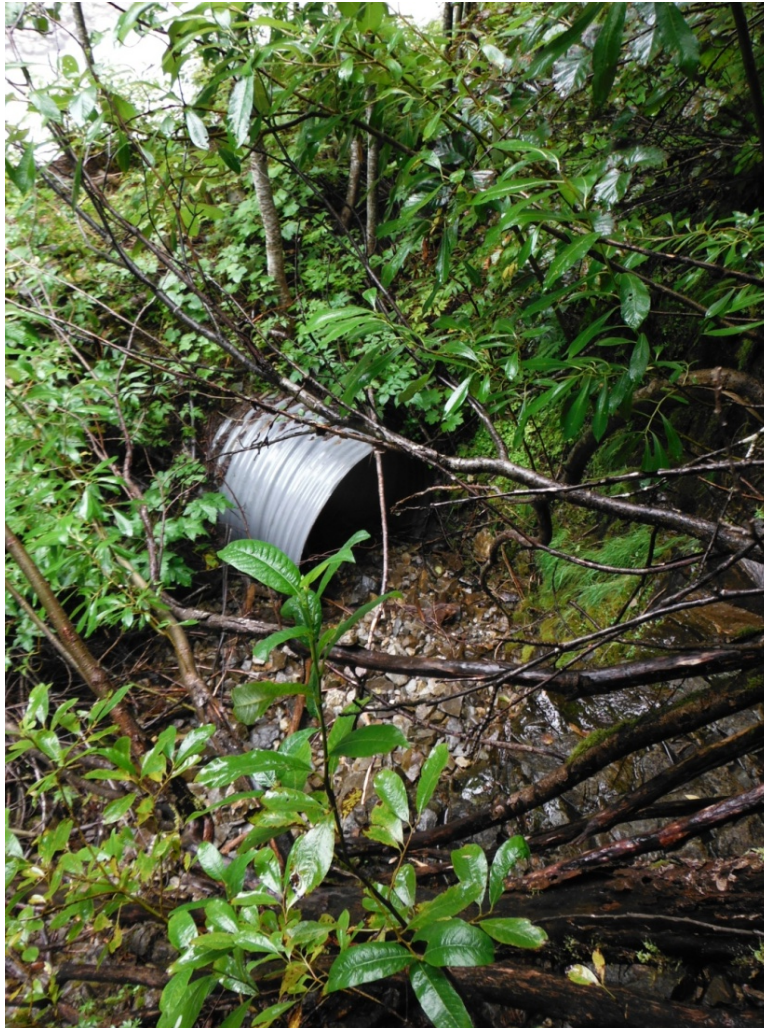
Figure 7-2: Culvert outlet below former road at Unnamed Creek 2.

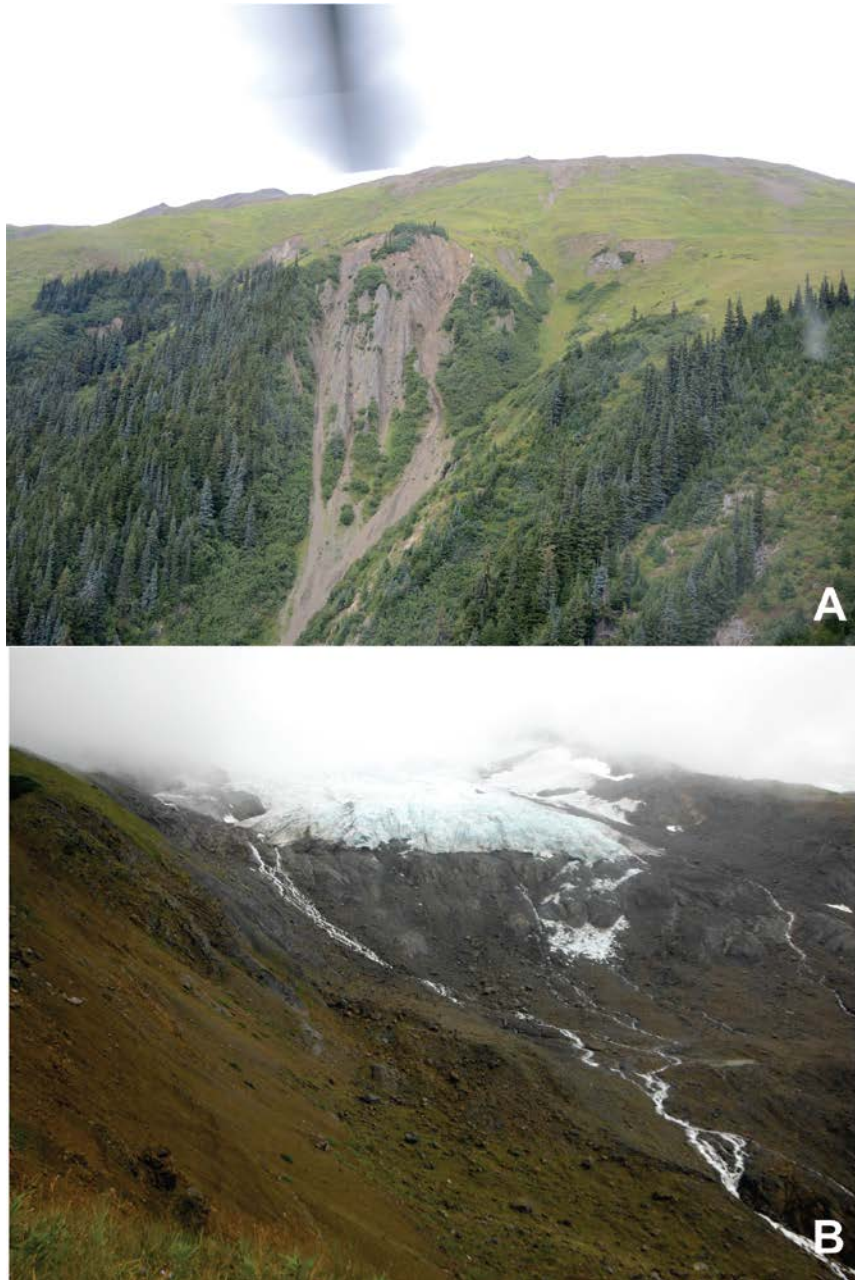
Figure 7-3: Examples of actively eroding areas and transport-limited watersheds. A) Debris flow channel with multiple branches and significant accumulation of debris mobilized by water run-off (Unnamed Creek 6). B) Unvegetated slope showing unconsolidated rock fragments, covering bedrock (Otter Creek)

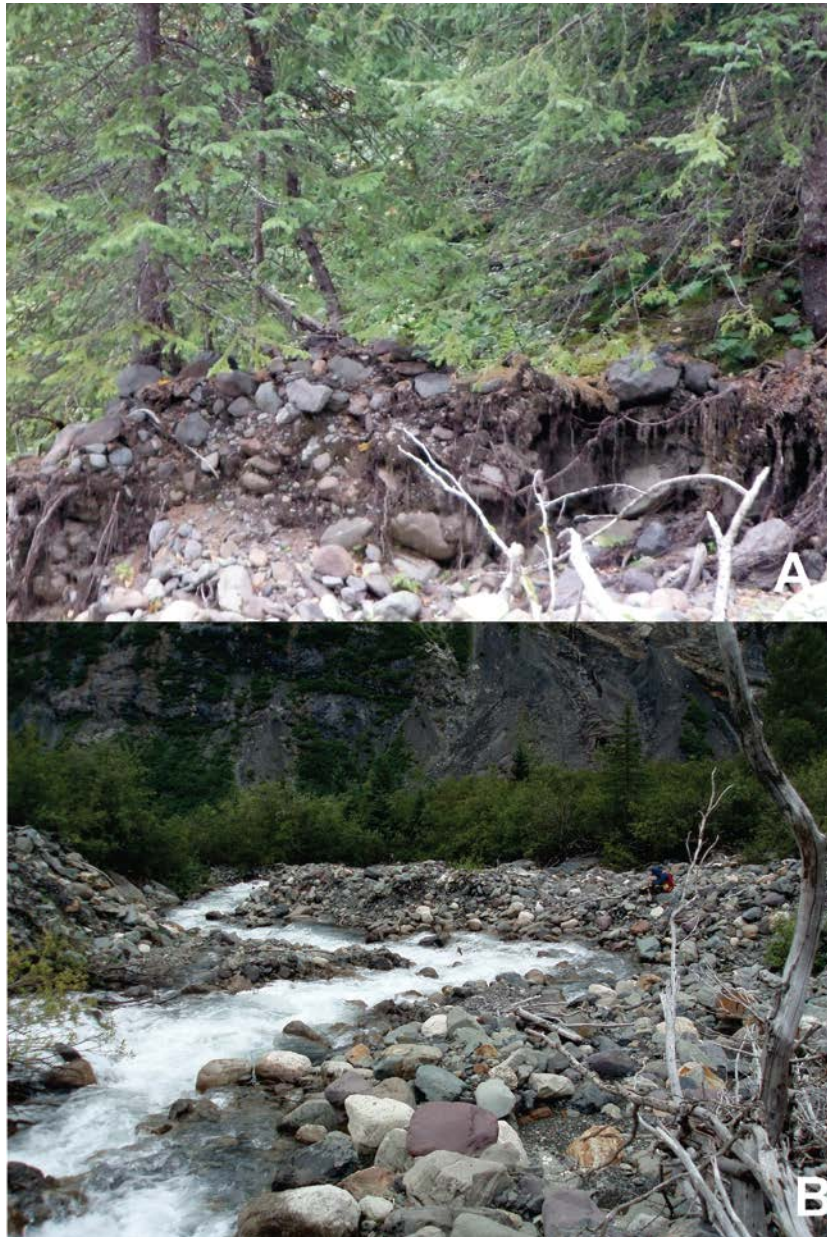
- › Deposition zone: fans vary in size and activity. Active fans within the GeoRSA are generally unvegetated or covered with low pioneer vegetation; lobes and levees are visible on ground or LiDAR, boulders on levees and debris flow deposits are very loose (Figure 7-4).

Figure 7-4: Some examples of debris flow evidence within the transport and fan zone. A) Debris flow deposit at Cambria Creek. Note range of particle sizes and angularity of boulders. B) Bare fan displaying large boulders and step-sided levees (Otter Creek)
