APPENDIX B

Photos of Stream Crossings

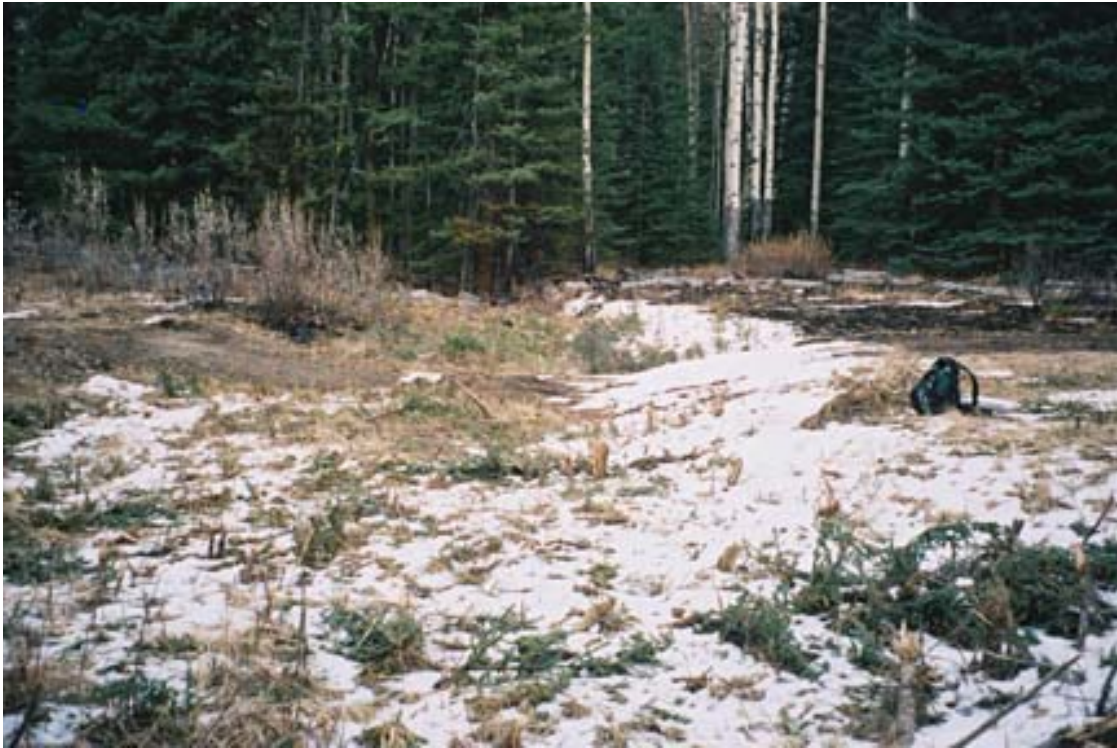
Photo 1. Dry streambed from east end of Johnson Lake (M54L Poles 253-252), November 2002. Creek is also dry at pole crossings 249-248 and 259-258, allowing year-round access.

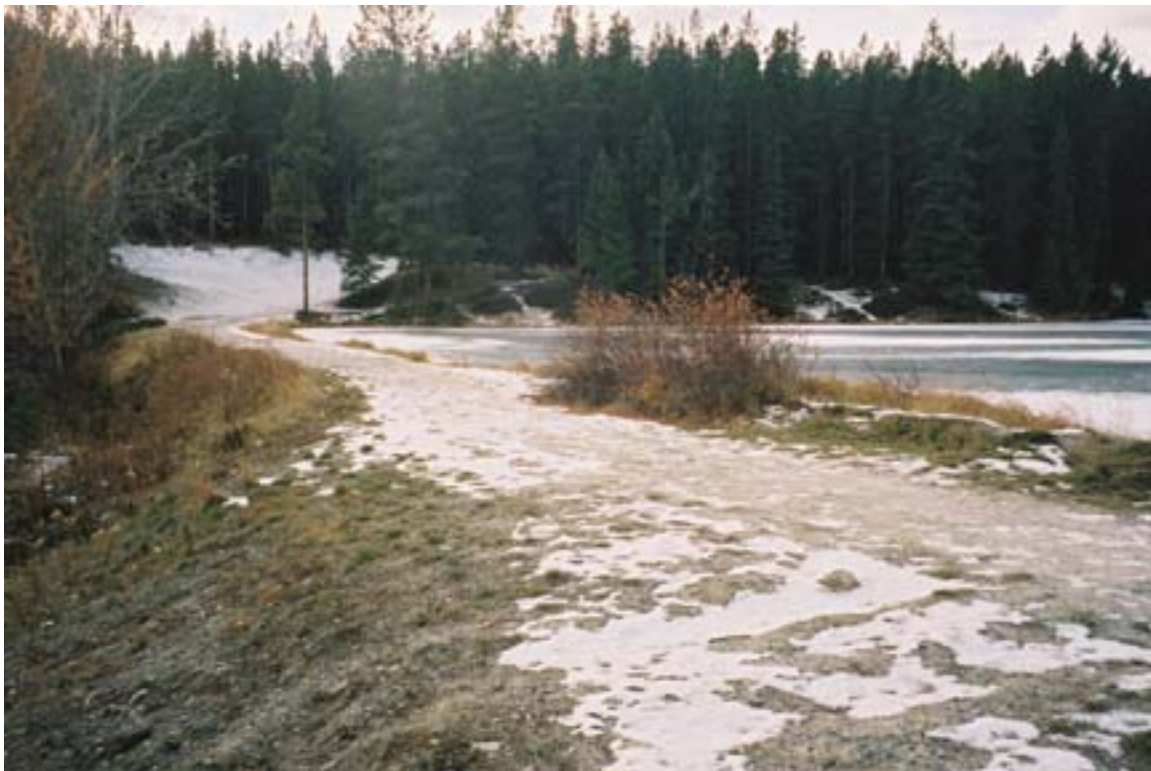
Photo 2. Berm at east end of Johnson Lake, November, 2002. Berm prevents flows to the east and resulting in dry streambeds at M54L Poles 249-248, 253-252 and 259-258.

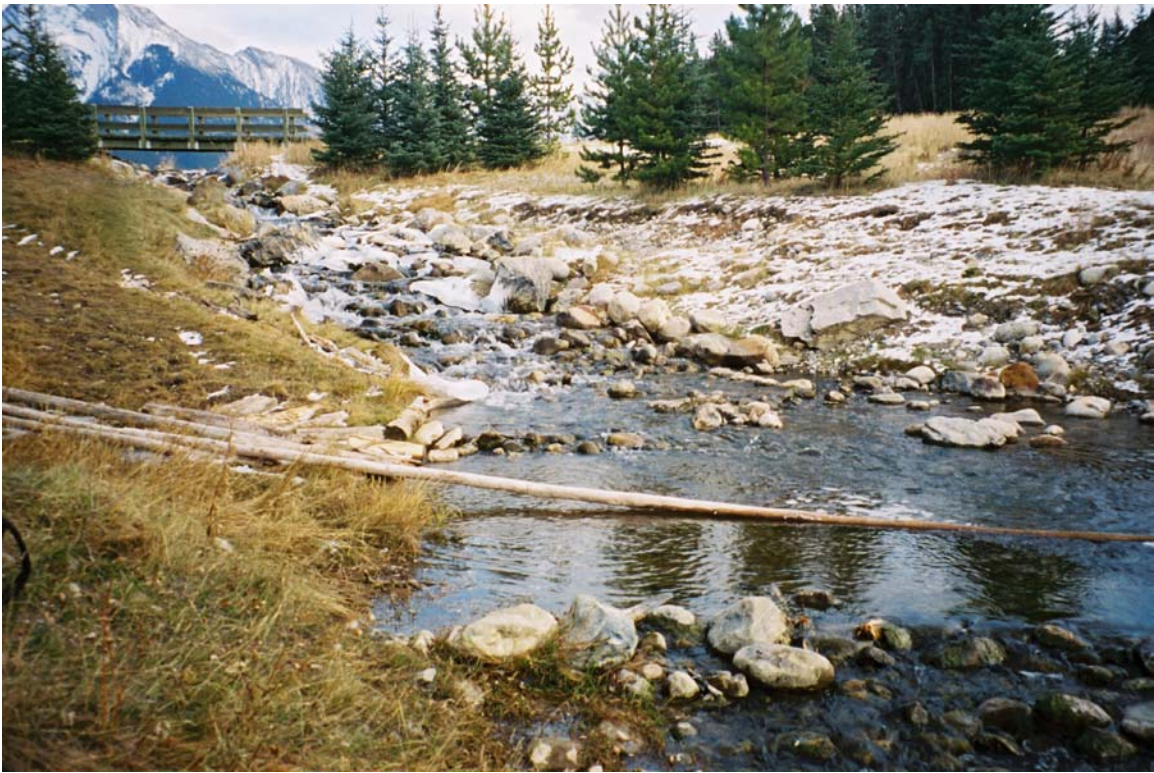
Photo 3. Unnamed creek from Johnson Lake (M54L Poles 265-264), November 2002. The low and stable streambanks are suitable for crossing throughout the year.

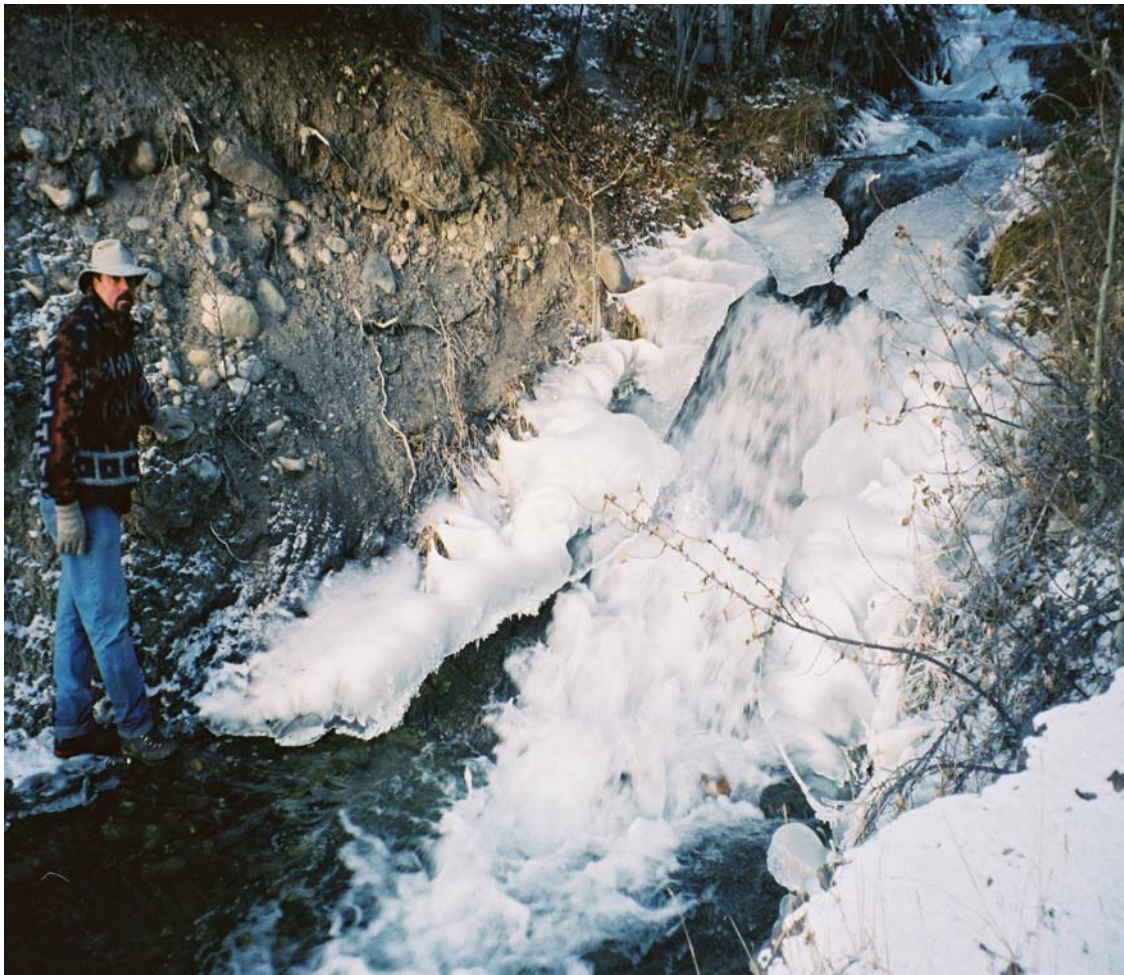
Photo 5. Unnamed creek from Johnson Lake just downstream of the crossing, December 2002. A series of steep falls prevents upstream fish migration, and limits fish habitat in this creek.

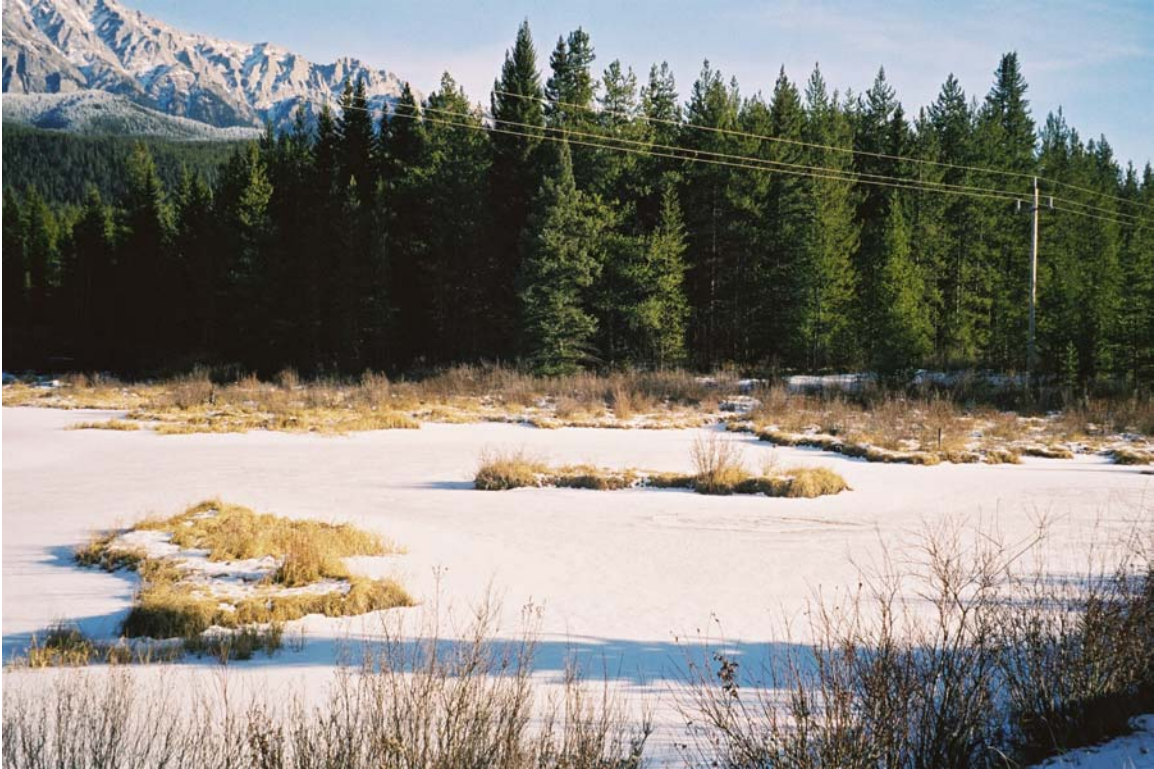
Photo 9. Borrow Pit Springs (M551L Poles 190-189), December 2002. Creek is frozen to substrate at this crossing, allowing winter access.

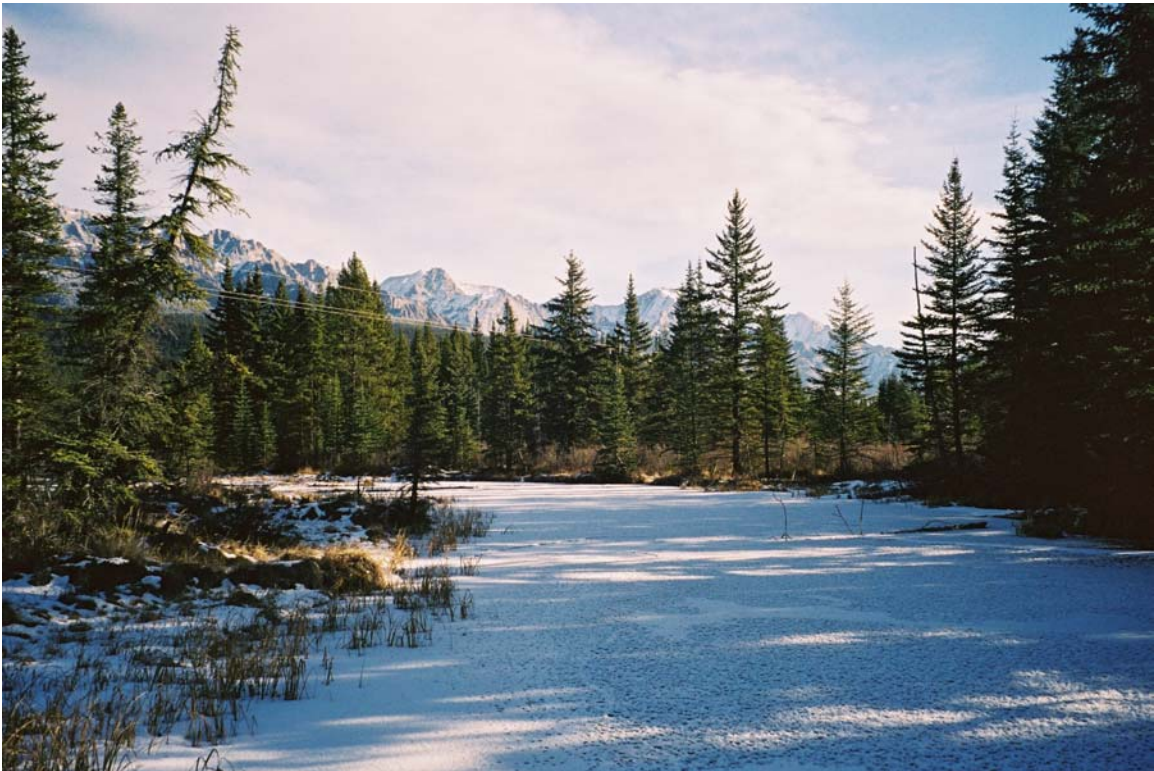
Photo 10. Borrow Pit Springs (M551L Poles 195-194), December 2002. The creek is partially frozen over at this crossing.

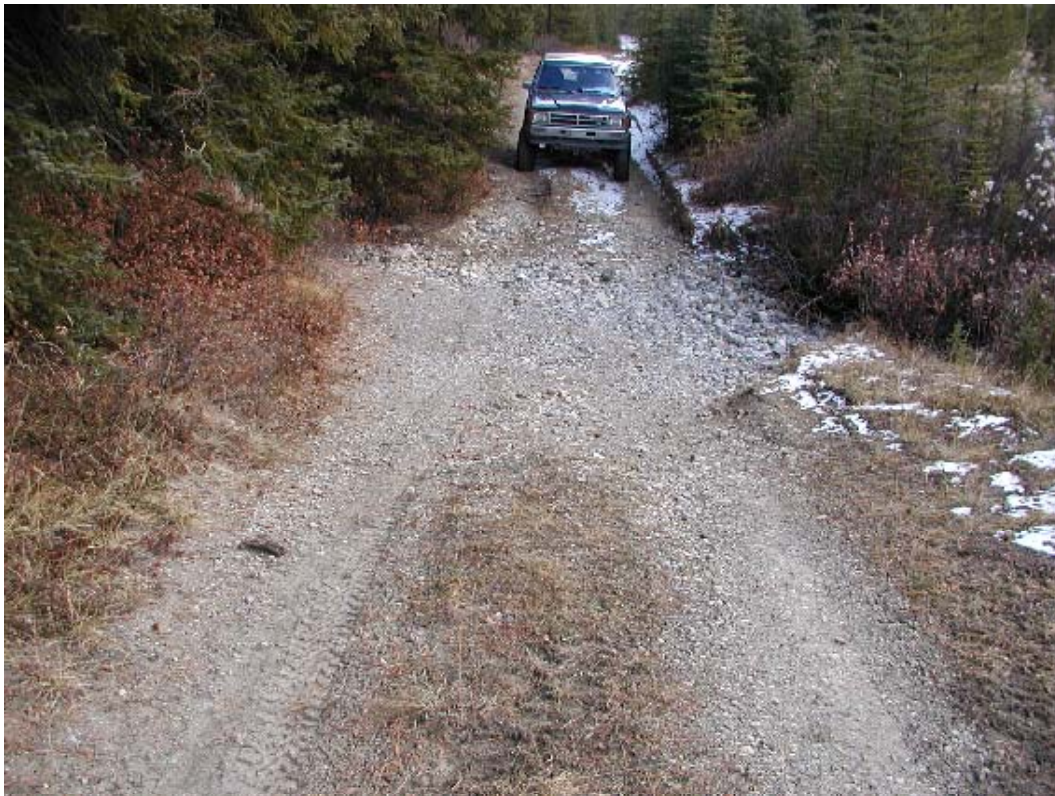
Photo 11. Silverton Creek (M551L Poles 337 – 236A), November 2002. The streambed is completely dry, allowing winter access.

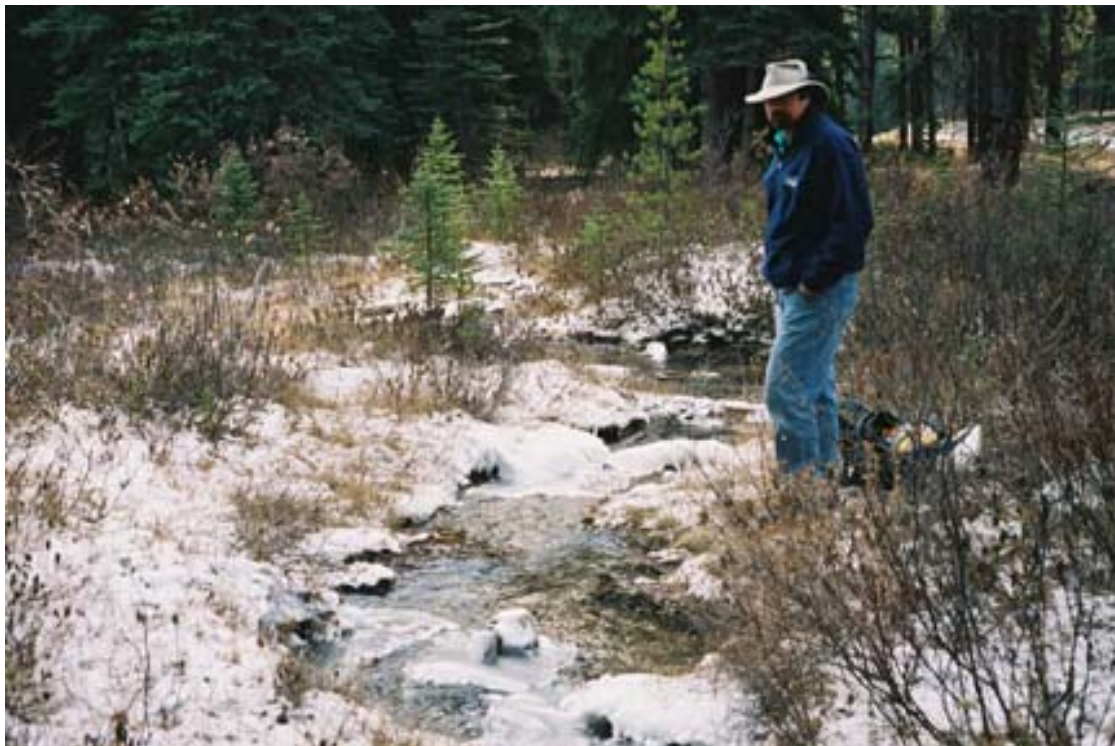
Photo 12. Unnamed Creek to Bow River (M551L Poles 284-283), November 2002. Creek flows year round, however, alternate access is available and stream crossing unnecessary.

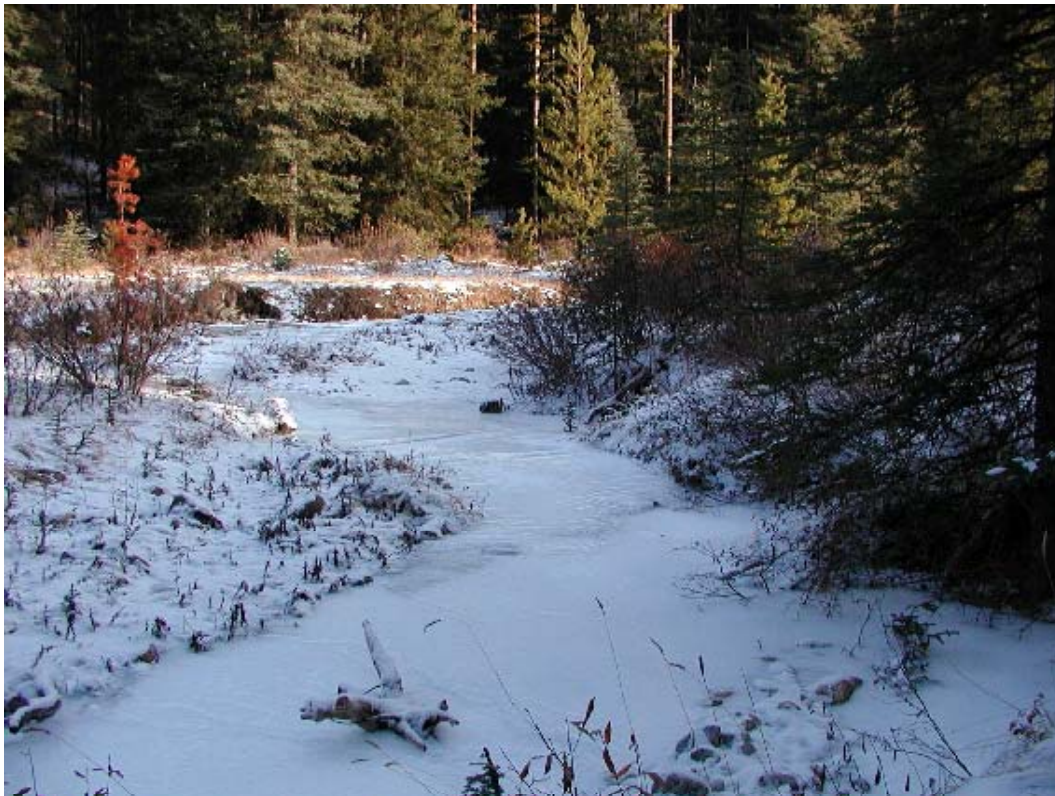
Photo 13. Unnamed Creek to Bow River (M551L Poles 330-329), November 2002. The creek is frozen to the substrate, allowing winter access. Access will depend on ingress and egress routes across the streambanks, which appear to be mobile.

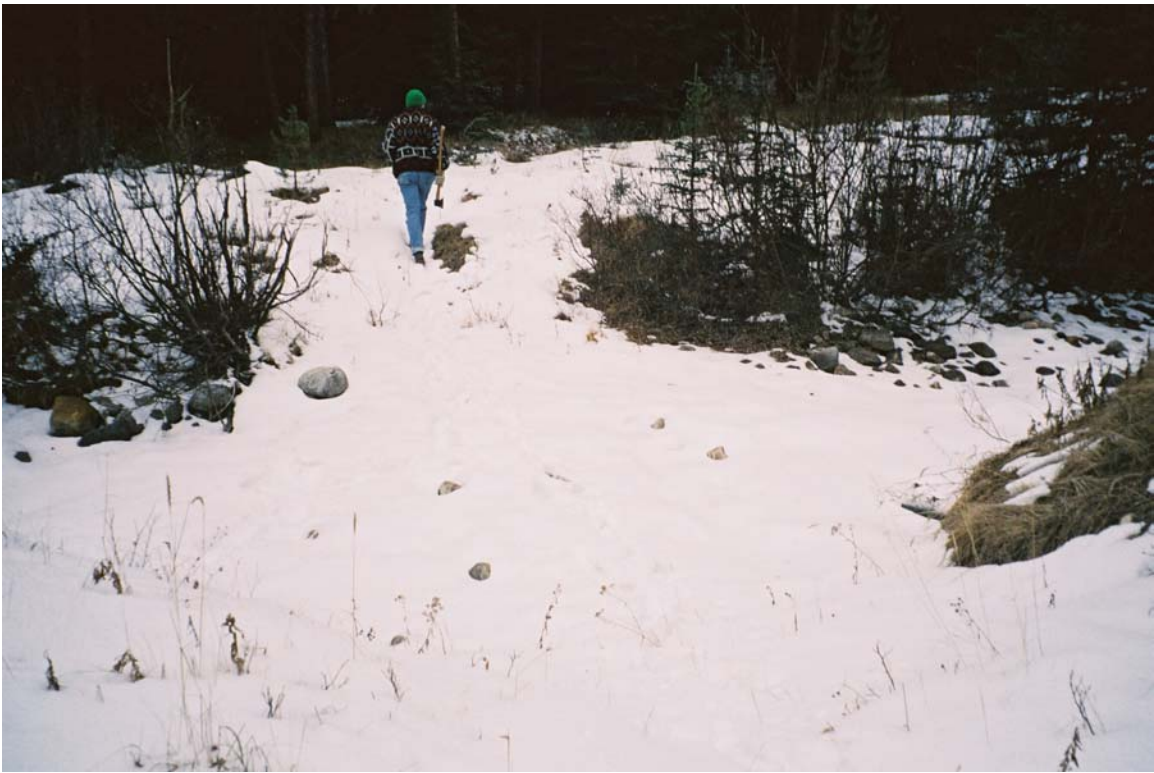
Photo 14. Corral Creek (M551L Poles 442-441), December 2002. The creek is dry and frozen to the substrate, allowing winter access.

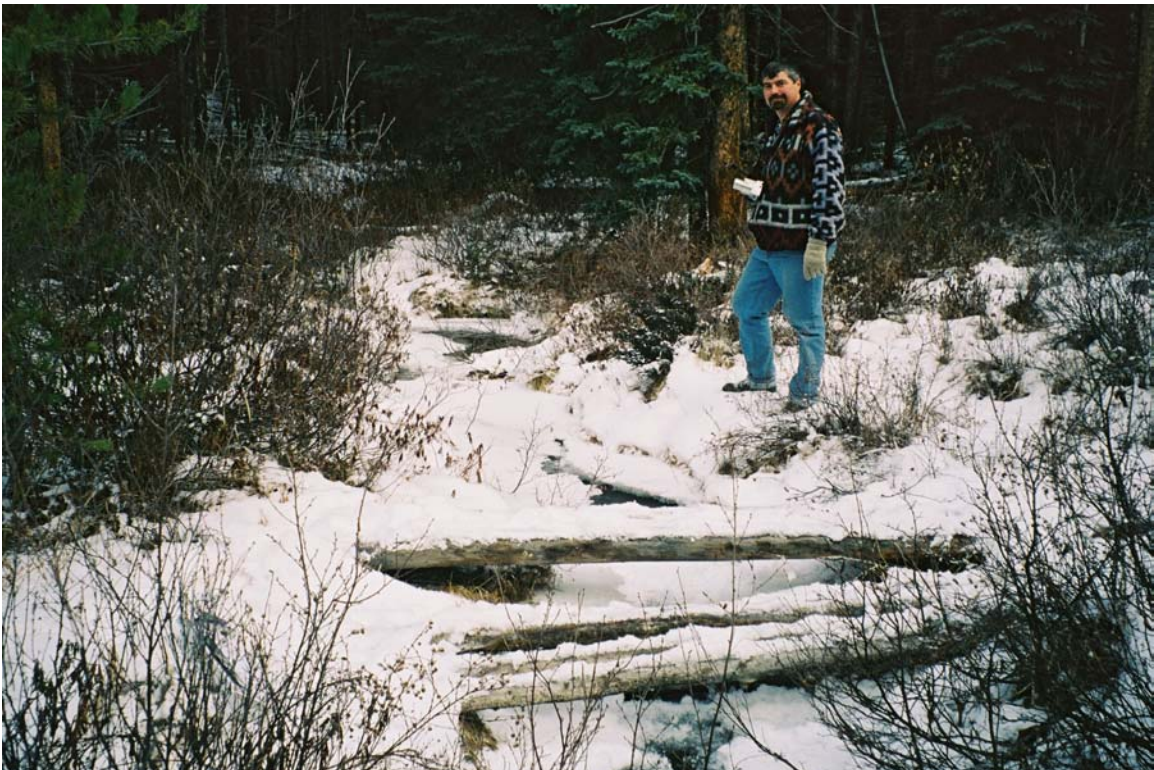
Photo 15. Unnamed Creek (M551L Poles 447-446), December, 2002. Streambed flows continuously at this crossing. Banks are suitable for log crossing all year.

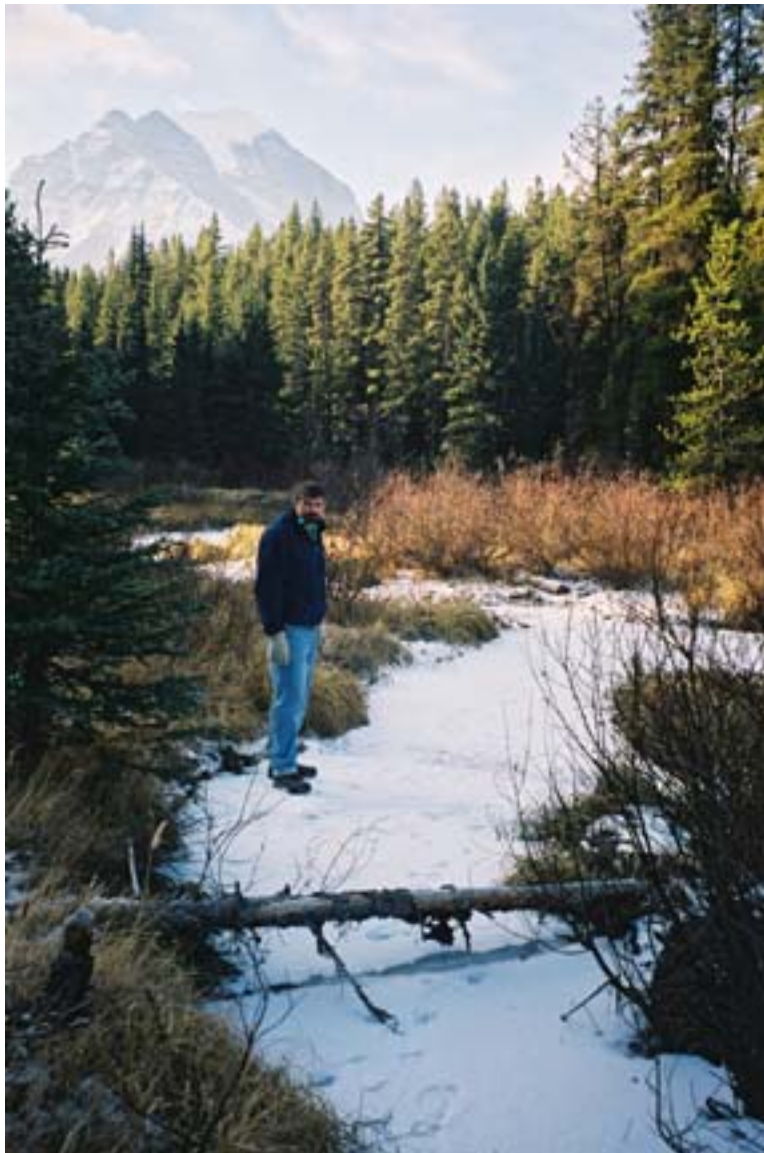
Photo 16. Unnamed Creek to Kingfisher Lake (Poles 458-457), November 2002. The creek is frozen to the substrate, allowing winter access. The low and stable streambanks are suitable for a log crossing during the rest of the year.
