**Hillslope and Fluvial Processes Along the
Proposed Pipeline Corridor,
Burns Lake to Kitimat,
West Central British Columbia**

James W. Schwab P.Geo., Eng.L.

Prepared: September, 2011

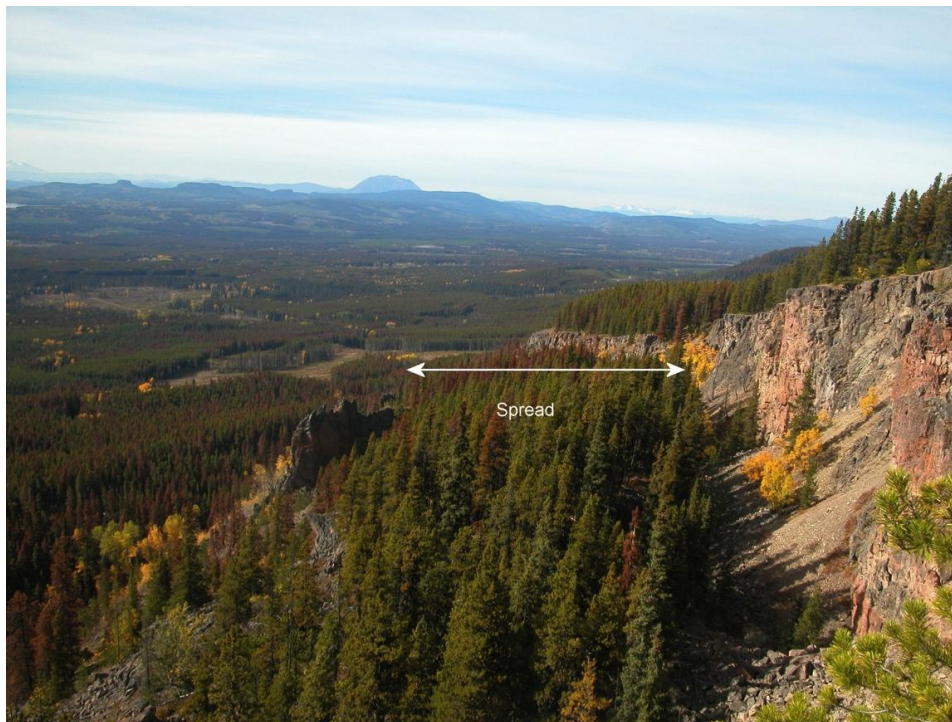
Figure 4: Bedrock spread located east of Parrott Creek. The overlaying volcanic bedrock has split apart and is slowly moving away from the scarp along a deeper surface of much older volcanic bedrock.

Bedrock spread, a form of landslide movement, is active along the ridge above Parrott Creek within the general corridor for the pipelines (Figure 4). Geertsema et al. (2009) mentions these landslides but they remain unstudied. Bedrock geology along the ridge above Parrott Creek is an important factor in the instability of the ridge; it comprises flat and gently dipping lava that covers much older volcanic, sedimentary and intrusive rocks (Tipper and Richards 1976). The spread of upper bedrock layers on older rocks may continue gradually over a long period or may reach a point of catastrophic failure sometime in the future (Figure 5). The active bedrock spread occurring along the ridge near Parrott Creek may be an indication or foreshadowing of further movement at other locations along these ridges.

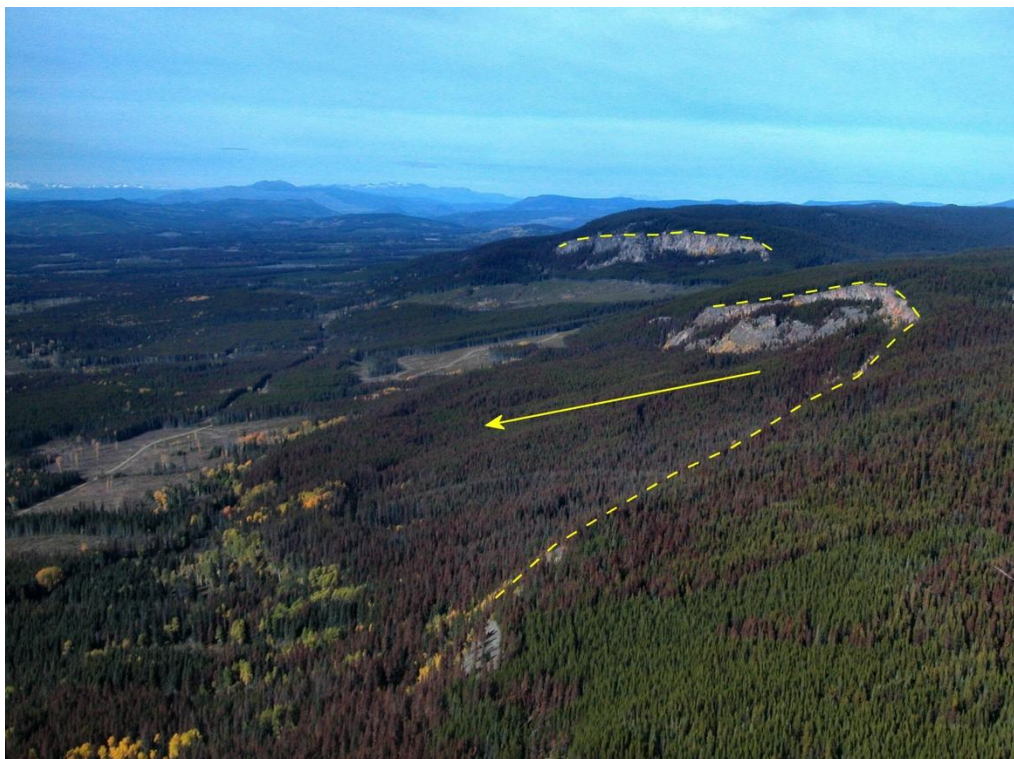
Figure 5: Bedrock spread lead to catastrophic landslides along a 2.5 km scarp (photo lower centre to upper right) and a 1.3 km scarp (photo distance) on the ridge above Parrott Creek. The landslides involved up to 150 and 50 Mm³ of material, respectively. The yellow dashed line delineates the landslides' headscarp. The arrow shows the direction of movement.

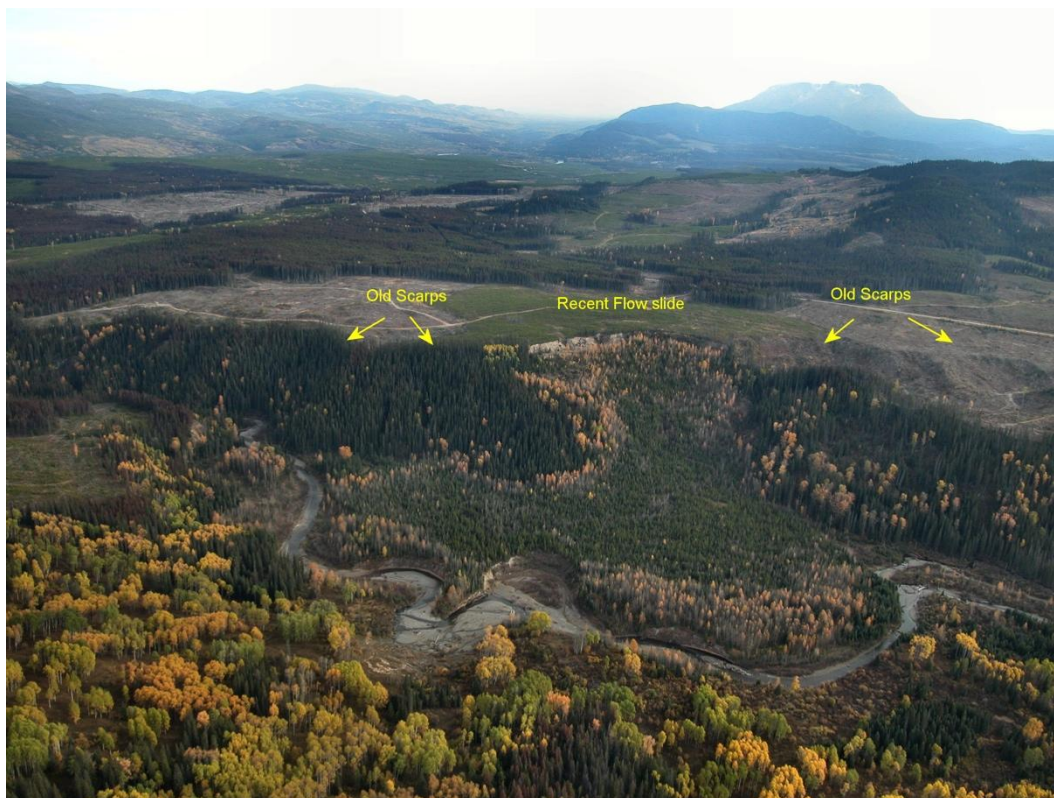
Figure 6: A low gradient flow slide in advance-phase glaciolacustrine sediment at Houston Tommy Creek. Older landslide scarps are indicated with arrows.

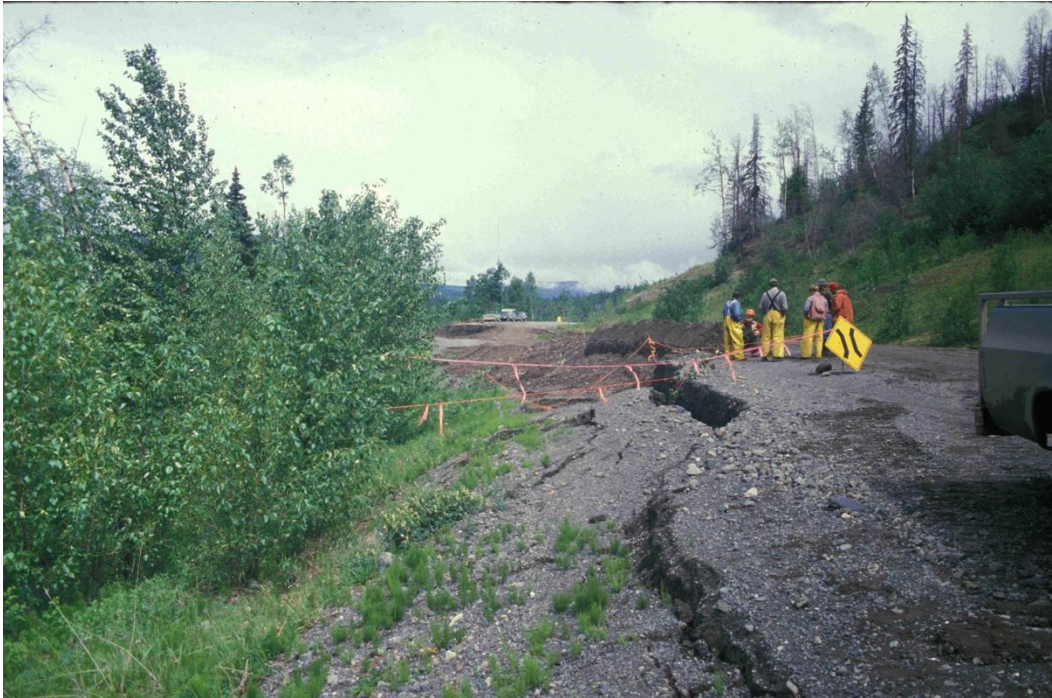
Figure 7: A reactivated slump earth flow after an up-grade of the Morice Road. Attempts to stabilize the road have cost millions of dollars over the past 30 years.

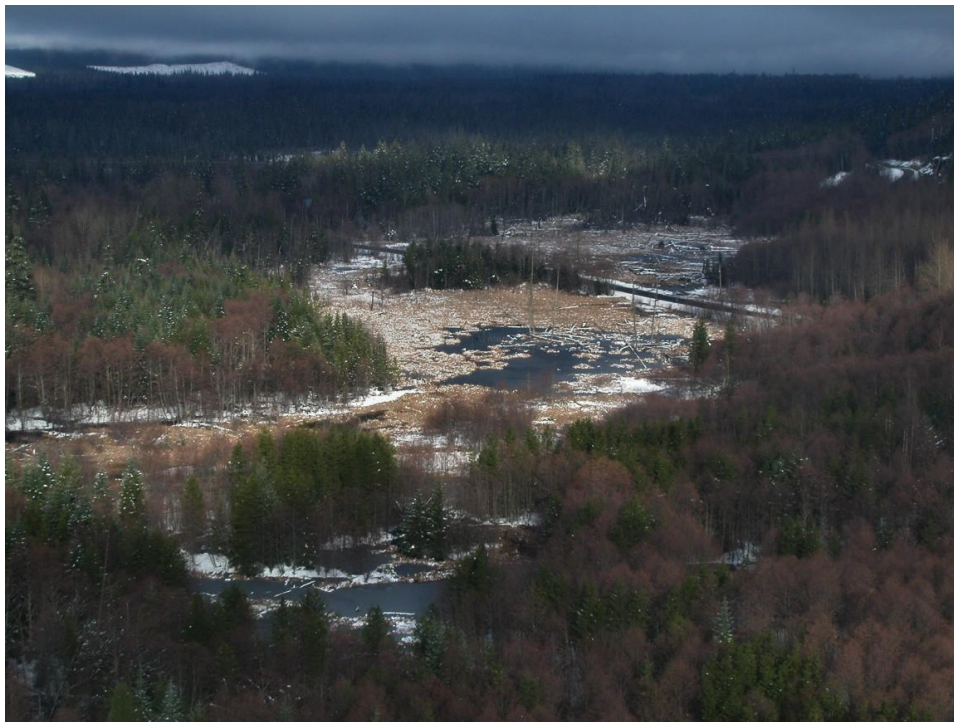
Figure 13: This large swampy area is the location of the May 1962 Lakelse flow slide. Highway 37 crosses the landslide depletion zone. The Provincial Park is located middle left of the photo.

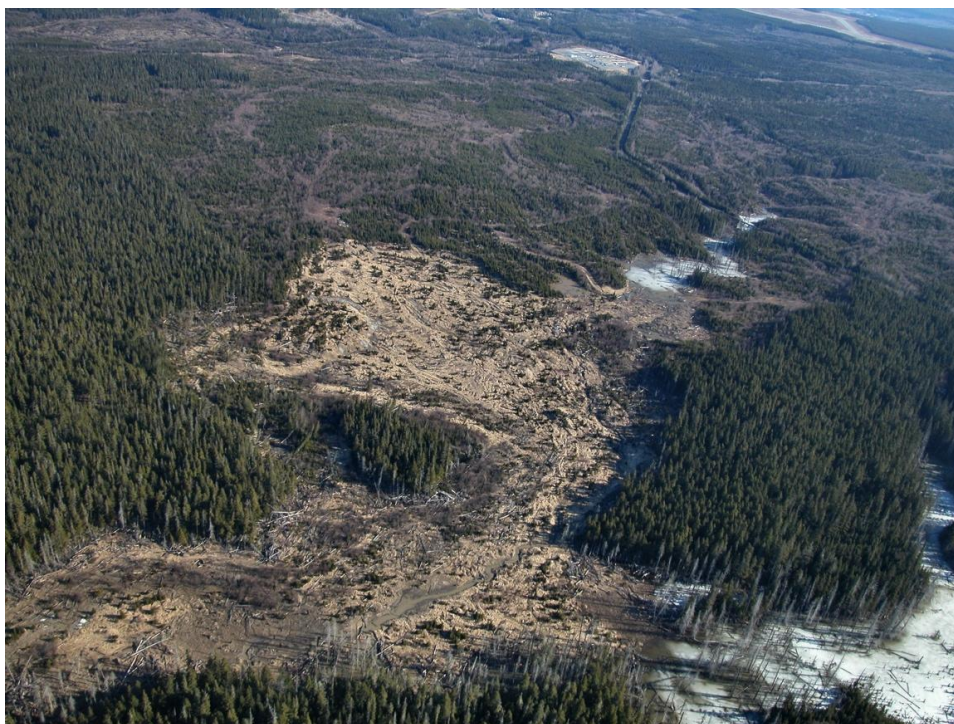
Figure 14: The Mink Creek flow slide rapidly retrogressed along a slope of about 3°, approximately 23 ha flowed into Mink Creek, extending downstream for 1 km.

- A landslide occurred sometime between mid December 1993 and early January 1994 into Mink Creek, a tributary of Lakelse River (Geertsema and Schwab 1995; Geertsema and Schwab 1996; Geertsema 2004; Geertsema and Torrance 2005; Geertsema et al. 2006b). The landslide likely started as a small failure along the creek that exposed sensitive clays in the cut bank. Once the sensitive materials were exposed, the landslide rapidly retrogressed along a slope of about 3°. About 23 ha slid and flowed into Mink Creek, filling the channel, extending downstream for about 1 km. Debris dammed the creek, raised water levels by 10 m and backed water up stream for 1200 m (Figure 14).

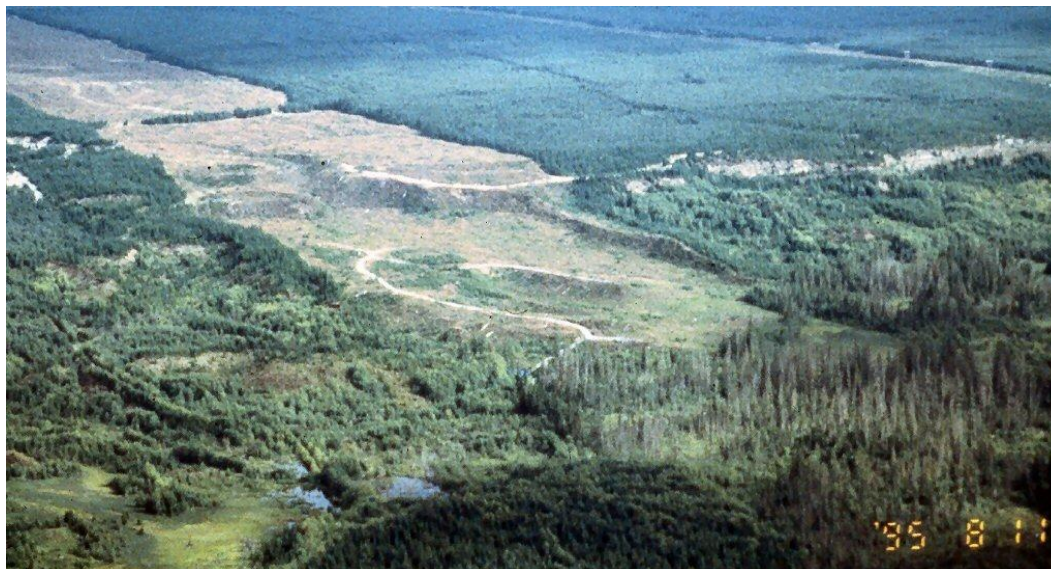
Figure 15: Foreslope of the Onion Lake Flats (fan-delta) to the east of Cecil Creek. Roads follow arcuate ridges that outline prehistoric flow slides. The ridges are visible in the clearcut (photo centre) and in the area reforested (photo centre-left).
