Harper Creek Fish Habitat Baseline Report

HARPER CREEK PROJECT

Application for an Environmental Assessment Certificate/ Environmental Impact Statement

January 2015

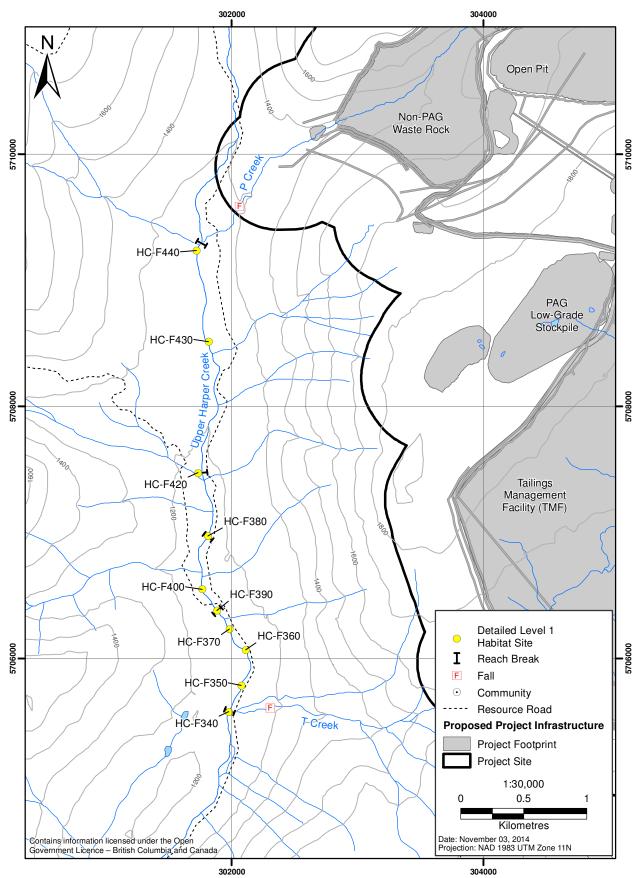
Detailed Level 1 Fish Habitat Survey Sites, 2014

Detailed Level 1 fish habitat surveys were conducted at 11 sites on upper Harper Creek, between P Creek and T Creek, from September 11 to 13, 2014 (Table 2.1-1; Figure 2.1-1). This approximately 4 km stretch of upper Harper Creek includes stream reaches 12 to 16. Site names, stream reaches, and locations were based upon previous studies conducted by Knight Piésold (2013). These 11 sites also correspond to electrofishing site locations conducted by Knight Piésold in 2011 and 2012.

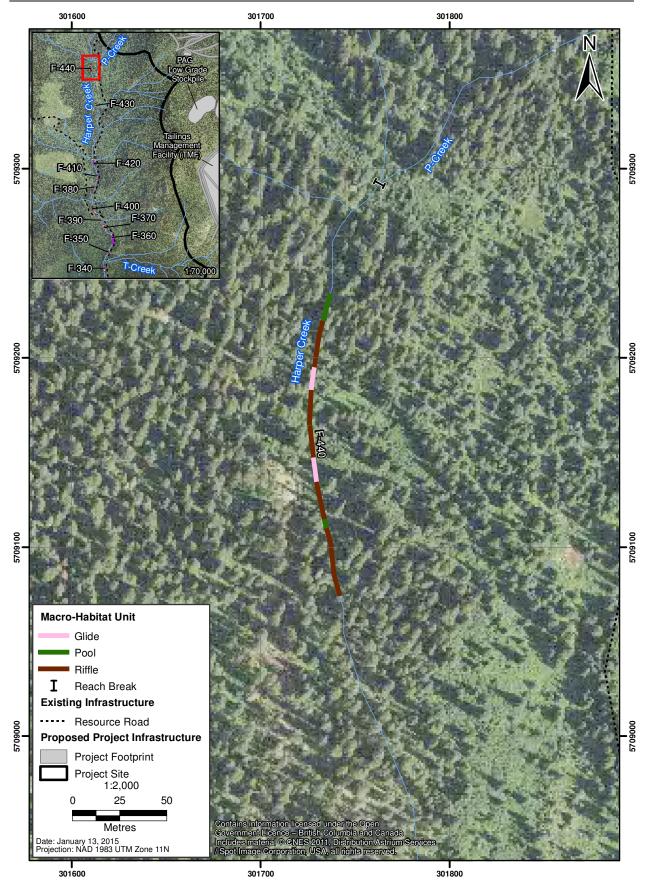
Macro-Habitat Units at Site HC F-440, Upper Harper Creek

Reach 16 (mainstem km 22.4 to 24.3) included three sites (HC F-440, HC F-430, and HC F-420). Figures 3.1-1, 3.1-2, and 3.1-3 show the distribution of habitat types at sites HC F-440, HC F-430, and HC F-420, respectively. A total of 30 habitat units were surveyed over a 420 m section of reach 16. Stream morphology of reach 16 was classified as riffle-pool, with riffle and glide habitat representing the dominant and sub-dominant macro-habitat types, respectively. Habitat units ranged in length from 3 m to 34 m, with a mean length of 13.4 m. Stream gradient was low, ranging from 1% to 4%. A total of six pools were recorded, with maximum depth ranging from 0.4 m to 1 m.

The dominant substrate varied widely within reach 16; from boulder (site HC F-420) to cobble (site HC F-440) to gravel (site HC F-430). Large woody debris, overhanging vegetation, and boulder were the most common cover types within reach 16. Overall habitat was rated as important, with critical adfluvial Bull Trout spawning habitat observed at habitat unit 5 within site HC F-430.

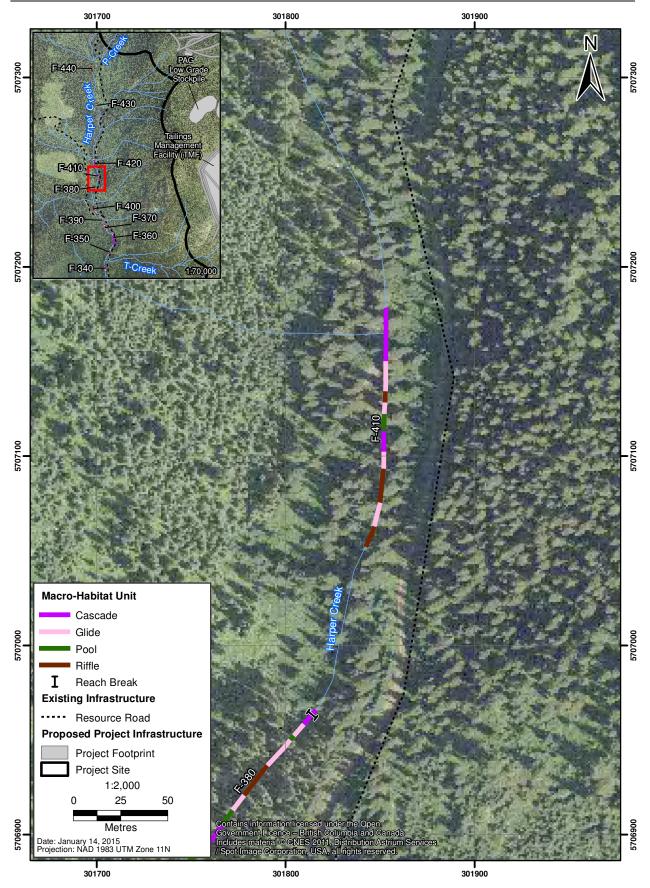
Macro-Habitat Units at Site HC F-410, Upper Harper Creek

Reach 15 (mainstem km 21.3 to 22.2) included four sites (HC F-410, HC F-380, HC F-400, and HC F-390). Figures 3.1-4, 3.1-5, 3.1-6, and 3.1-7 show the distribution of habitat types at sites HC F-410, HC F-380, HC F-400, and HC F-390, respectively. In total, 504 m of fish habitat was surveyed and divided into 40 habitat units. Stream morphology of reach 15 was classified as riffle-pool, with glide and riffle habitat representing the dominant and sub-dominant macro-habitat types, respectively. Habitat units ranged in length from 3 m to 78 m, with a mean length of 12.6 m. Cobble and gravel represented the dominant and sub-dominant substrate type, respectively. Pea gravel and coarse gravel for adfluvial Bull Trout spawning was abundant in glide and pool habitat units, particularly within site HC F-380. Overall, habitat was rated as important, with critical adfluvial Bull Trout spawning habitat units within this reach.

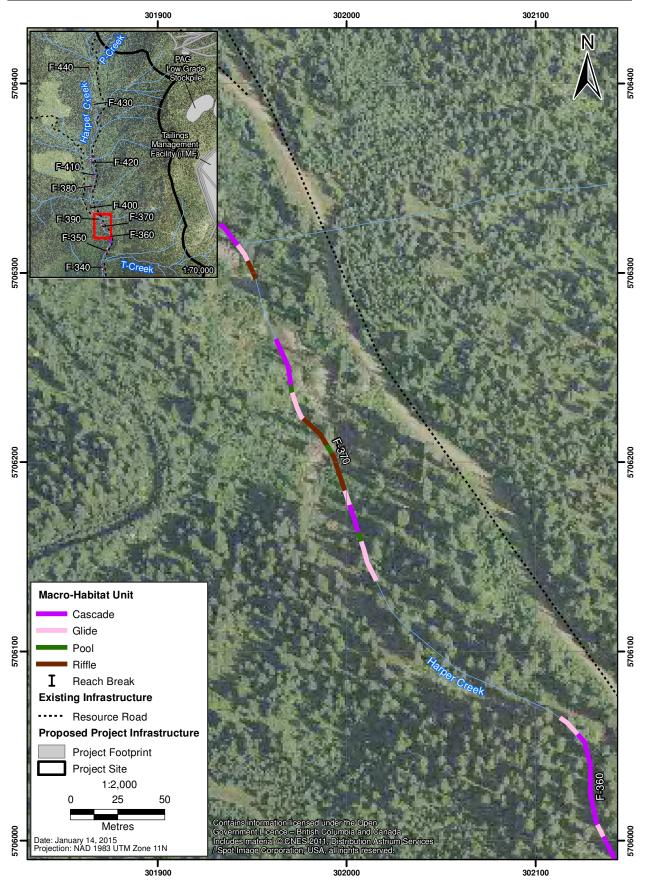
Macro-Habitat Units at Site HC F-370, Upper Harper Creek

Fish habitat within reach 14 (mainstem km 21) was surveyed at site HC F-370. Figure 3.1-8 shows the distribution of habitat types at site HC F-370. A total of 138 m of fish habitat was divided into 10 habitat units, and classified as riffle-pool morphology. Pools and glides were the most common macro-habitat type. Habitat units ranged in length from 4 m to 26 m, with a mean of 13.8 m. Cobble and gravel were observed as the dominant and sub-dominant substrate types, respectively. Large woody debris (dominant) and overhanging vegetation (sub-dominant) were the most commonly observed cover types. Pea gravel and coarse gravel for adfluvial Bull Trout spawning was present in glide and pool habitat units. Overall, habitat was rated as important, with critical adfluvial Bull Trout spawning habitat observed at glide and pools within this reach.

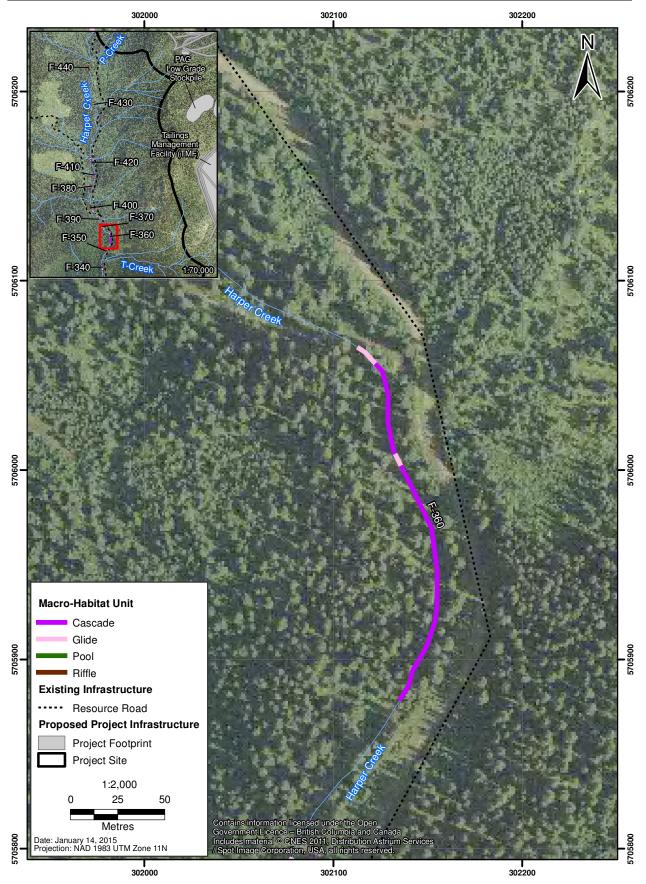
Macro-Habitat Units at Site HC F-360, Upper Harper Creek

Fish habitat was surveyed at two sites (HC F-360, HC F-350) within reach 13. Figures 3.1-9 and 3.1-10 show the distribution of habitat types at sites HC F-350 and HC F-360, respectively. A total of 324 m of fish habitat was divided into 14 habitat units, and classified as step-pool morphology. Habitat units ranged from 4 m to 130 m, with a mean of 22.3 m. This reach was characterized by steeper gradient, long cascades, and coarse substrate (boulder and cobble). Spawning gravel was typically limited to lower gradient habitat types such as glides and pools. Overall, habitat was variable, ranging from marginal (site HC F-360) to important (site HC F-350). Critical adfluvial Bull Trout spawning habitat was observed at glide habitat units within site HC F-350.

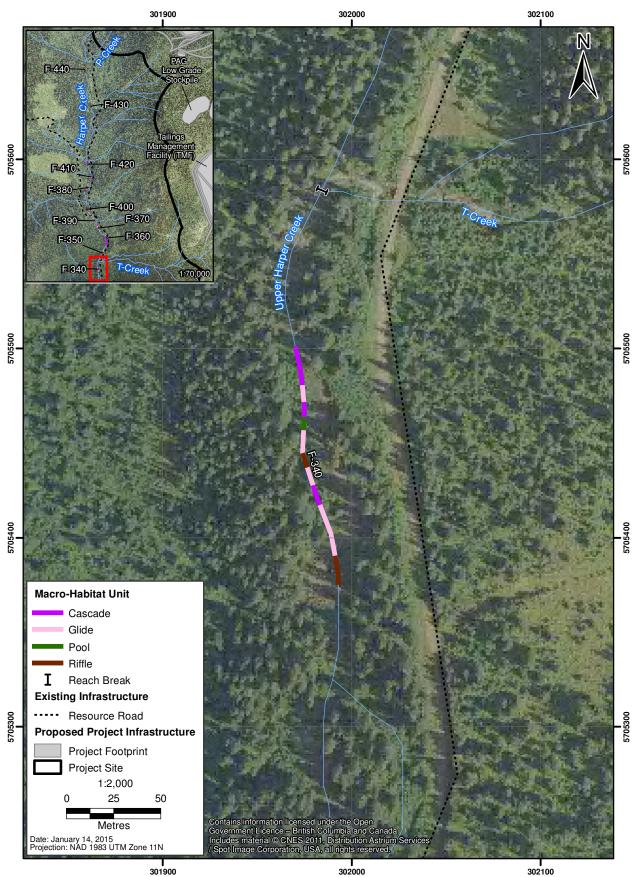
Macro-Habitat Units at Site HC F-340, Upper Harper Creek

Reach 12 was surveyed at site HC F-340 near at the confluence of T and Harper creeks. Figure 3.1-11 shows the distribution of habitat types at site HC F-340. A total of 127 m of fish habitat was divided into 10 habitat units, and classified as riffle-pool morphology. Glide and cascade were the dominant and sub-dominant macro-habitat type, respectively. Habitat units ranged in length from 7 m to 28 m, with a mean of 12.7 m. Cobble (dominant) and gravel (sub-dominant) were the most commonly observed substrate types. Coarse gravel and spawning habitat was associated with glide and pool habitat units. Overhanging vegetation and large woody debris formed the majority of fish cover. Overall, habitat was rated as important, with critical adfluvial Bull Trout spawning habitat observed at glide and pools within this reach.

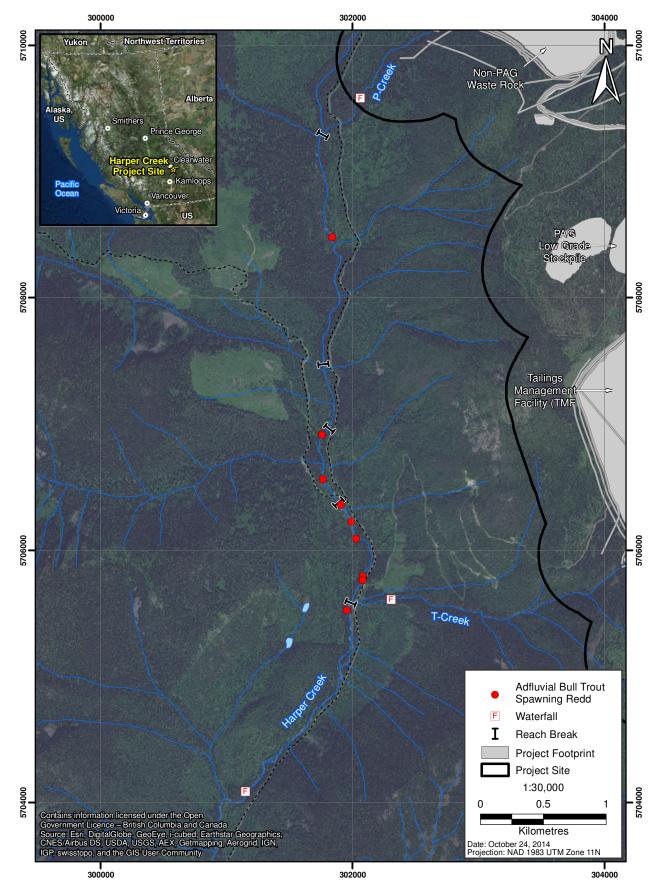
Bull Trout Redd Locations, 2014

Data associated with each Bull Trout spawning redd are presented in Appendix C. A total of 11 adfluvial Bull Trout redds were observed in upper Harper Creek, between P and T creeks from September 11 to 13, 2014 (Table 3.2-1; Figure 3.2-1). The distance between P Creek and T Creek is roughly 4.1 km; however, a total of 1.5 km of fish habitat was surveyed. Thus, adfluvial Bull Trout redds were distributed approximately 1 redd per 138 m. Adfluvial Bull Trout redds were located in the highest density from the confluence of Harper and T Creek to approximately 1.5 km upstream on the Harper Creek mainstem (Figure 3.2-1). The timing, presence of adfluvial Bull Trout, and redd locations observed in September 2014 are similar to observations documented in Knight Piésold (2013).

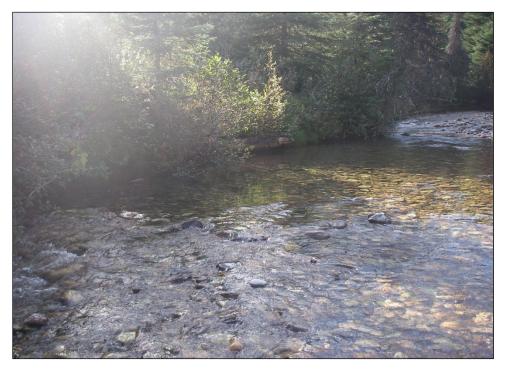
All Bull Trout redd sites were associated with glide or pool tail-outs (which contain slow, laminar or upwelling flow; Plate 3.2-1), coarse gravel substrate, and overhanging cover (e.g., overhanging riparian vegetation, large woody debris, or undercut bank; Plate 3.2-2).

Plate 3.2-1. Pool tail-out located at site HC-F390 habitat unit 4, redd site F390-1, Upper Harper Creek, September 12, 2014.

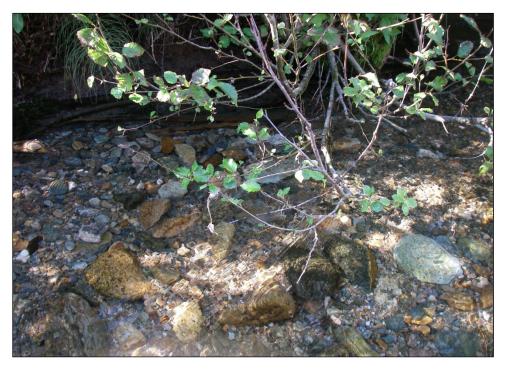
Plate 3.2-2. Redd site F390-1, Upper Harper Creek, September 12, 2014.

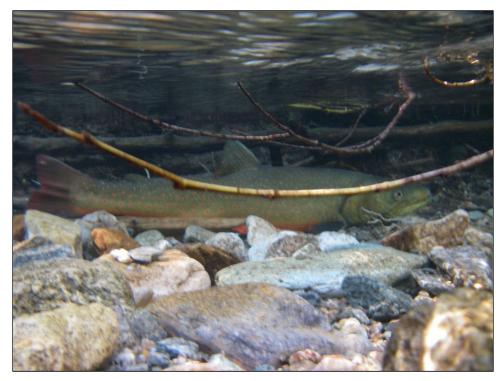
Adfluvial Bull Trout were observed in spawning colour (e.g., bright orange/red spots and belly, pronounced white leading fin rays; Plate 3.2-3), and holding on or in the vicinity of redd sites. Adfluvial Bull Trout spawning pairs were observed at two locations (F370-2; F390-1) holding on redd sites. A resident and adfluvial Bull Trout spawning pair were also observed at redd site F380-1. These observations indicate that both resident and adfluvial Bull Trout utilize upper Harper Creek for spawning and rearing habitat. In addition, resident and adfluvial Bull Trout may spawn together, causing population interaction and gene transfer between resident and adfluvial forms. Therefore, based upon the low frequency and availability of suitable spawning habitat in upper Harper Creek, Bull Trout redd sites were classified as critical habitat features.

Plate 3.2-3. A 52 cm adfluvial Bull Trout observed at redd site F390-1, Upper Harper Creek, September 12, 2014.
