ANNUAL MONITORING OF OFFSET MEASURES- 2021

YEAR 5 OF 5

NEW GOLD INC.
Rainy River Mine
P.O. Box 5
Emo, Ontario
P0W 1E0

Ecometrix Incorporated
www.ecometrix.ca
Mississauga, ON

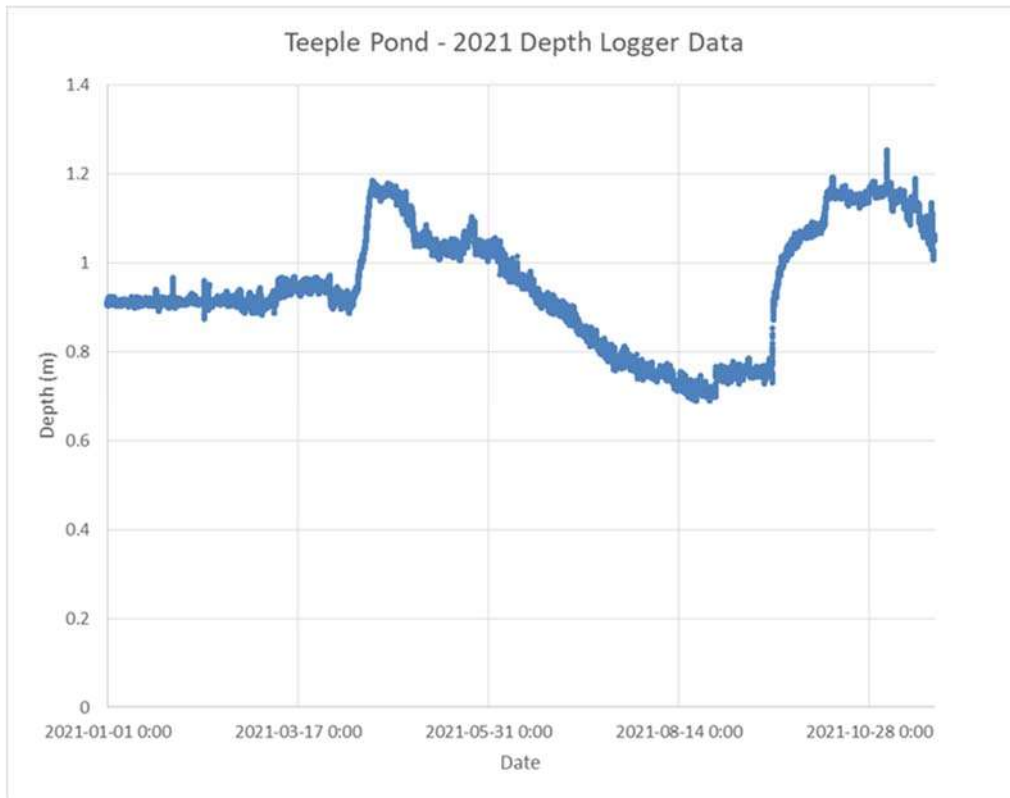
Figure 3-1: Teeple Pond Depth (January 01 to November 22, 2021)

Similar to the results in 2019 and 2020, Teeple Pond depths from January 1st to November 22nd 2021, fluctuated around 1 m. Depths ranged from a low 0.69 m to a high of 1.25 m (Figure 3-1). Teeple Pond water levels were very similar to those observed in both 2019 and 2020 (Figure 3-2).

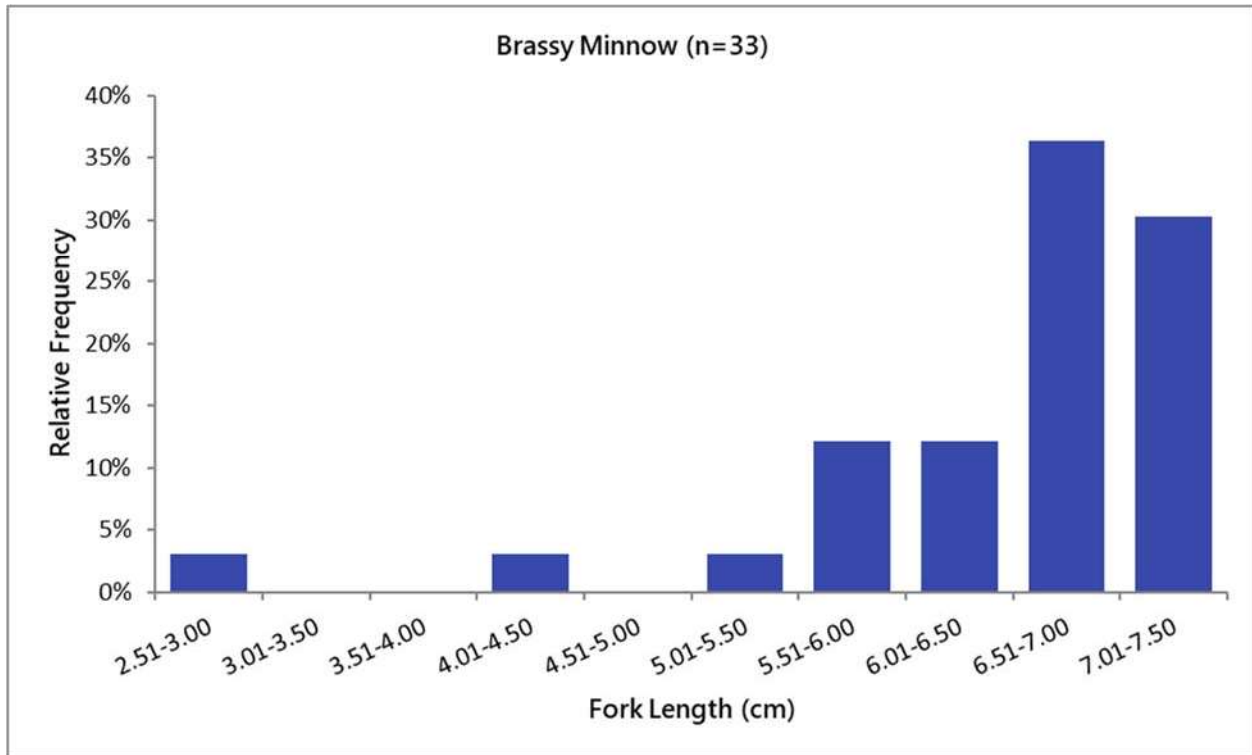
Figure A-1: Length frequency Distributions for Fish Collected at Teeple Pond, Rainy River Mine 2021

In Teeple Pond the fish community included (listed in order of abundance) Finescale Dace, Brook Stickleback, Northern Redbelly Dace, Central Mudminnow, Fathead Minnow, Brassy Minnow, Pearl Dace, and Johnny Darter (Tables 3-2 and 3-3). There was an abundant fish community in the Pond with a total of 6,911 fish captured. This included CPUEs of 31 fish per 1,000 seconds for electrofishing effort, 575 fish per 15 m seine net haul, and 0.49 fish captured per minnow trap hour (Table 3-3; Appendix Table A.3 to A.5). Histograms indicate that multiple age classes of a variety of species were captured in the Pond (Appendix Figure A-1).

Note: Johnny Darter (n=1) and Pearl Dace (n=3) not plotted due to low capture

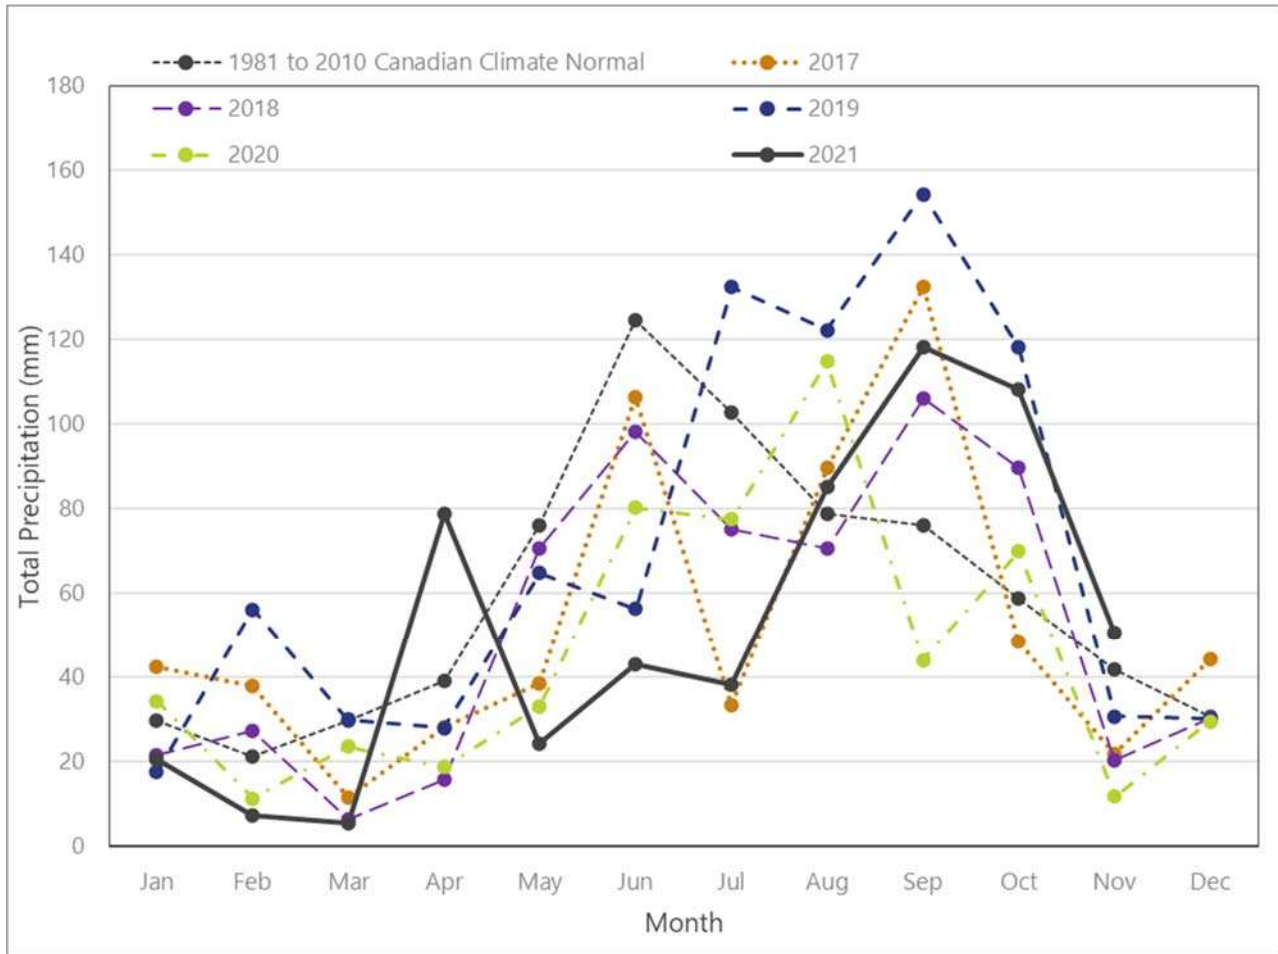
Figure A-2: Precipitation Values Measured in the Vicinity of Rainy River Mine

In 2021 the RRM site received less than the 20-year Environment Canada norm for six of seven months (between January and July). Owing to both the lack of precipitation and ongoing beaver activity at the outlet of Teeple Pond into the constructed channel, the Teeple Pond Outlet was generally dry in 2021 and did not provide connectivity to Teeple Pond. This impacted the status of fish passage from the Pond to downstream habitats. Spring flow monitoring (freshet period) over the five year period at the Outlet indicated that when beaver activity at the inlet was managed, connectivity occurred throughout the constructed habitat and the form and function was maintained. However, in the summer of 2021 there was no water in the constructed outlet with the exception of the pool at the downstream end.

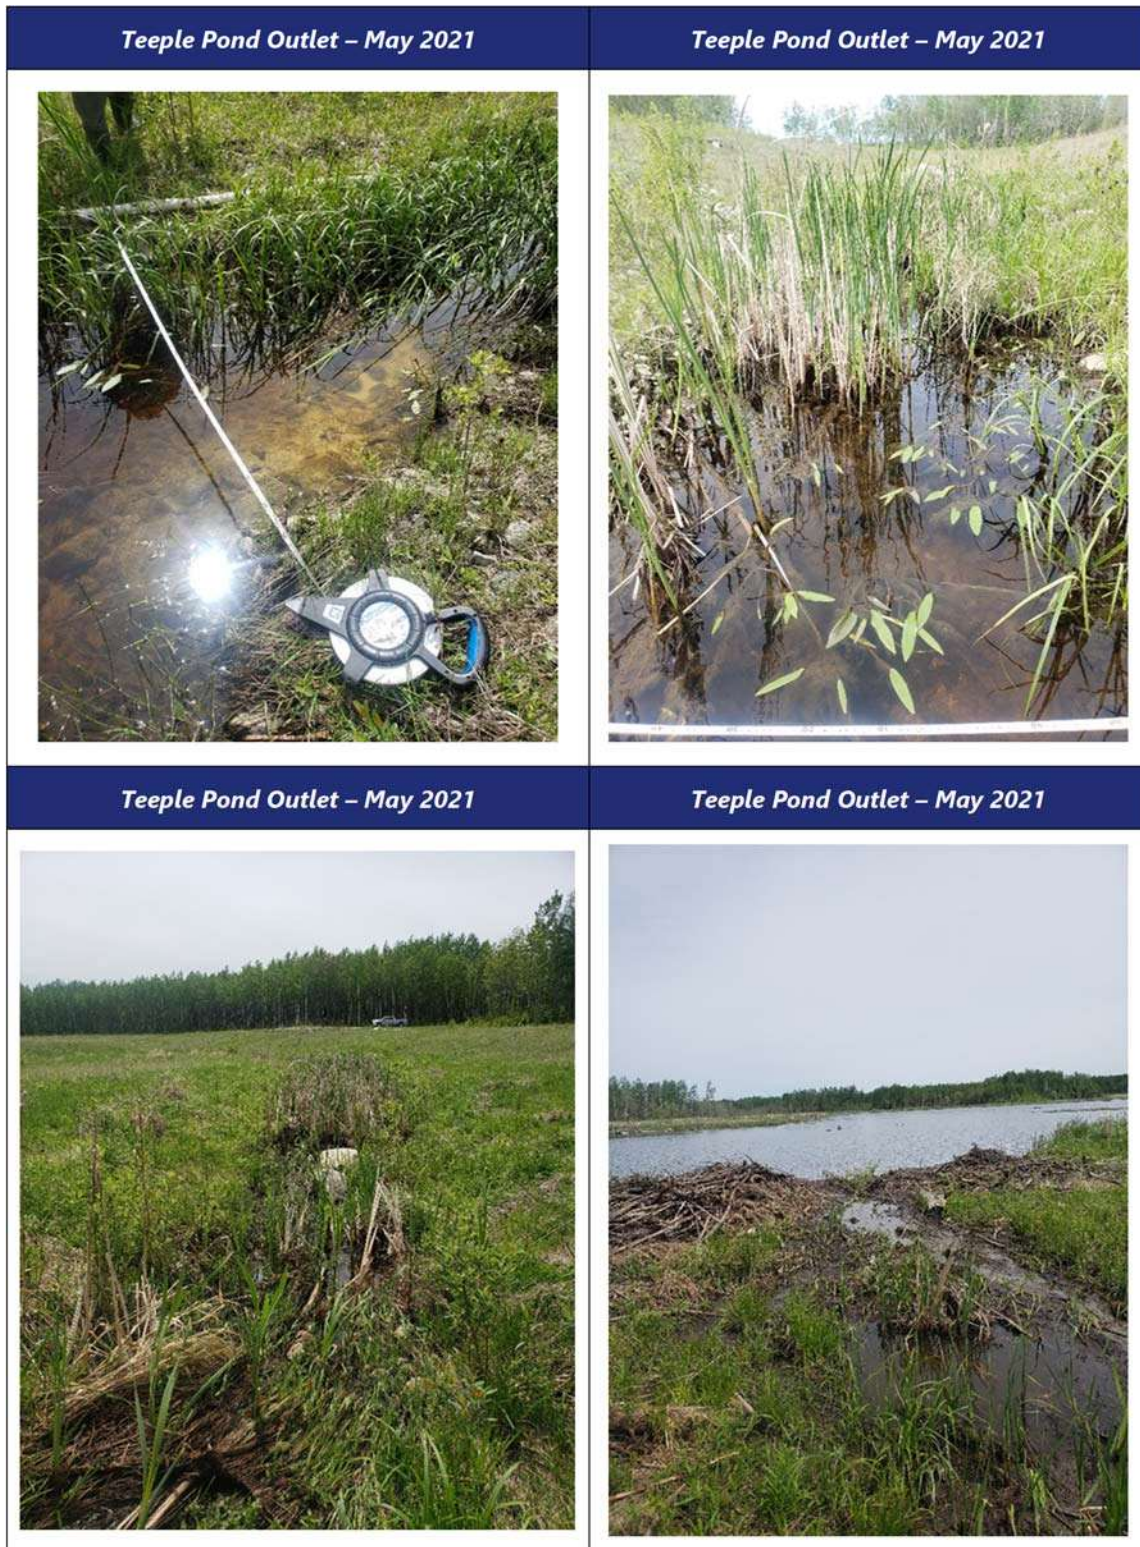
Photo B-1: Teeple Pond Outlet Habitat, May 2021

The Teeple Pond Outlet channel had an average depth and flow velocity of 12.7 cm and 0.02 m/s respectively during the spring survey. In the spring, transect TPDD-3 had a wetted width of approximately 0.6 m and a depth of <5 cm. and contained no measurable flow. In the summer season all four transect locations were dry and consequently no flow, depth or channel width measurements were conducted (Table 3-1, Appendix Tables A.1).

Riparian vegetation along Teeple Pond Outlet is extensive with little exposed soil. Cattail, grasses and sedges (*Carex* spp.) comprised the majority of the vegetation (Appendix Photo B-1 and B-2). Other species included, red clover (*Trifolium pratense*) small willow (*Salix* sp.) and alder (*Alnus* sp.). Submergent macrophytes were primarily coontail whereas burreed, pond weed and sedges along the shoreline were the dominant instream emergent vegetation. Throughout the constructed channel instream cover for fish is comprised of numerous boulder clusters and pool habitat. However, monitoring over the last five years indicates that the Outlet only provides seasonal habitat and is not meeting the intent of the Offset Plan (Appendix Photo B-2) due to insufficient connectivity to Teeple Pond as a result of beaver activity and in 2021 likely the result of extremely low amounts of precipitation (Section 3.1.2). It should be noted that during the May Outlet survey a beaver dam was present at the upstream end of Outlet and beaver activity continued until early summer.

- 1) To address low water levels in Teeple Pond Outlet investigate solutions or mitigation to address water levels that are not consistent with those specific in the plan ensure stabilization of connectivity between the Outlet and Teeple Pond.
- 2) Species diversity within the Pond and Outlet remain below the target of nine species. It is recommended that New Gold review opportunities to relocate fish at the RRM under appropriate permits and approvals to increase the overall community diversity; and,

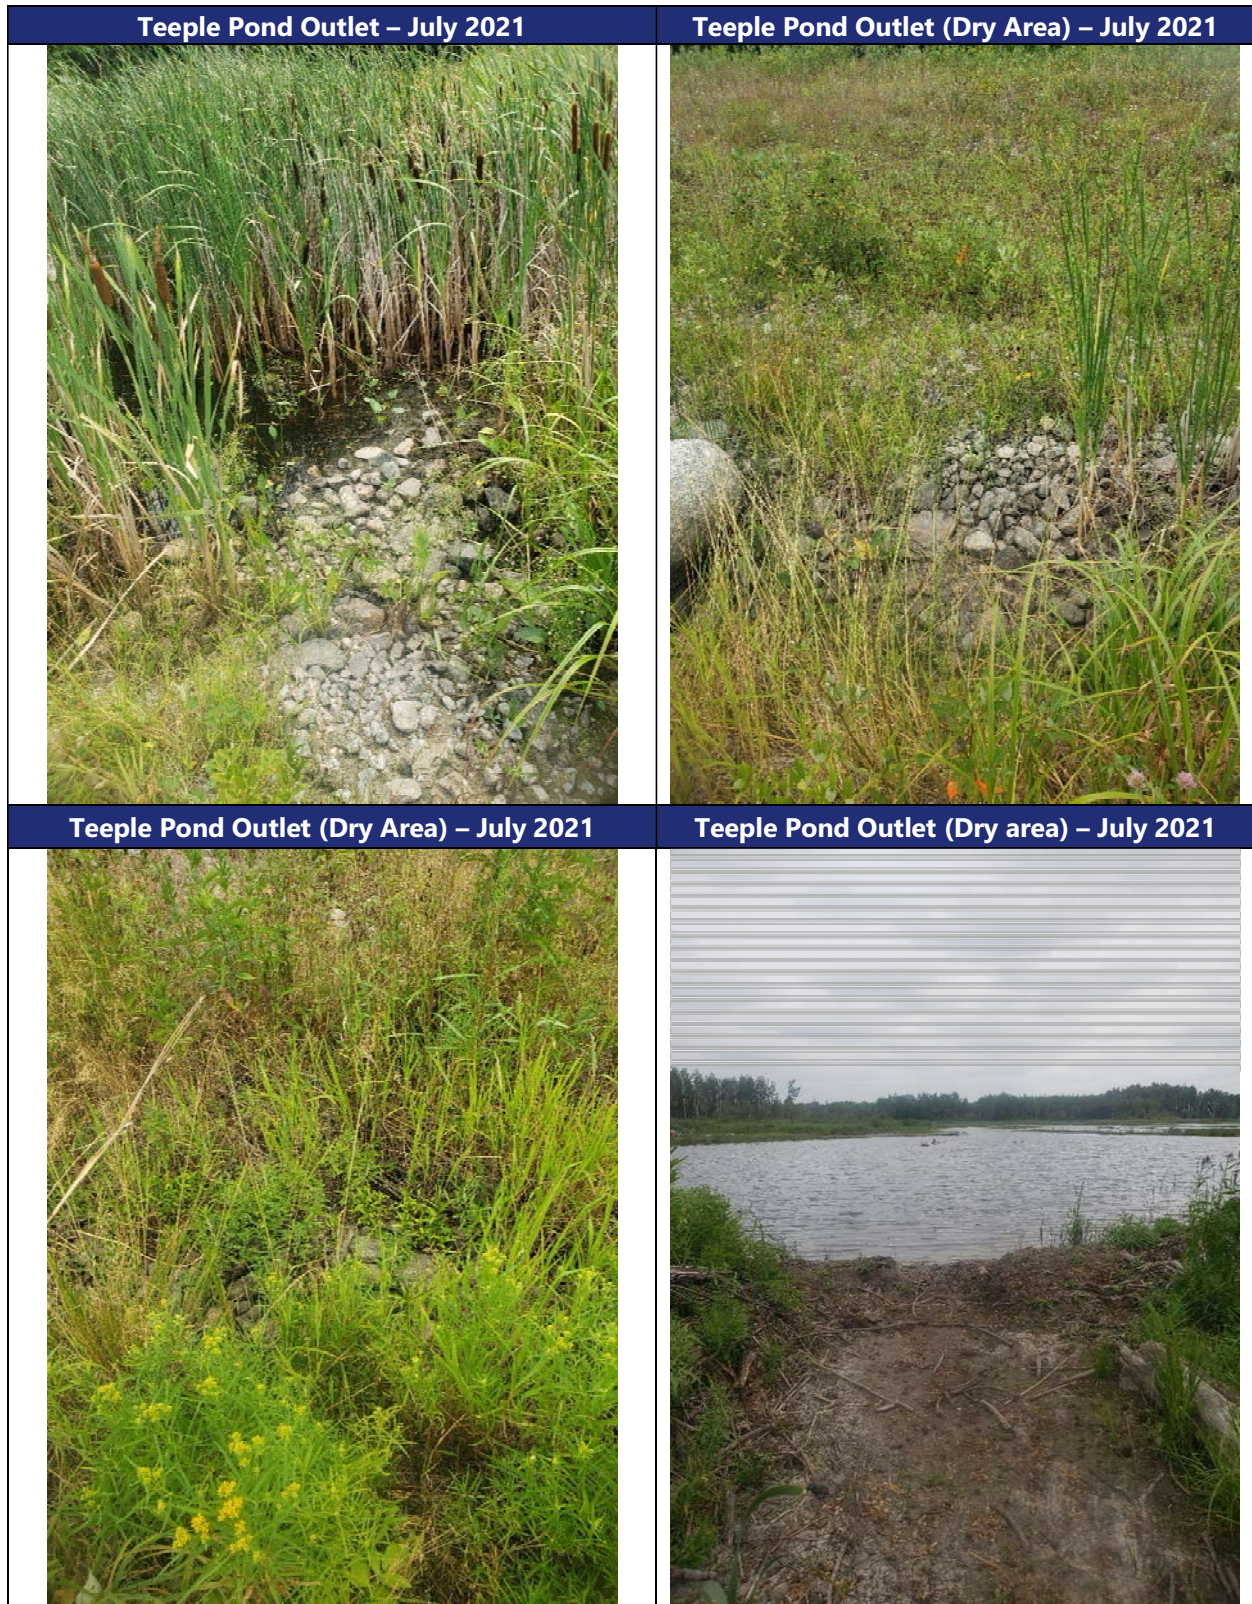
Photo B-2: Teeple Pond Outlet Habitat – July 2021

The July fish community survey in the Teeple Pond Outlet was relegated to one small pool at the downstream end as the remaining constructed channel was dry at that time. Persistence of fish in this pool and multiple age classes in the catches indicated it provided good refuge for resident aquatic life during periods of low water. Teeple Pond did not meet the diversity success criterion (species richness of nine or more) in 2021. Fish catches within Teeple Pond included multiple age-classes including young of the year (YOY) indicating adequate spawning and rearing habitat for the species inhabiting the Pond.

Limited effort expended in the isolated pool at the downstream end of the Outlet resulted in the capture of a total of 16 fish representing three species. Brook Stickleback (*Culaea inconstans*) were the most common species followed by Central Mudminnow (*Umbra limi*), and dace species inferred from YOY (Tables 3-2 and 3-3). Fish capture results for Teeple Pond Outlet were 60 fish captured per 1,000 seconds of electrofishing effort and 0.03 fish captured per minnow trap hour (Table 3-3; Appendix Tables A.2 and A.4). These catches included individuals from multiple year classes of both Brook Stickleback and Central Mudminnow.

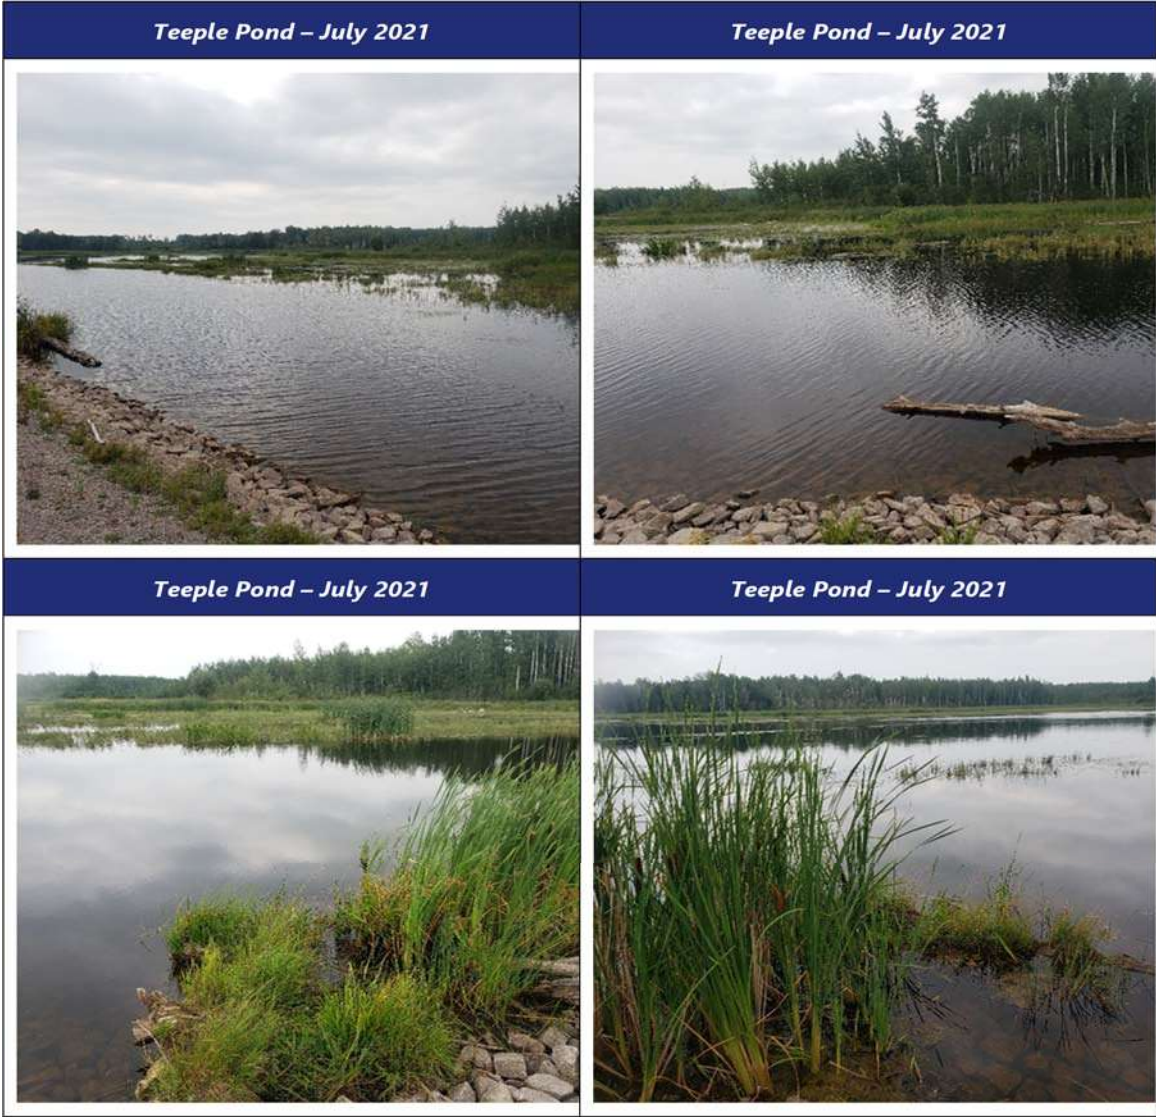
Photo B-3: Teeple Pond Habitat – Jul 2021

The shoreline of Teeple Pond is well vegetated with the primary species identified including cattails, sedges and grasses. Aside from the wetted dam face, greater than 90% of the perimeter of the Pond has a robust and self-sustaining riparian vegetation community (Appendix Photo B-3). Within the Pond there were many submergent macrophytes including burreed, pond lily, pond weed and coontail. In-water structures remain stable from original construction and include boulders and wood debris piles that continue to provide cover for fish. The beaver dam observed in May was likely affecting the Pond level and the water level within the Pond / Outlet complex.

- 3) RRM staff should continue to manage beaver activity in the Teeple system to maintain the flows downstream.
