Appendix 7.2.6A
Blackwater Gold Project
Navigable Waters Baseline Report and
Technical Assessment 2014

BLACKWATER GOLD PROJECT Navigable Waters Baseline Report and Technical Assessment 2014

June 2014

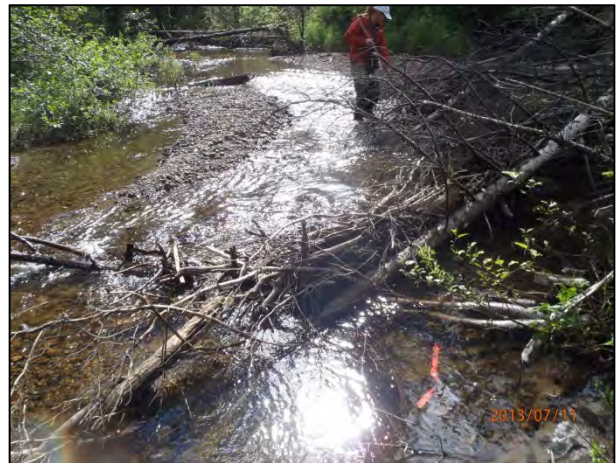
a. Reach 2: Large woody debris looking upstream (left) and downstream (right)

Reaches 2, 5 and 6 in Davidson Creek are rated as having Very Low capacity to support physical navigation in Table 3.1-1. Field observations found that Reach 2 (Appendix C, Plates 13 and 14) has 10 blockages to navigation, so this reach is considered markedly characterized by obstruction, and is not considered navigable as a result. Reach 5 (Appendix C, Plate 10) has four obstacles recorded from field observation, but the aerial shots of this hard to access reach indicate that it is marked by multiple obstructions caused by MPB blowdown (Appendix C, Figure 1); this reach is considered markedly characterized by obstruction and not reasonably navigable. Reach 6 (Appendix C, Plate 9) was also challenging to access in the field, where one obstruction to passage was recorded; however, the aerial view of this reach (Appendix C, Figure 1) reveals considerable blowdown along this stretch of Davidson Creek, indicating that it is obstructed, and not reasonably capable of supporting navigation.

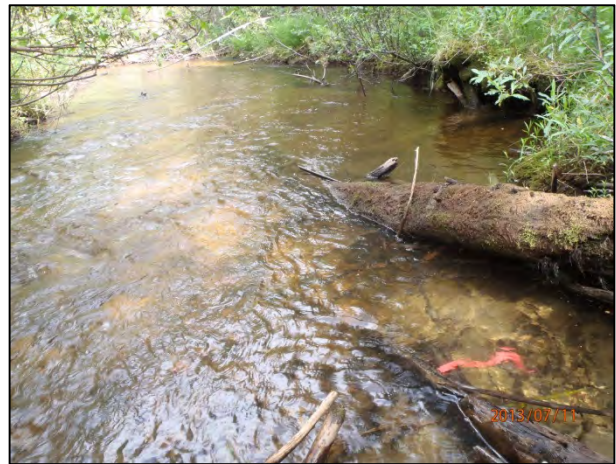
b. Reach 2: Shallow riffle and large woody debris, looking upstream (left) and downstream (right)
