As per Blackwater Gold's Accidents and Malfunctions Management Plan, the information below acts as the 30 follow up report to the "Initial Spill Report – November 26th, 2025" submitted on November 27th, 2025.

Blackwater  
Mine

## 30 Day Follow up Report

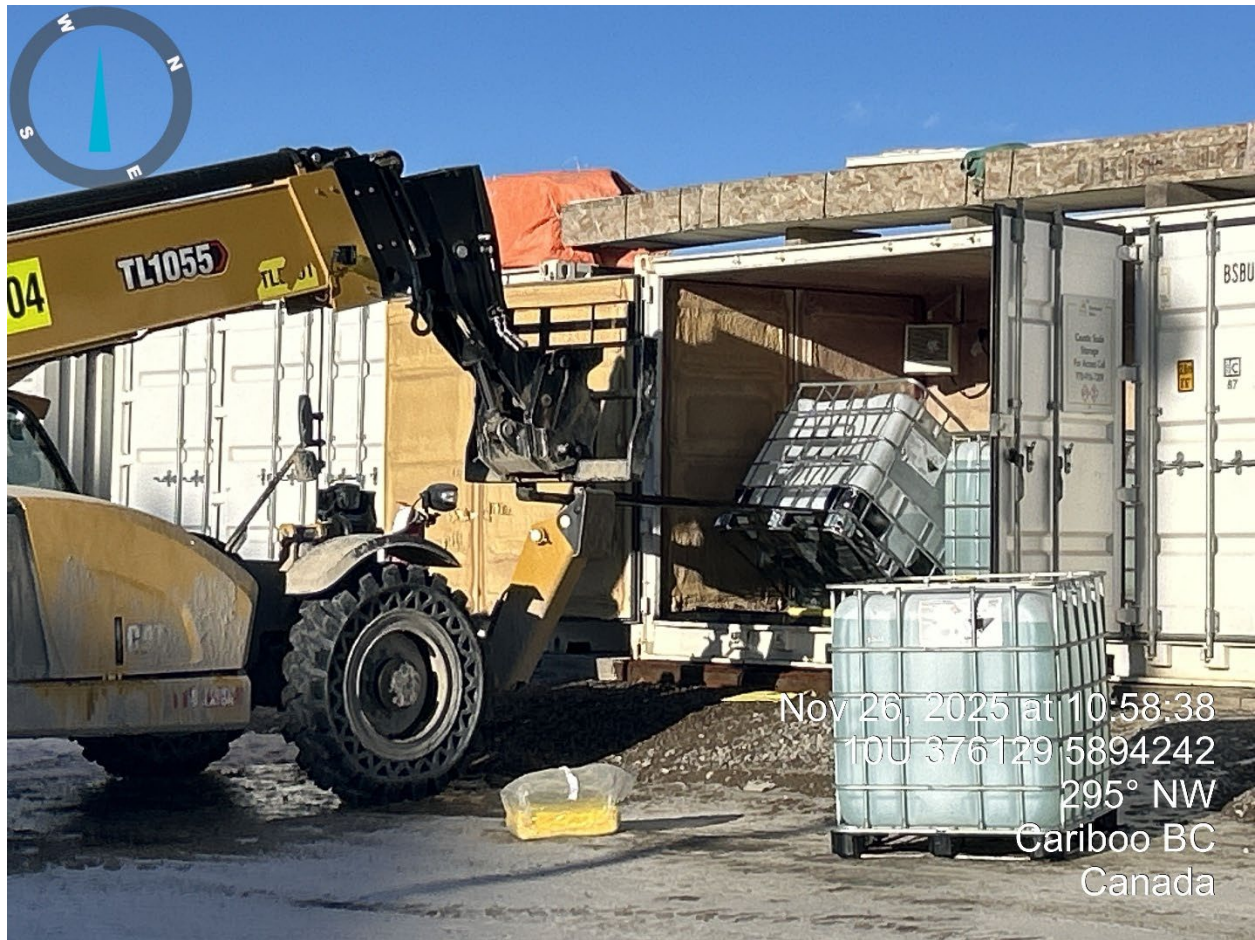
On November 26, 2025, an operator was placing totes of caustic soda into a storage sea can and punctured a tote in the second row with forks of the telehandler, resulting in a spill amount of 500L to ground. The affected location (10U 376107 5894241) (Image 7) was at the BWG warehouse laydown within the contained plant site footprint.

**Image 1: Spill location with telehandler forks holding tote to prevent further spillage**

Source of the spill was stopped by tilting the punctured section up so remaining liquid would not spill out. A portion of the released spill was contained within the sea-can built in secondary containment, and a tertiary berm was constructed around the spill area on construction aggregate ground to further contain the remaining release. Spill response included deploying chemical sorbent pads and absorbent organic compound on spilt material and a vac-truck deployed to remove pooled liquid for disposal in the tailings storage facility. Contaminated material was then excavated with heavy machinery into lined bags and transferred to a lined hazardous containment area for temporary holding. This material was then disposed of through the plant site crusher and processing mill.

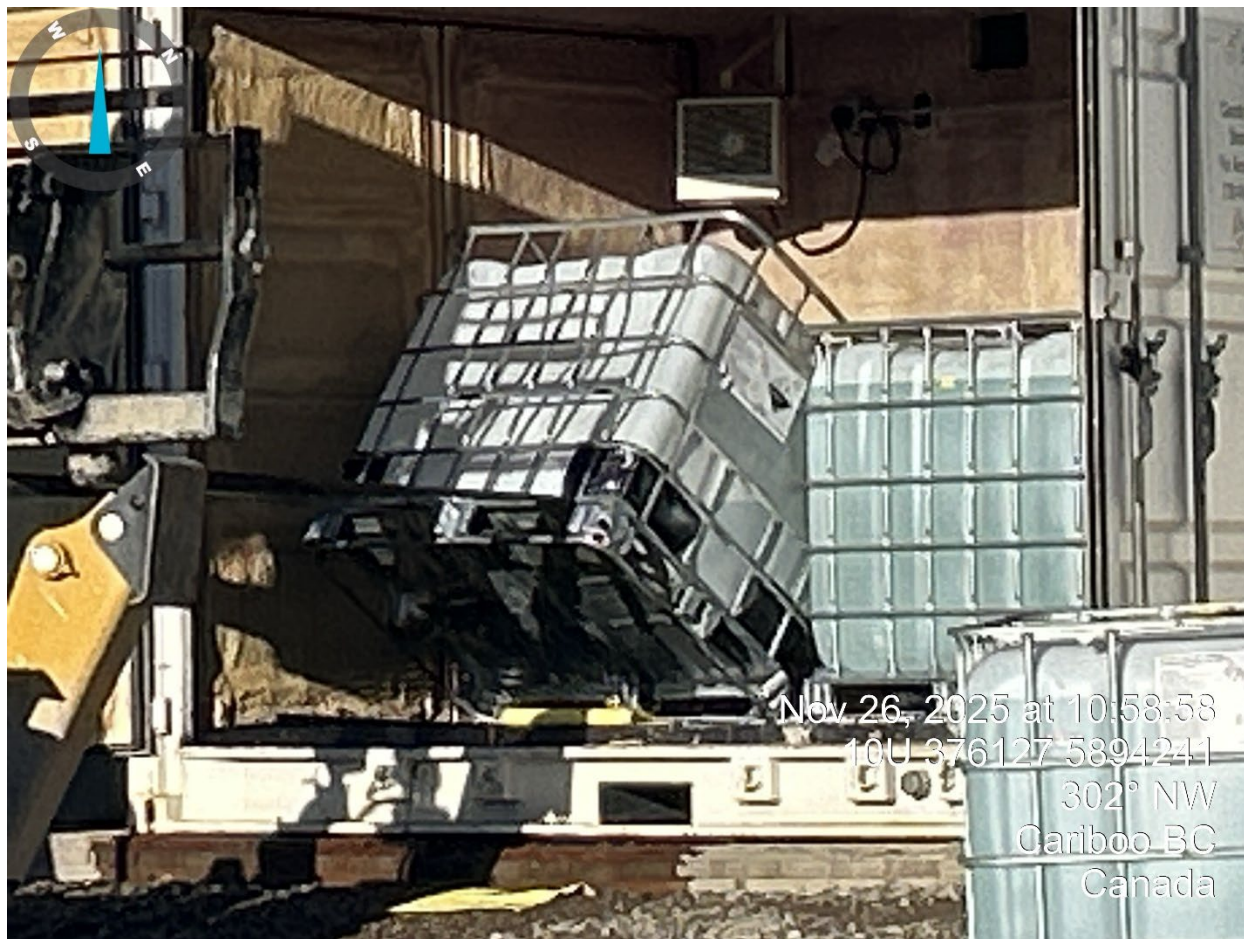
**Image 2: Spill location close up**

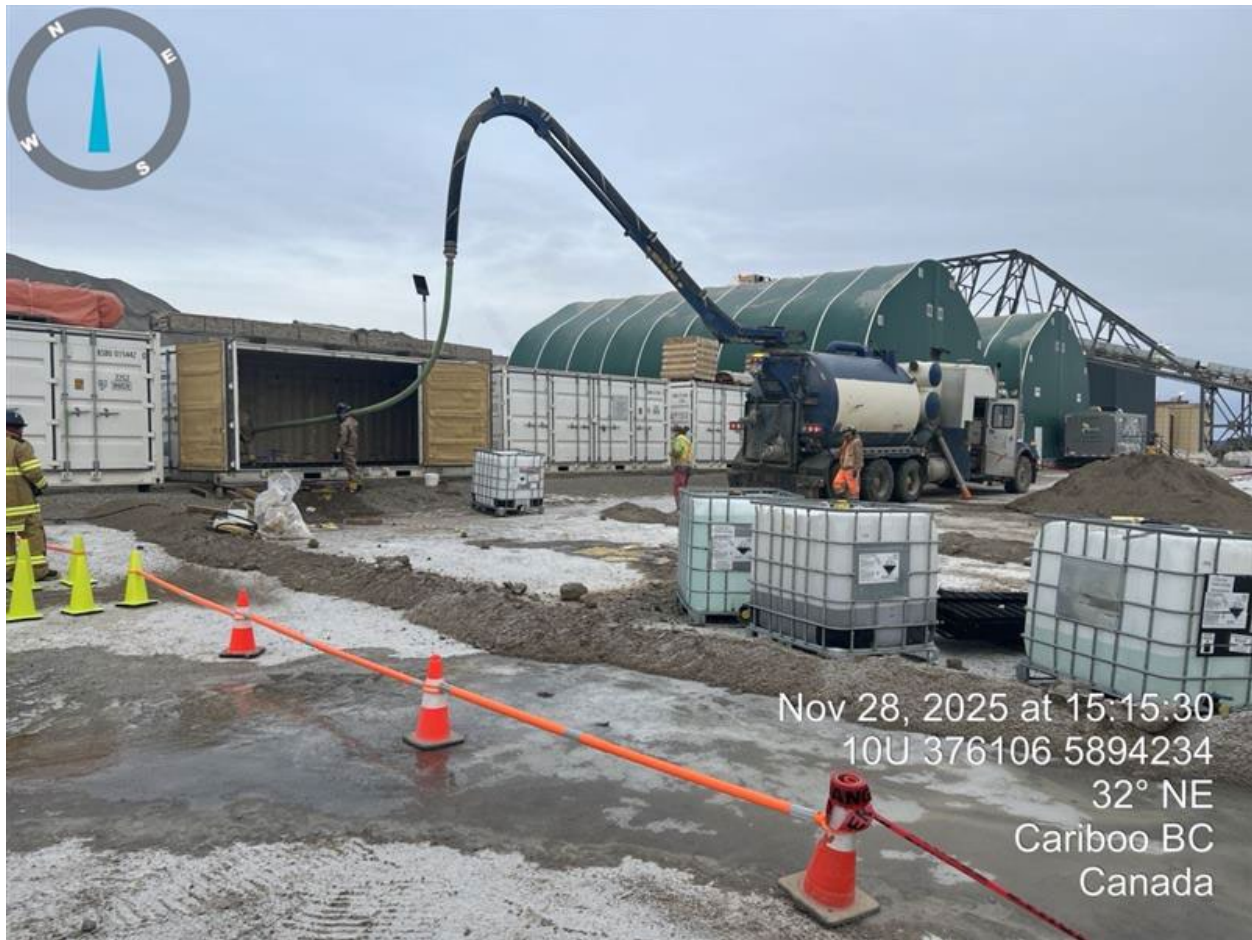
**Image 4: Clean up of caustic soda within sea-canister with containment.**

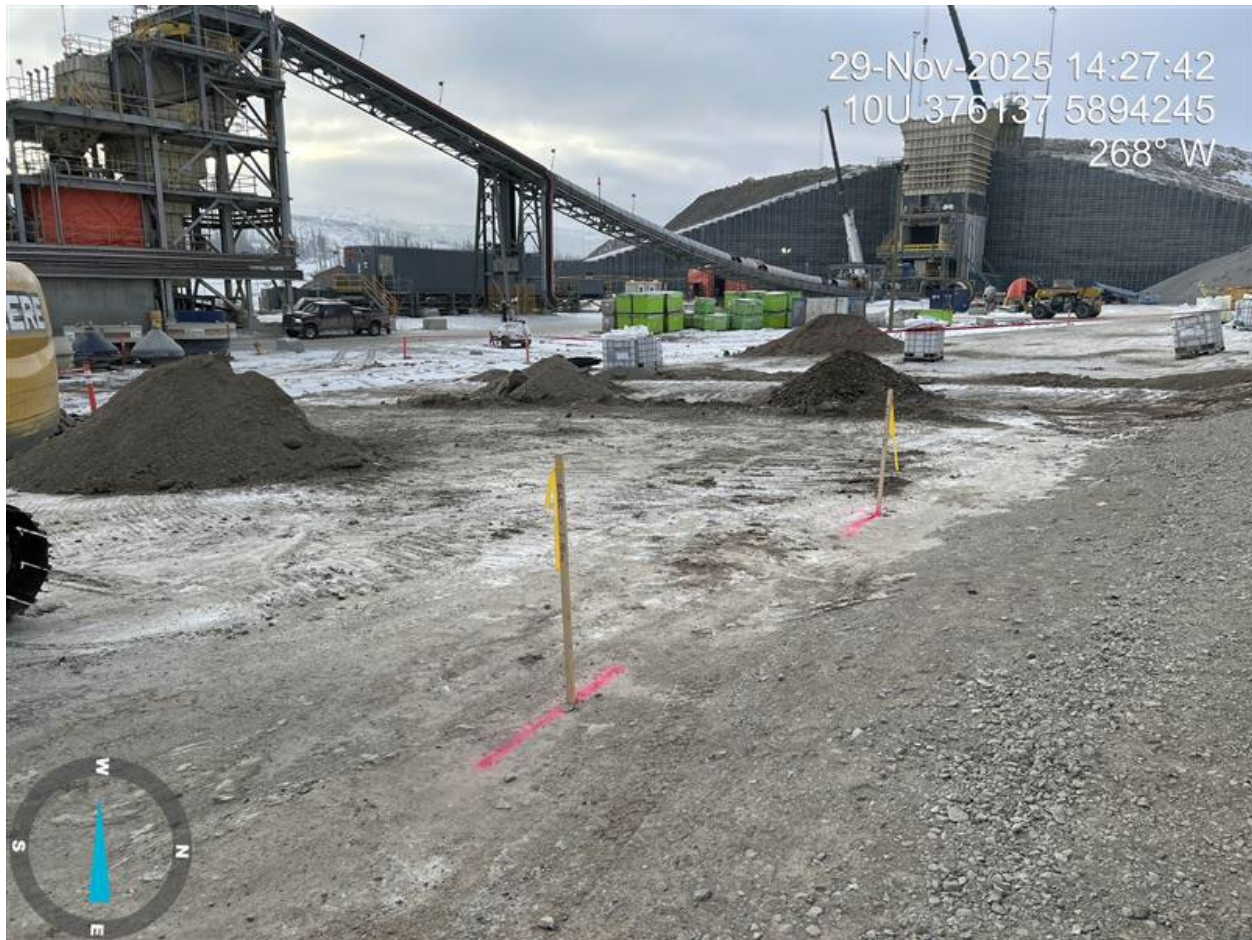
**Image 5: Image of contaminated pile ready to be bagged and collected**

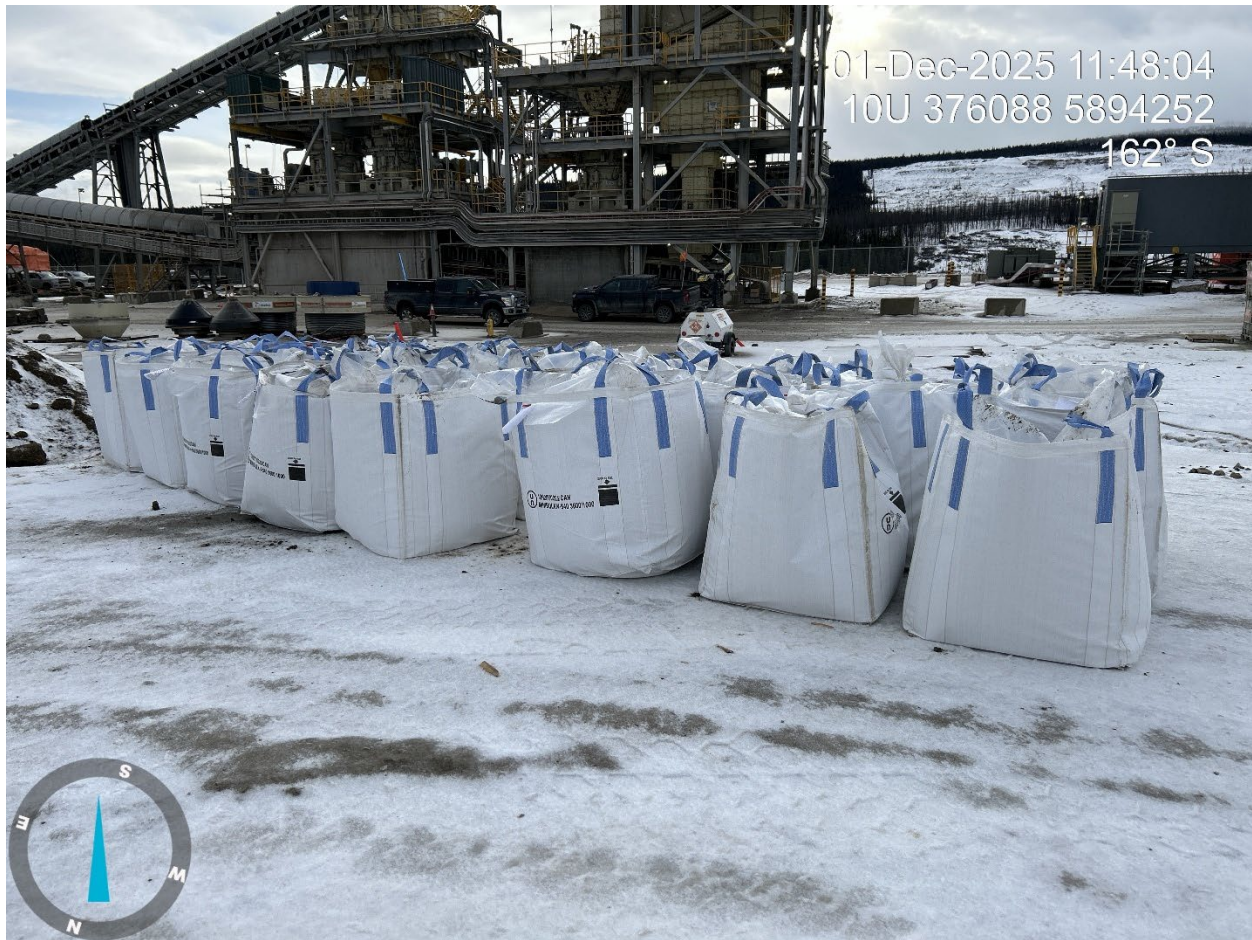
**Image 6: Lined bags containing contaminated material prior to transfer to hazardous containment area for holding.**
