# Lake St. Martin Outlet Channel Baseline Shoreline Assessment

**The KGS Group**

July 22, 2020

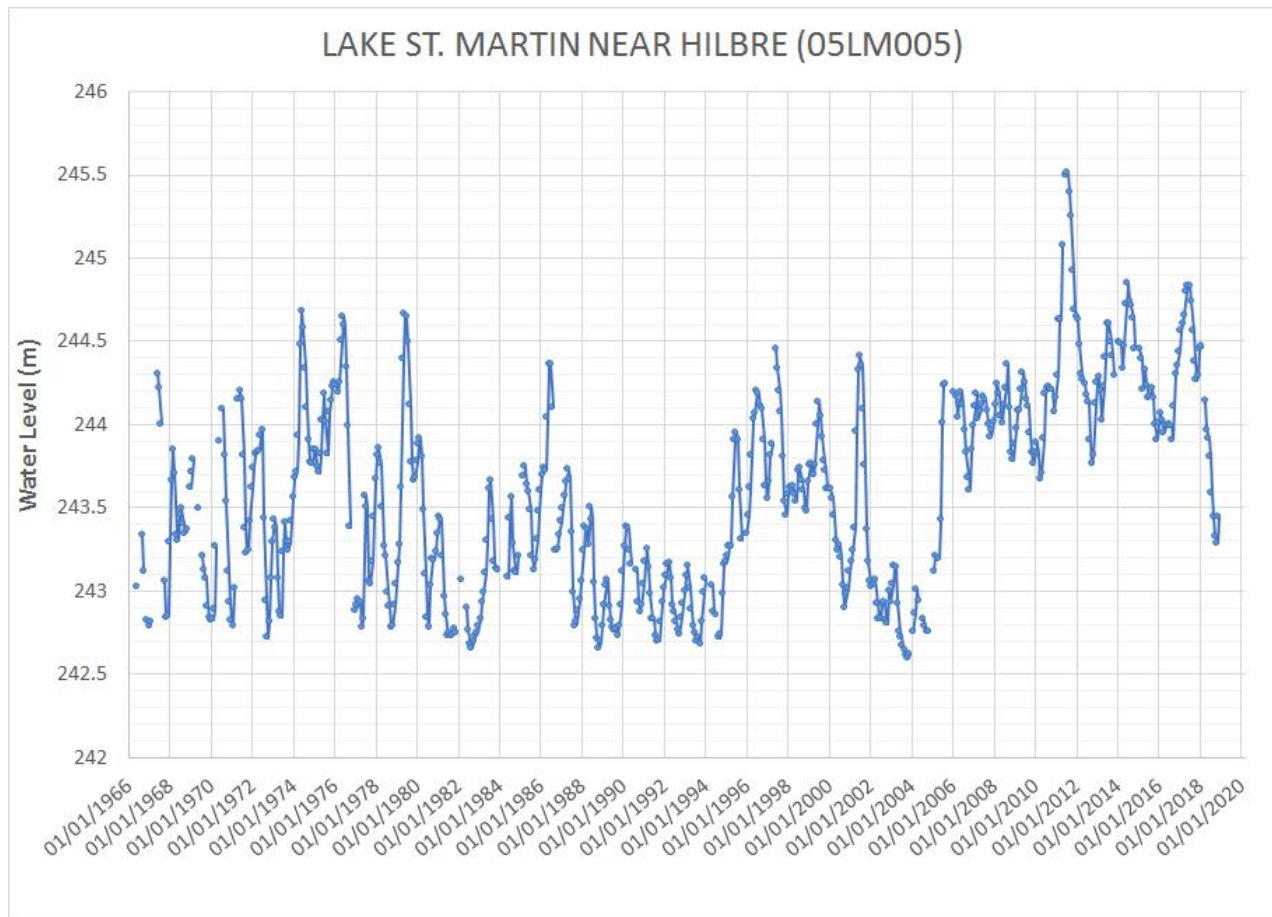
**Figure 2.1 Measured Water Levels at the Hilbre Gauge, Lake St. Martin (data from ECCC)**

Monthly mean water levels for the Hilbre gauge on Lake St. Martin are presented in Figure 2.1, and date back to 1966. The location of the gauge relative to the channel is noted in Figure 2.3. The lake levels are not regulated but they are influenced by the rate of water released from the Fairford Dam. Water levels during the survey were approximately 243.4 m, which is near the lower range of historical conditions, but still rough 0.8 m higher than the recent lows in 2003.

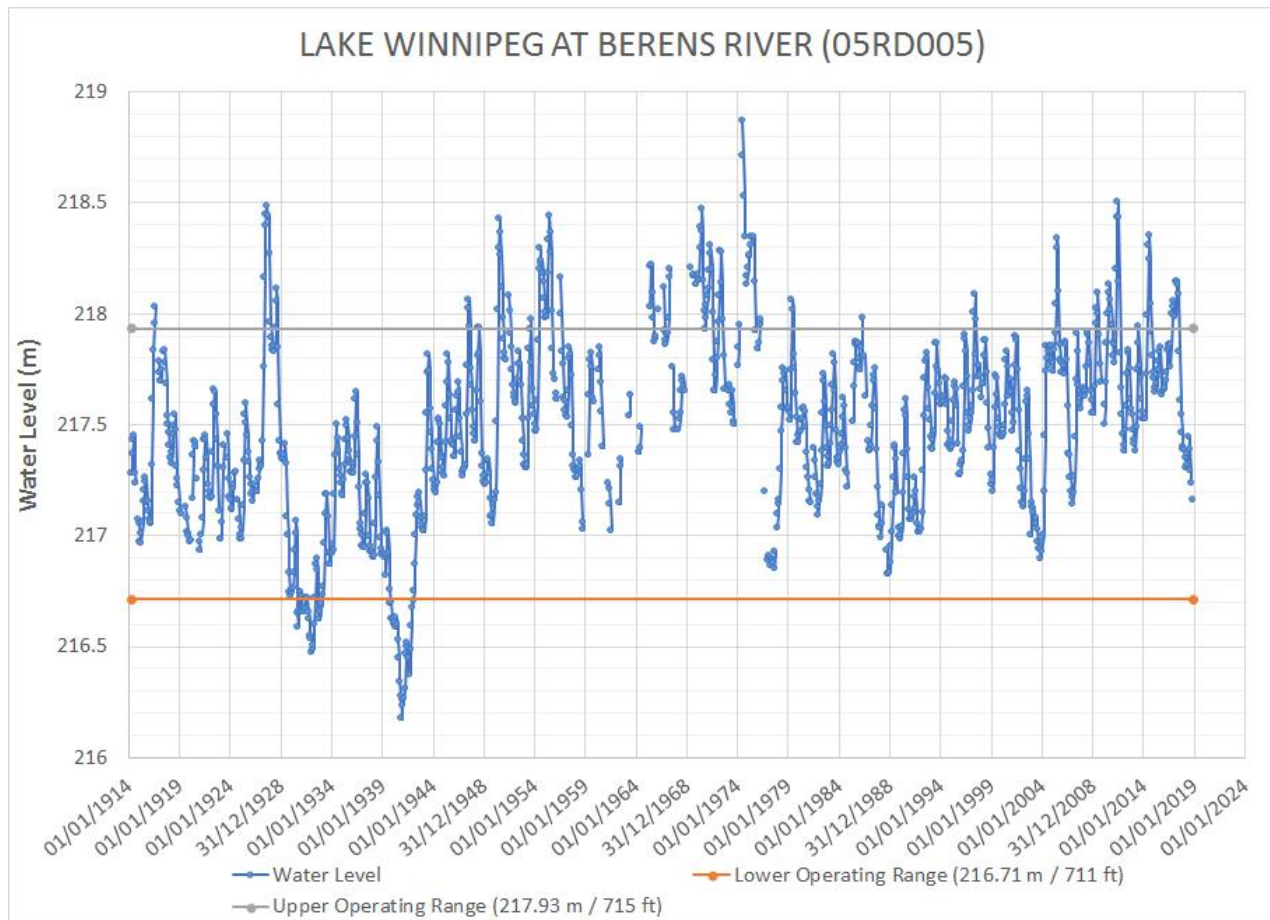
**Figure 2.2 Lake Winnipeg Water Levels from the Berens River Gauge (data from ECCC)**

The Berens River gauge is in the northern basin of Lake Winnipeg, east of Sturgeon Bay and the proposed outlet. Monthly mean water levels are presented dating back to 1914 in Figure 2.2. The location of the gauge is noted on Figure 2.5. It is important to note that Lake Winnipeg Regulation began in 1976 with the construction and operation of the Jenpeg Generating Station. The upper and lower operating range for the lake (217.9 m and 216.7 m respectively) is noted on the water level plot. During the survey, water levels were approximately 217.5 m.

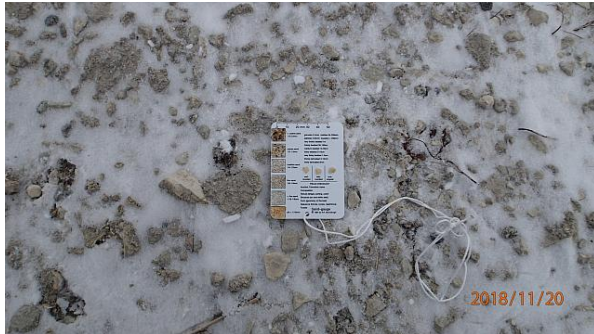
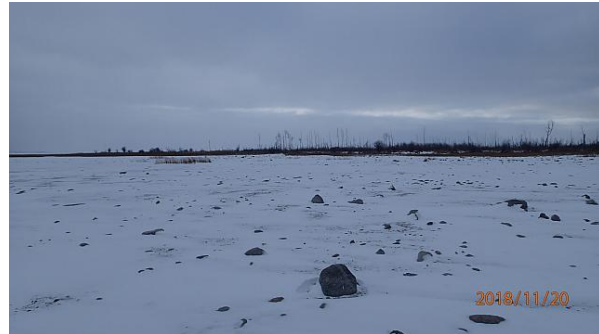
A: Angular Lake Bottom Material (WP 18-24)

B: Boulders and Cobbles on the Exposed Lakebed (WP 18-24)

**Figure 2.4 Pictures from Nov. 20, 2018 Site Visit**

- **Exposed Lake Bottom:** the exposed lake bottom in the embayment featured angular pebbles and cobbles, with larger rounded (fluvial or glacially weathered) boulders. Refer to Photos A and B in Figure 2.4. These initial field observations suggest that the wave climate on Lake St. Martin can erode the glacial sediment (tills and lacustrine clays) but is not energetic enough to transport the larger material (cobbles and boulders) along the shoreline. Where the glacial sediment features high concentrations of cobbles and boulders, a self-armouring process leads to the formation of the rocky headlands prevalent on Lake St. Martin. Refer to Photos C and D in Figure 2.4. Also, when the in-situ rock reaches a sufficient volume, the underlying glacial sediment is protected from further erosion and stabilizes at low to average lake levels.

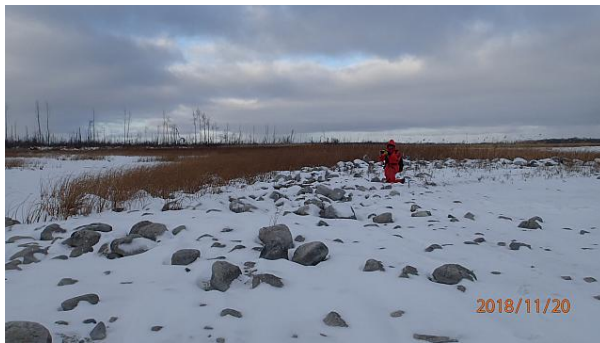
C: Boulder Headland Protecting Emergent Marsh Vegetation (WP 18-26)

- **Marsh Shoreline:** Between the headlands and sheltered from direct wave attack, dense stands of emergent vegetation have developed on Lake St. Martin (Photo C in Figure 2.4).

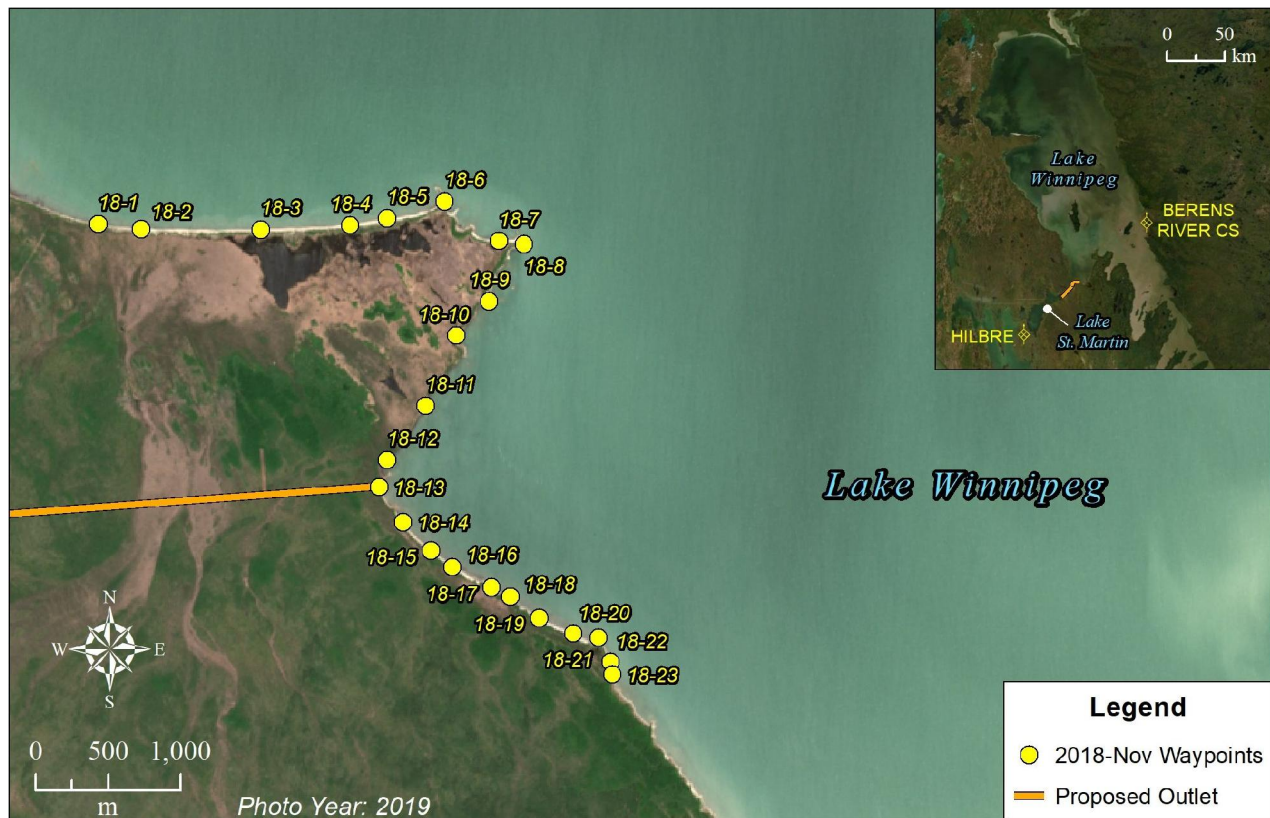
**Figure 2.5** Waypoints 1 to 23 on Lake Winnipeg (visited Nov. 20, 2018)

Approximately 7 km of shoreline north and south-east of the proposed outlet were observed by traversing the frozen shoreline on November 20, 2018. Figures 2.3 presents the Waypoints, with 18-13 representing the proposed outlet location.

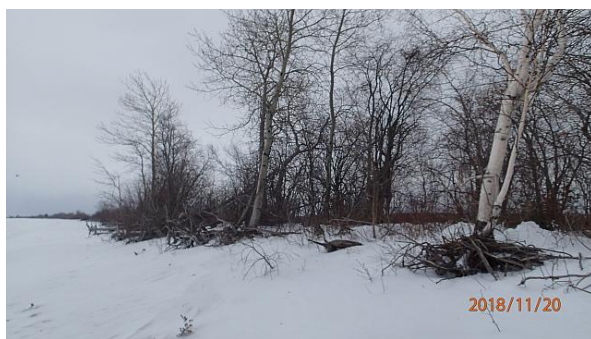
A: Exposed Tree Roots on Dune Ridge Suggest Slow Erosion Rate (WP 18-1)

**Figure 2.6 Photographs from the Nov. 20, 2018 Site Visit**

- WP1 to WP6 - Beach and Ridge System: Sandy shoreline with signs of small long-term erosion rate, especially between WP1 to WP 2. Refer to Photo A in Figure 2.6. The vegetated ridge increases in elevation towards the tip of Willow Point (to the east). Shoreline erosion generates new sediment that is transported to the east.

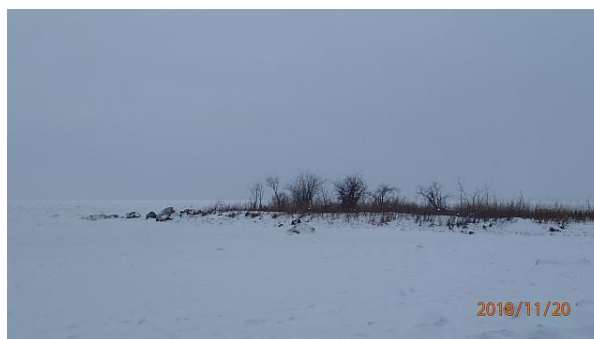
B: Boulder Headland at Willow Point (WP 18-8)

- WP6 to WP8 - Headland for Willow Point: The headland features a higher concentration of cobbles and boulders than the adjacent shoreline, possibly due to a glacial ridge or ground moraine. Another explanation is ice-push processes, during breakup, when ice-entrained boulders are pushed onshore in ice-sheets and concentrated in a ridge at the waterline (Barnes, 1982; Philip, 1990). A picture of the western boulder headland is provided in Photo B of Figure 2.6. Between the hardpoints of the headland, signs of shoreline erosion were observed (i.e., exposed tree roots).

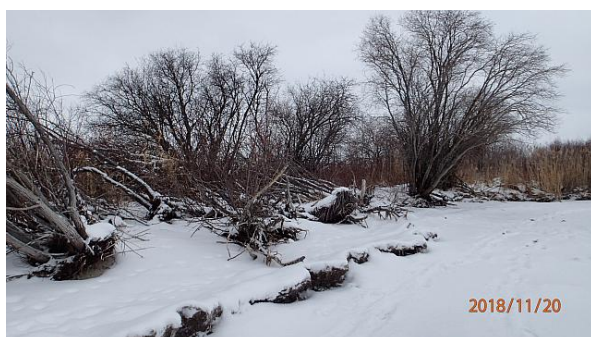
C: Eroding Peat Shoreline SE of Willow Point (WP 18-10)

- WP8 to WP13 – Southeast Shore of Willow Point: Limited wave exposure (small fetch to the east and sheltered from waves from the north Lake Winnipeg basin) but the shoreline appears to have a long-term erosion rate based on the exposed and eroding peat at the shoreline. See Photo C in Figure 2.6. The orientation of the shoreline is not conducive to sand accumulation and there are no significant beach deposits.

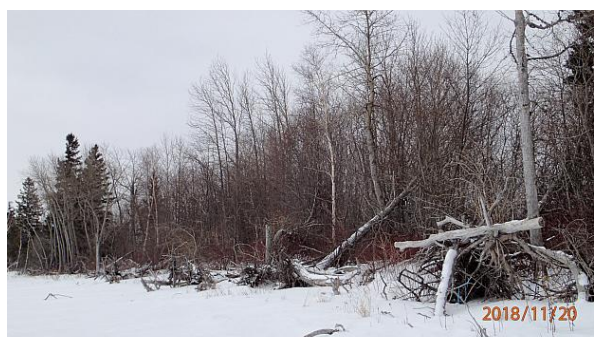
D: Eroding Shoreline East of Outlet (WP 18-16)

sandy beach and vegetated ridge separate the lake from the marsh/bog, and appear to be related to wave overtopping processes and aeolian transport of sand onshore. Exposed tree roots suggest there is a low long-term erosion rate, as seen in Photo D of Figure 2.6. Sections of shoreline that feature ground moraine with a higher concentration of cobbles and boulders erode slower than the adjacent shores and form small headlands. These ground moraine areas also have higher elevations (e.g., WP17 to WP21). Eroded peat debris on the beach suggests the outlet could become a sediment trap and zone of accumulation when not in operation.

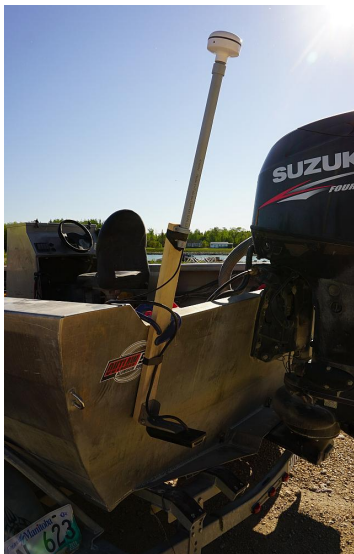
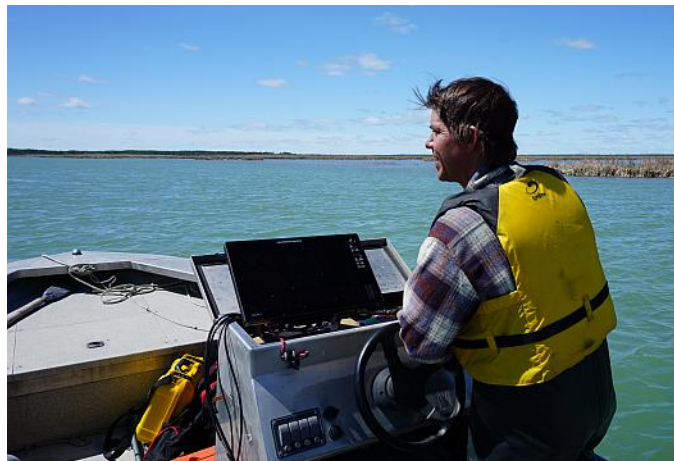
Transducer Mount

Control Monitor for Navigation

**Figure 2.7 SOLIX Transducer Mount on Survey Boat and Control Head**

The SOLIX is a single-beam bathymetric and sonar system with built-in recording and navigation tools. The transducer was mounted at the back of the boat with a dedicated GPS antenna located directly above the unit. Refer to Figure 2.7. The unit auto-corrects for the depth of the transducer below the lake surface and the depths were recorded every second.

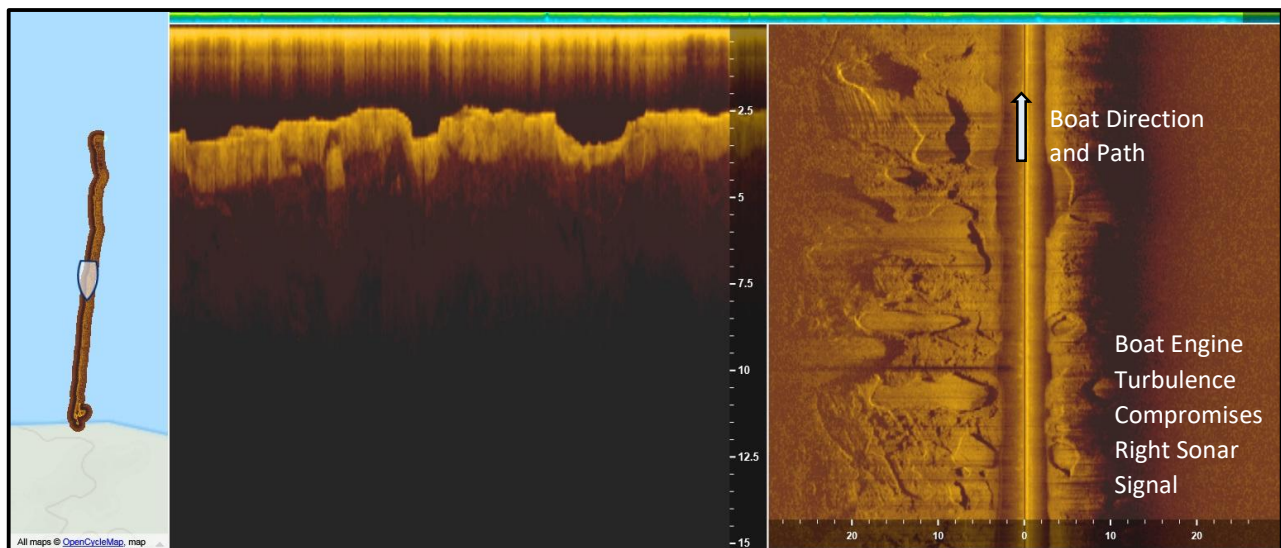
**Figure 2.9 SOLIX Data for Line 9 (potential peat lake bottom)**

The Line 9 SOLIX image data is presented in Figure 2.9 and features a lake bottom with an irregular honeycomb pattern. Given the rapid long-term erosion rate of this shoreline, as discussed in Section 3.1, it is possible that the substrate features exposures of eroded peat. The holes or depressions may represent former open water areas in the marsh, while the higher surrounding surface area represents former locations with dense, peat forming emergent vegetation.

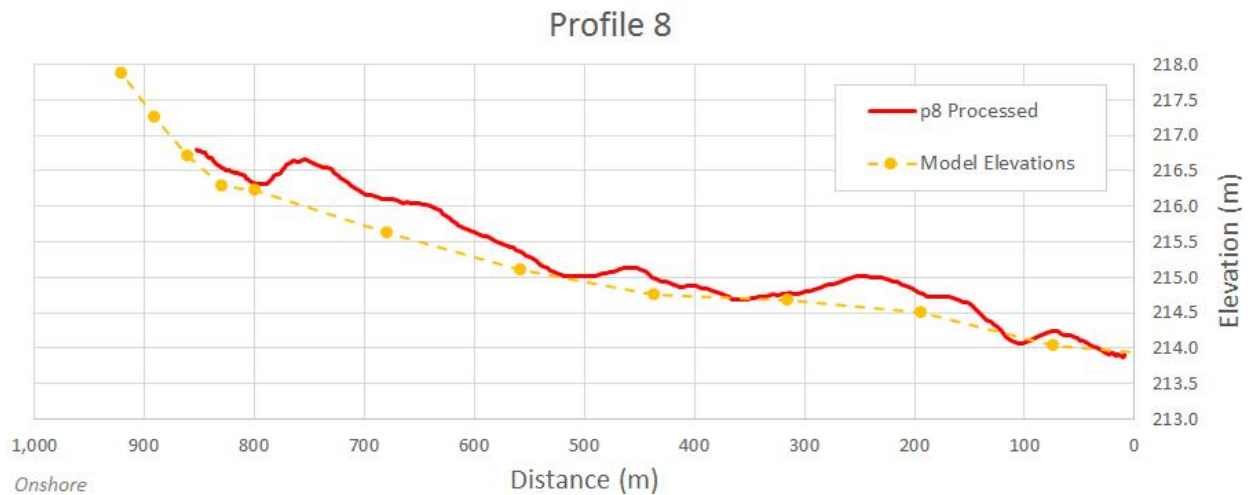
Figure 2.12 Comparison of SOLIX Bathymetry at Line 8 (east of outlet) and MIKE21 Model Bathymetry

The primary cause of this difference is mainly attributed to the level of detail captured during the surveys. The SOLIX survey was generally more detailed than the 2017 North South survey allowing for better representation of nearshore bathymetric characteristics such as sand bars. The 2017 North South survey was also completed for a different purpose than to assess shoreline morphology and was therefore based on an approximately 500m spaced tracklines offset from shore. For example, along Line 6 north of the proposed outlet, there simply is very little bathymetric data available from the 2017 survey to characterize the nearshore (refer to Figure 2.11). This is not uncommon with lake surveys, as the shallow depths along the shoreline are typically the most difficult to capture in a traditional boat-based bathymetric collection. To develop the DEM, a linear interpolation was applied between survey points and the shoreline. This can introduce error when compared to the actual bathymetry within the interpolated zone, such as the depths collected with the SOLIX survey.

Another source of error includes the variability in water levels that may have occurred during one or both surveys due to wind and wave conditions on Lake Winnipeg. This could have resulted in the assumed water level used to develop the DEM to be higher or lower than the actual water level for each survey points.

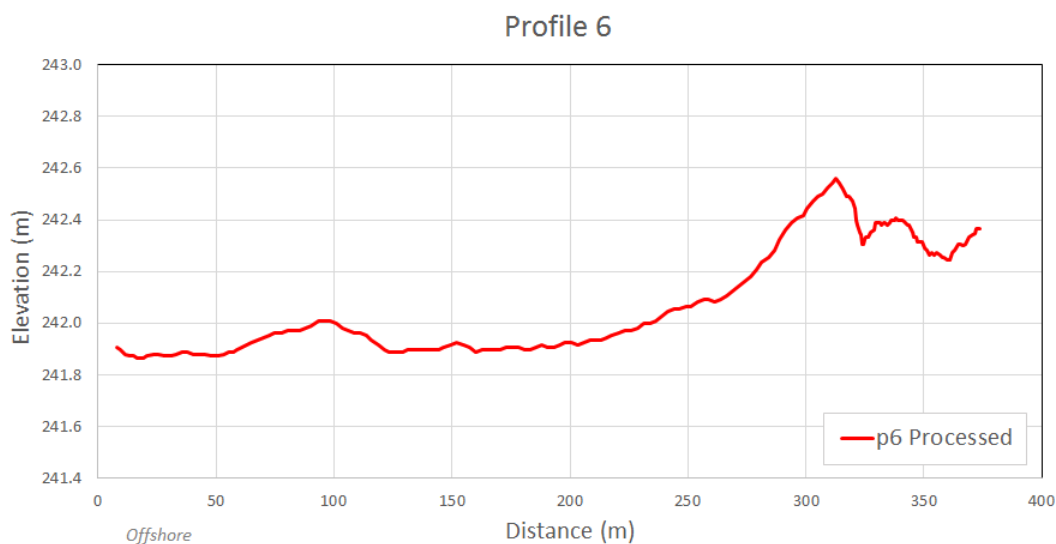
**Figure 2.14 Profile LSM-6**

The location of Profile LSM-6 is presented above in Figure 2.13. The lake bottom was relatively flat and then featured a cobble-boulder ridge close to shore. Refer to Figure 2.14.

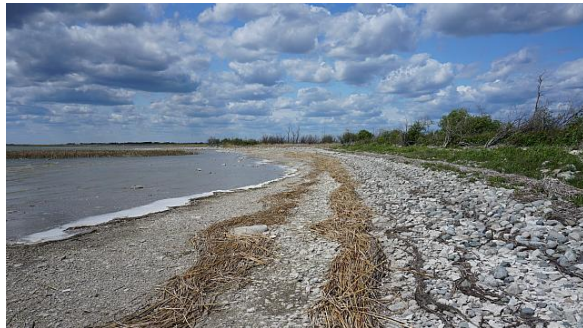
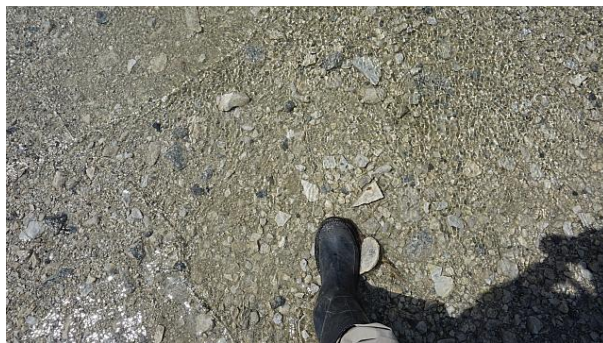
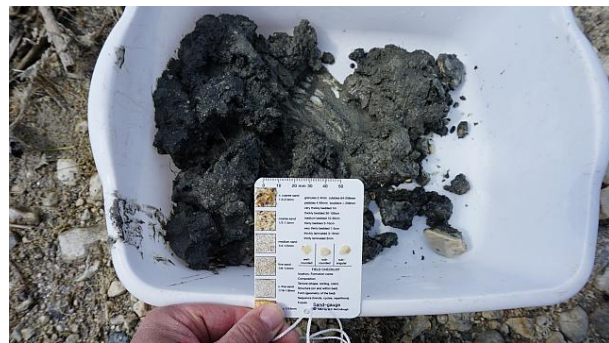
In Figure 2.15 a series of photographs for a typical cobble-boulder headland found in the lake (taken from WP 11 in Figure 2.13) are presented. Well sorted gravel, cobble, and boulders are

present at different shore elevations, with the larger material (i.e., boulders) found higher up the beach slope, possibly attributed to ice-push. The nearshore features scatter pieces of rock fragments, gravel, and sand. From a shallow hole, glacial till or lacustrine sediment was encountered below the surface layer of sand and gravel, softened by exposure on the lake bottom.

Typical Shoreline with Sorted Material

Mixed Angular Substrate at the Waterline

Till/Lacustrine Sediment from the Waterline

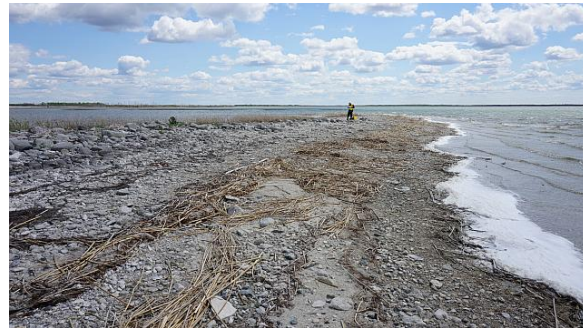
Typical Headland Anchored by Boulders

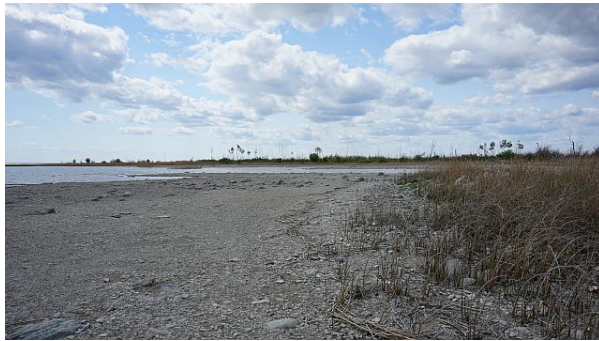
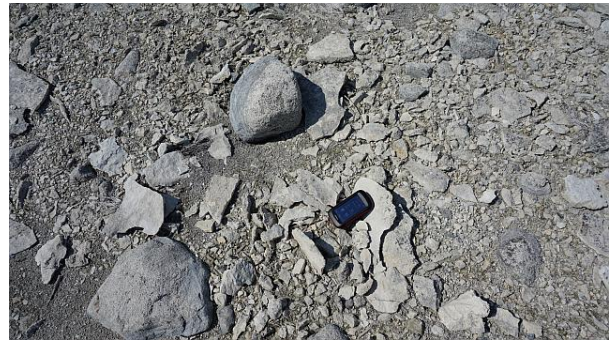
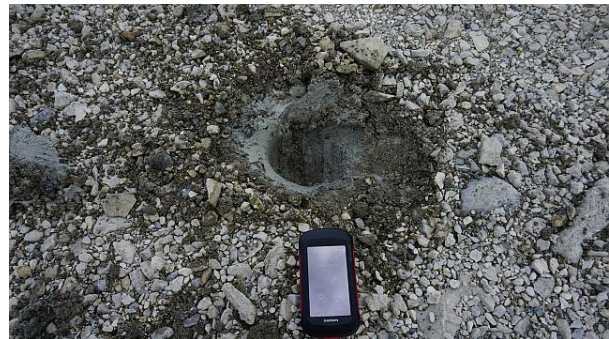
**Figure 2.16 Shoreline Conditions North on the Inlet, June 10, 2019**

Fracturing of the limestone cobbles and boulders was observed, and this process creates newer small angular beach material over time. Below the beach sediment, glacial sediment was again observed, as seen in Figure 2.16.

Headlands Backed by Marsh

Freeze-thaw Processes

Clay/Mud below the Hard Beach Sediment

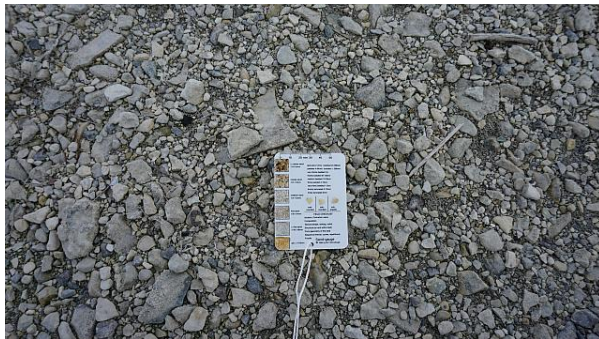
Angular Beach Sediment

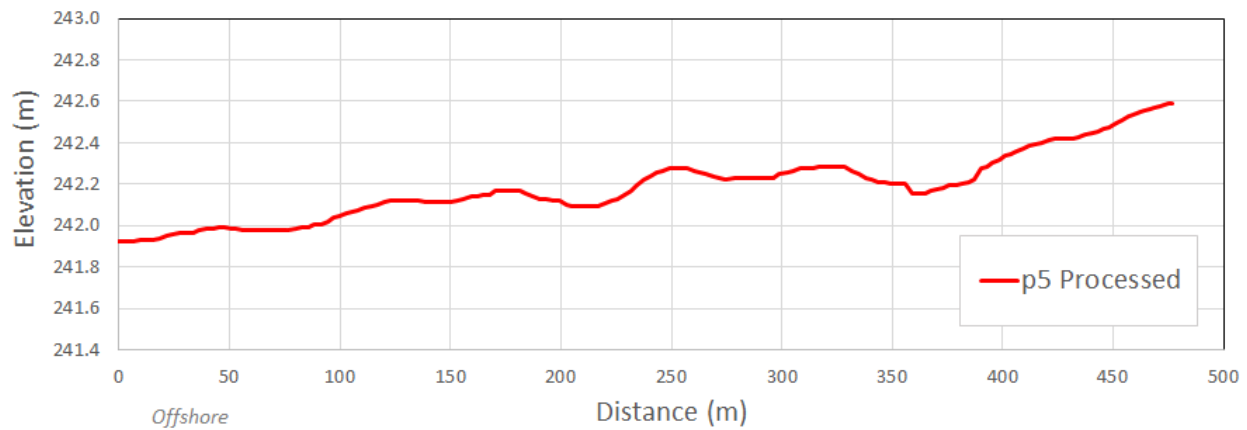
**Figure 2.17 LSM Profile 5**

The water elevation during the bathymetric survey was 243.4 m CGVD, making it impossible to navigate into the inlet embayment. Figure 2.17 presents the survey line (5) that terminates on the edge of the embayment. The water depth was less than 1 m at the terminus of the line. Since the embayment features scattered boulder piles, navigation further onshore was not possible.

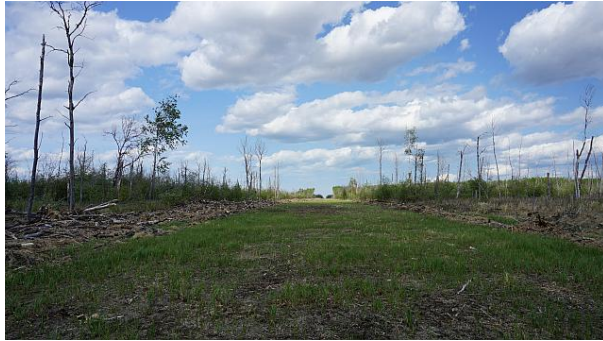
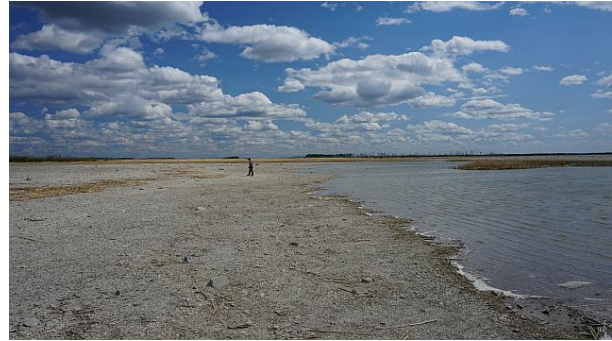
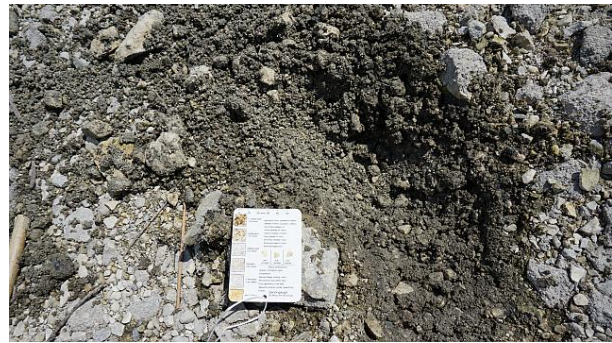
**Figure 2.18a Shoreline Conditions at the Inlet, June 10, 2019**

Photographs of the shoreline at the proposed inlet are presented in Figure 2.18, including the cutline, exposed lake bottom, and shallow nearshore conditions with boulder piles. At the water's edge glacial sediment was also encountered below the sand and gravel on the beach, as seen in Figure 2.18a. The shallow conditions at the proposed inlet, the exposed lake bottom, and boulder piles are best seen in the oblique photograph in Figure 2.18b.

Cutline for Proposed Inlet Alignment

Gently Sloping Nearshore

Sand-Gravel at Waterline with Clay

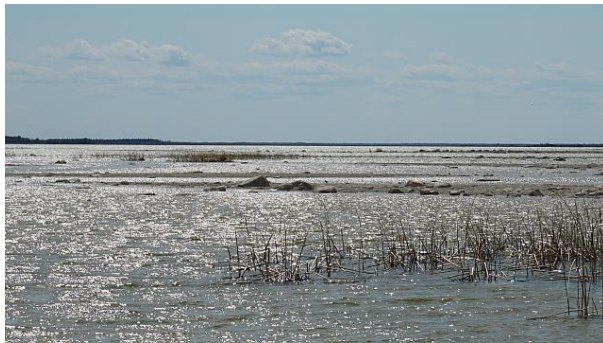
Shallow Nearshore with Boulder Piles

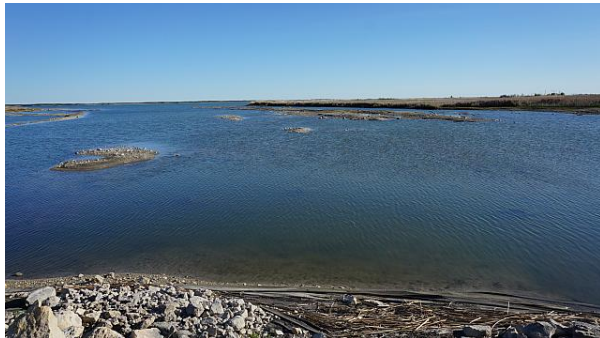
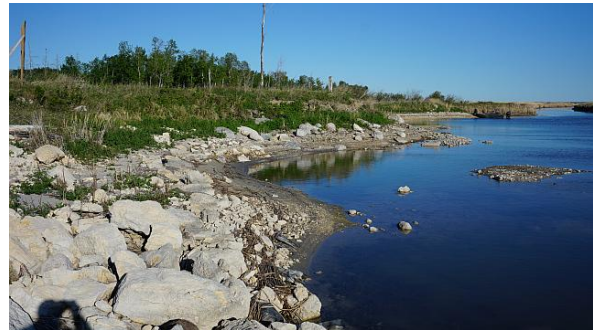
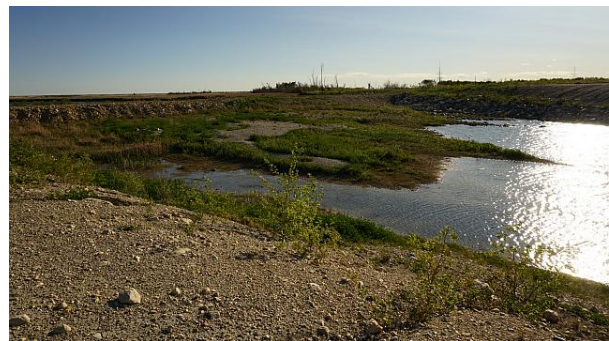
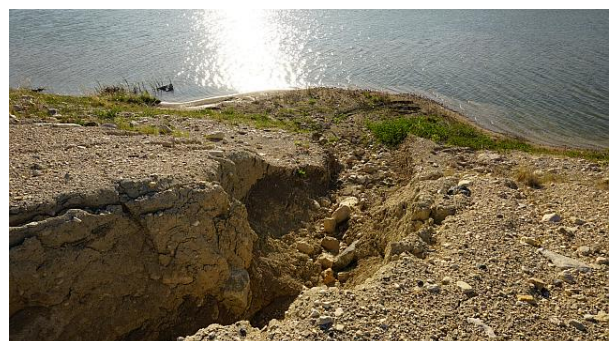
**Figure 2.20 Reach 1 Conditions on June 11, 2019**

- Photo A: Shallow condition lakeward of the cut-off berm. This area was excavated during construction and operation of Reach 1 (P.Leclercq pers com. July 22, 2019). Although not seen in Photo A, there were no visible signs of shoreline erosion observed on our approach,

- Photo B: The shoreline immediately east of the cut-off berm is presented in Photo B. Sorted sand-sized beach material has accumulated at the waterline. This is one of the few locations where a sand-sized beach deposit was observed on the northern reaches of the lake. Presumably the sand was transported to this area by currents during the operation of Reach 1,

- Photo C: Lake side of cut-off berm. Small sand-sized beach deposit at the waterline,
- Photo D: On the back side of the cut-off channel, a large depositional deposit was observed. This feature is attributed to the material (unsorted) used to construct the berm, not natural deposition during the operation of the channel. The large rock debris remained in the berm, while the finer sands and gravels were transported into the channel during decommissioning,

- Photo E: Reach 1 looking inland. Small delta-like deposits were observed at the base of the unvegetated side slopes.
- Photo F: Gully formation attributed to overland drainage, with sedimentation in a small delta.

A: Shallow Nearshore Conditions Lakeward of the Cut-off Berm (area of excavation)

B: Minor Sand Accumulation East of the Cut-off Berm

D: Sedimentation on the Channel Side of the Cut-off Berm

F: Gully in Channel Side-Slope and Sediment Accumulation (mini-delta)

In summary, our observations suggest there were no major shoreline alterations on the approach to Reach 1, with only one minor accumulation of sand-sized material along the east bank of the cut-off berm. The sedimentation inside of Reach 1 is attributed to the material used to close the channel, not sedimentation from the flows in the channel.

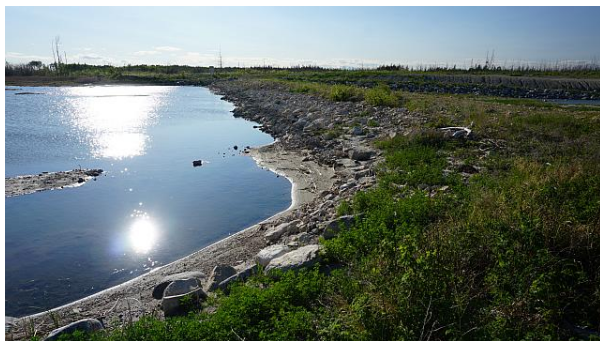
C: Lake Side of Cut-off Berm and Small Sand Deposit at the Waterline

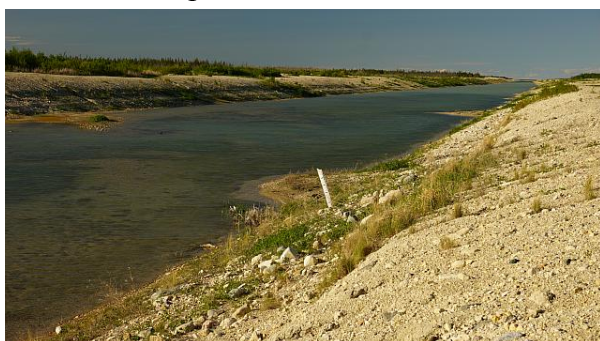
E: Reach 1 Channel with Exposed Side-slopes

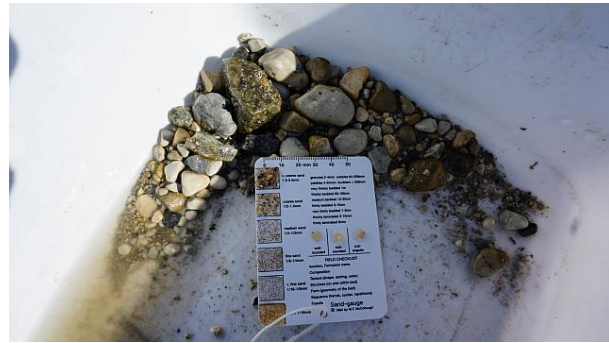
Shallow Nearshore with Boulder Piles

Sand-Gravel at Waterline with Clay

**Figure 2.22 Cobble-Pebble Bar in the Dauphin River and a Bed Sample from the Rivermouth**

The Dauphin River was traversed by boat on June 12<sup>th</sup>, 2019. The spatial extent of the survey is noted on Figure 2.10. Approximately 3 km upstream of the rivermouth, large pebble-cobble bar features were observed in the river. Refer to Figure 2.22 for a sample image, with Pelicans resting on the crest. With the lower river stage, these features were large and easy to identify (e.g. >50m long). At the mouth of the river, a ponar grab sample retrieved a large sample of pebbles and cobbles (Figure 2.22) from the riverbed. Investigating the sediment transport potential of the Dauphin River is not part of this investigation. However, these field observations suggest the river may be a small sediment source for the shoreline of Sturgeon Bay.

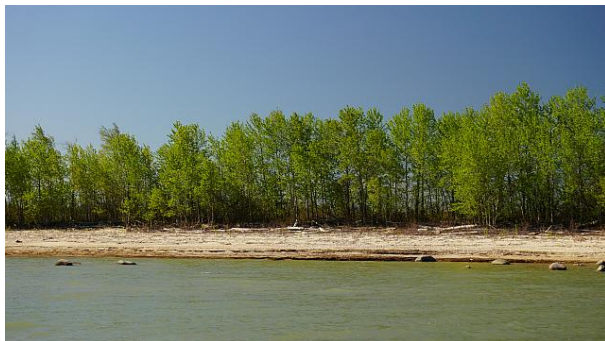
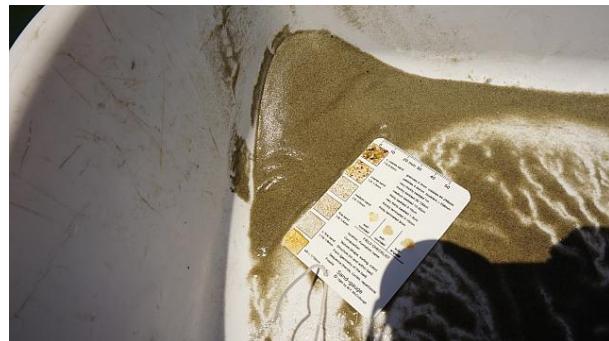
Line 2 Sandy Shoreline

Fine Sand from Nearshore Bay, Line 2

**Figure 2.23 Line 2 Shoreline and Lakebed Sample from Sandbar**

The shoreline from the mouth of the Dauphin River to Willow Point features a sandy beach and ridge system of varying height. The nearshore typically features scattered cobbles and boulders, and a sandy substrate close to the shoreline. Refer to Figure 2.23 for a picture of the Line 2 shoreline and sandy substrate captured with a ponar grab sample.

Closer to shore, a zone of submerged aquatic vegetation (SAV) was detected with the sonar and is presented in Figure 2.25 (bottom panel). The SAV transitions to a sand substrate, which was validated with the lakebed sample extracted and presented in Figure 2.23.

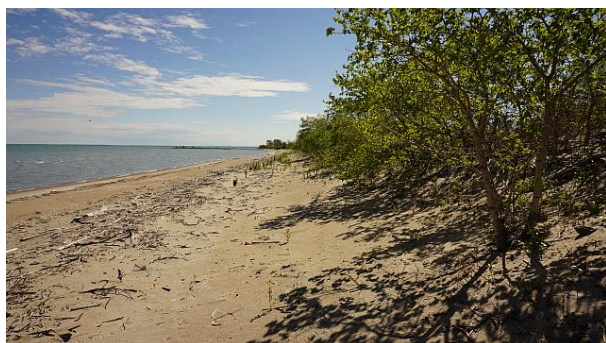
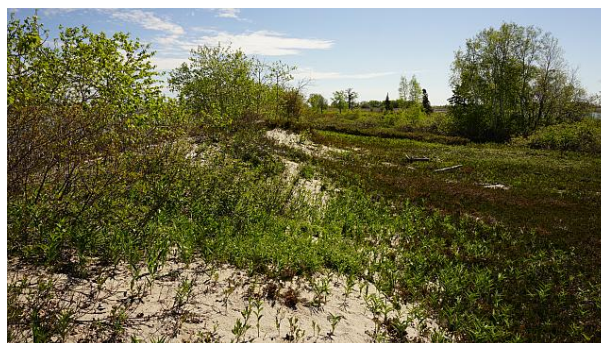
Cutline for Proposed Inlet Alignment

Gently Sloping Nearshore

**Figure 2.26 Wide Sand Beach and Ridge System at Line 4 (west side of Willow Point)**

The Willow Point headland functions as a sediment trap for sand transported from west to east in Sturgeon Bay. The shoreline adjacent to the point features a wide sand beach and vegetated ridge system, as seen in Figure 2.26. The area also features active aeolian transport, with evidence of beach sediment transported inland by wind.

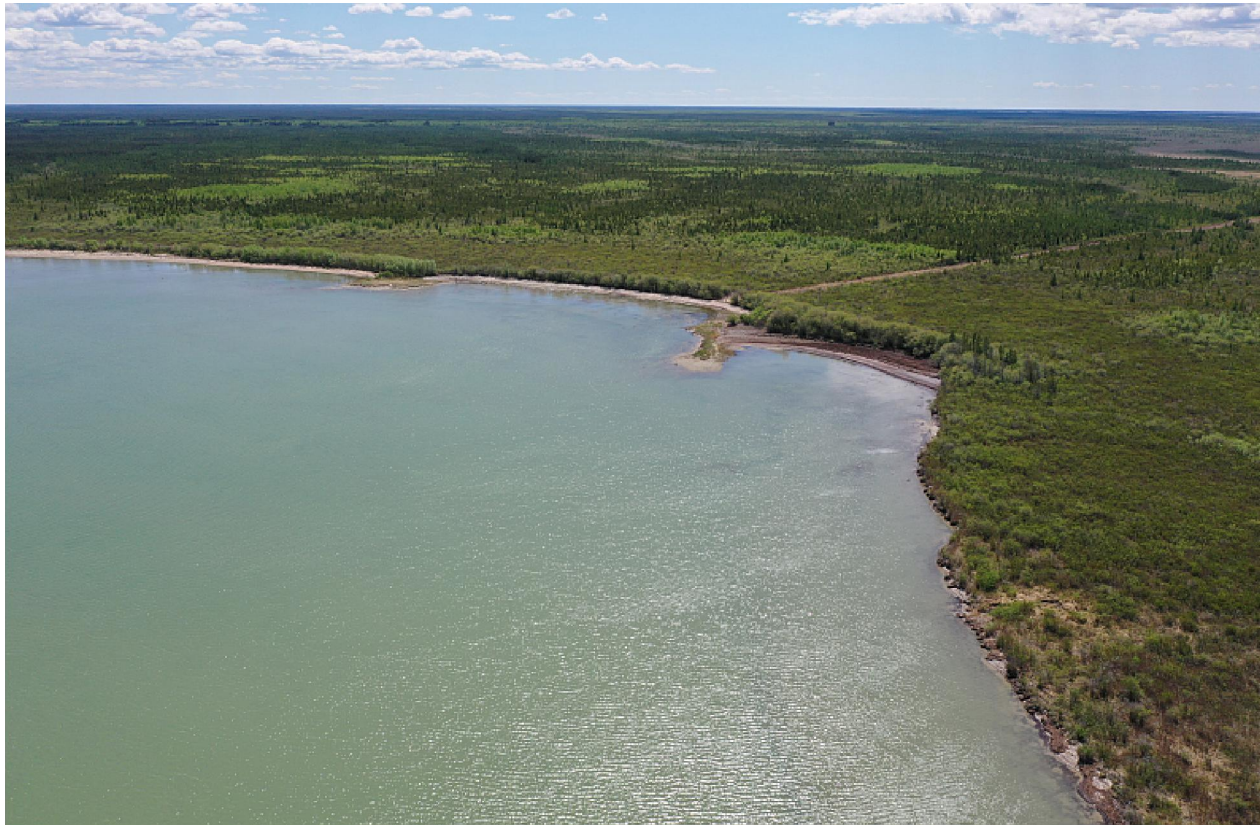
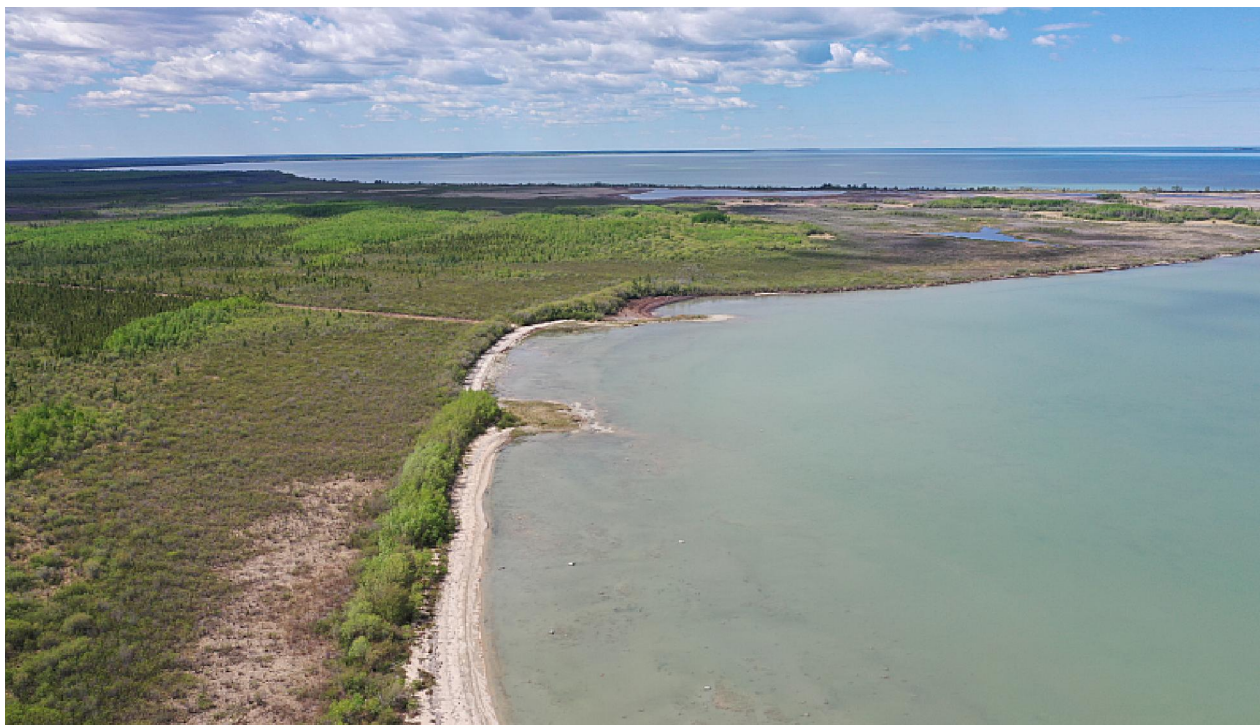
**Figure 2.27** Cut Line and Proposed Channel Outlet looking south (top) and looking northwest (bottom)

An oblique aerial photograph of the proposed outlet channel looking south is presented in the top photograph of Figure 2.27. The eroding peat shoreline on the east side of Willow Point, along with peat accumulation at the shore is seen on the right side of the image. The shoreline conditions, looking west towards the proposed outlet are presented in the bottom image of Figure 2.27. A wide sand beach is present, along with a vegetated sand ridge. The shallow and gently sloping nearshore features scattered boulders.

Outlet Shoreline Looking South (*image courtesy L. Wazney, KGS Group*)

Outlet Shoreline Looking West (*image courtesy L. Wazney, KGS Group*)

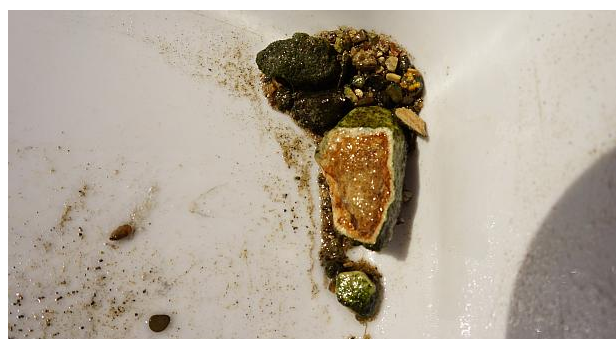
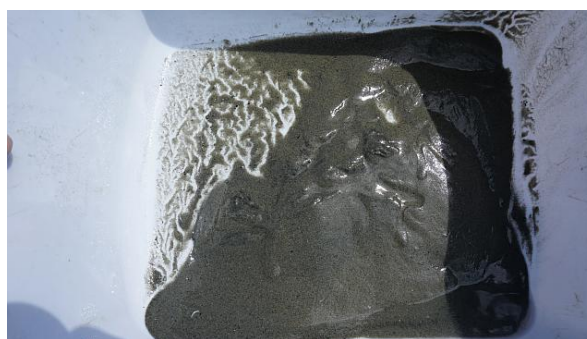
WP49 Cobble-Gravel Lakebed Sample

WP55 Sand Lakebed Sample

**Figure 2.29 Lakebed Samples near Proposed Outlet**

The material retrieved from two ponar grab samples close to the proposed outlet are presented in Figure 2.29. At WP49, approximately 1 km offshore, the lake bottom was hard and only a small sample of cobbles and pebbles were retrieved. Closer to shore at WP55, a fine homogeneous sand sample was retrieved.

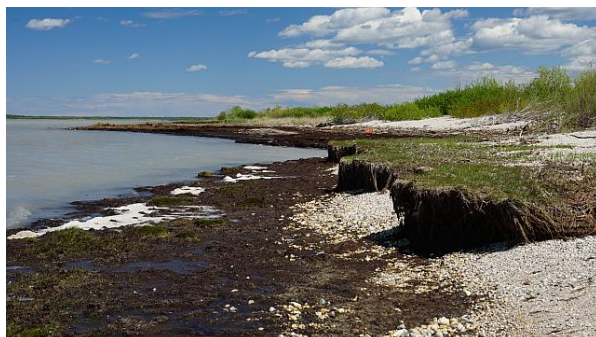
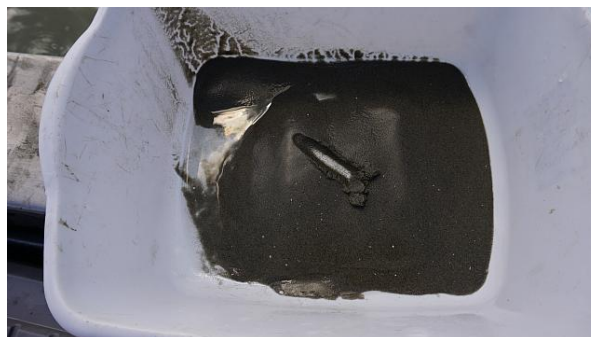
Eroding Peat Shoreline

Sandy Nearshore Lakebed (WP50)

Figure 2.29 Eroding Peat Shoreline and Sandy Lake Bottom Sample at WP50

The Sturgeon Bay Park Reserve shoreline features a long sandy barrier beach system, that is eroding and migrating inland into the marsh. As the shoreline migrates inland, former peat sediments that formed in the sheltered marsh are exposed in the nearshore, and at the waterline. Refer to Figure 2.29 for a typical picture of this eroding shoreline. Evidence of sand transport inland by wave overtopping during storms and aeolian transport was also observed, suggesting this region of the shoreline is a sediment sink.

A ponar grab sample from WP50, which corresponds to the terminus of Line 11, featured a homogeneous dark sand deposit, as seen in the right image of Figure 2.29.

These high rates of shoreline erosion explain the large exposures of peat observed on the beach at Line 10 (refer to Figure 2.29). As the barrier beach migrates inland into the marsh, lenses of peat that formed in the marsh are now exposed on the lake bottom and at the waterline.

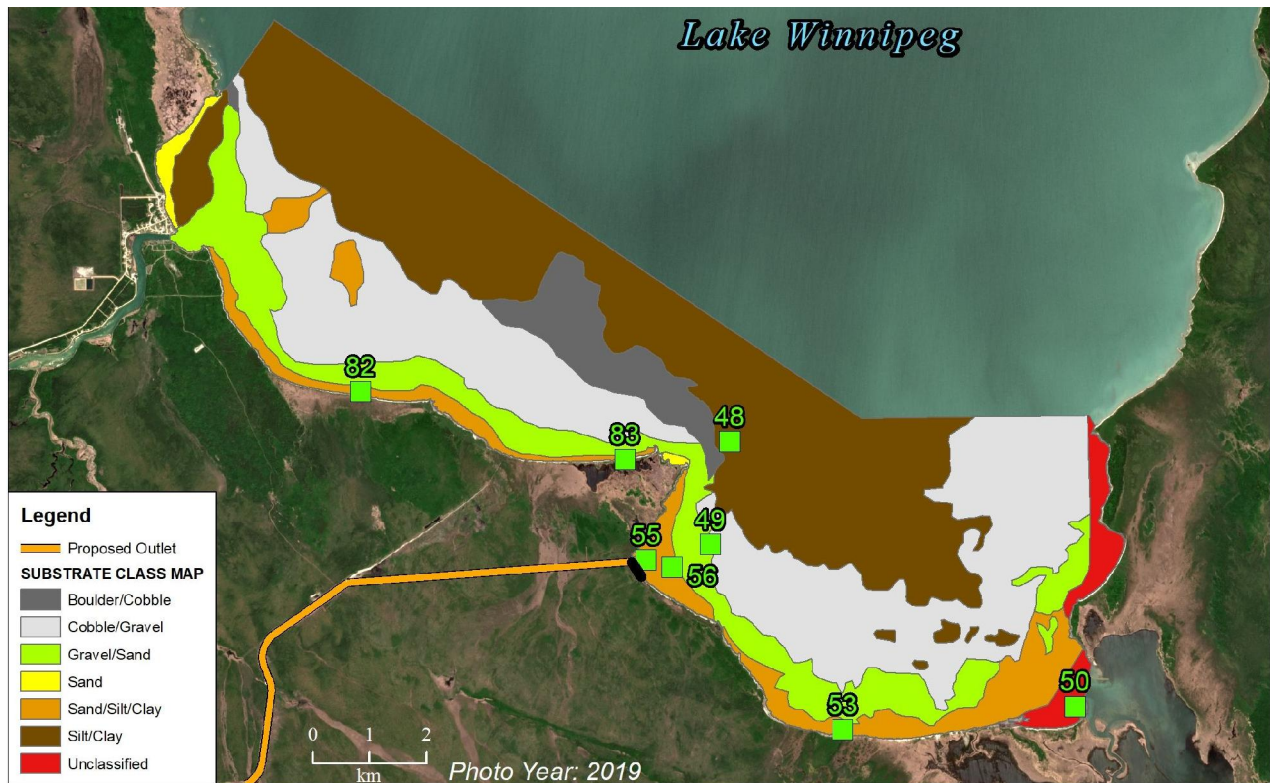
**Figure 2.31 Sturgeon Bay Lakebed Substrate by North-South Consultants**

The substrate classification map for Sturgeon Bay, also generated by North-South Consultants, is presented in Figure 2.31. A total of eight samples were retrieved on June 12, 2019 to verify the substrate classification and ensure the substrate zones had not migrated. The results are summarized in Table 2.1 and presented visually in Figure 2.32. Our samples are generally in agreement with the North-South substrate mapping. Our interpretation of the Sand/Silt/Clay classification, based on our observations, is: 1) close to shore, the lake bottom can feature exposures of glacial till and patches of sand (e.g., WP53), and 2) further offshore in deeper water, this classification represents a mobile sand sheet formed by longshore currents.

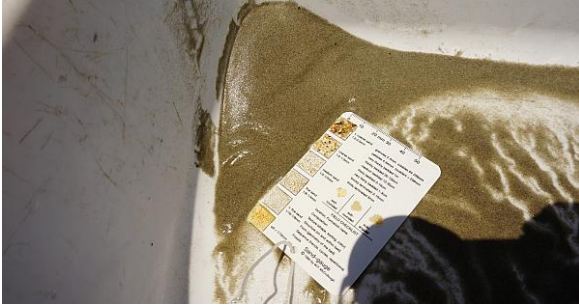
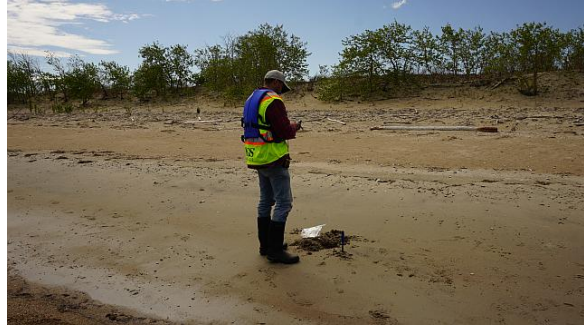
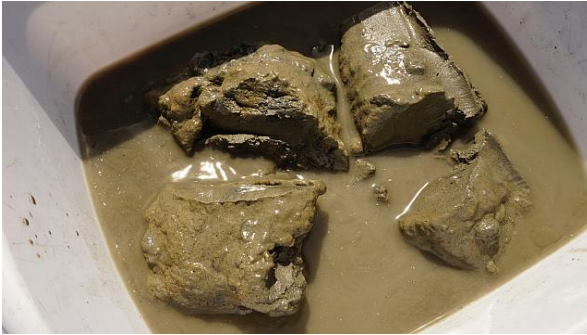
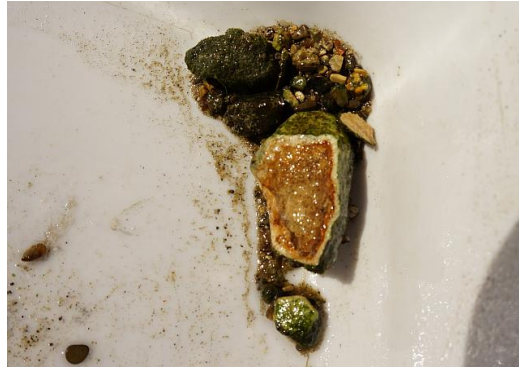
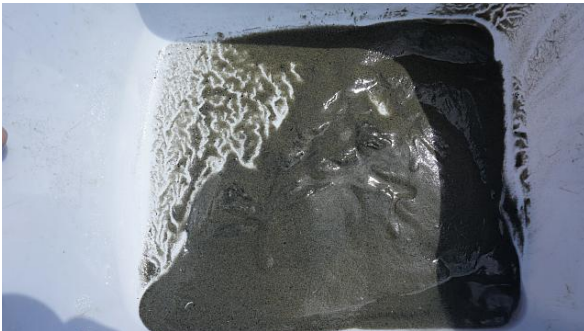
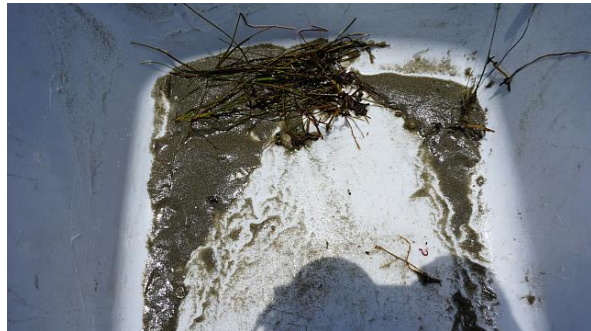
Line 2 WP82 - Sand

Line 4 WP83 - Sand

WP48 - Mud

WP49 – Sand and Pebbles

WP55 – Sand (proposed outlet excavation)

WP56 – Sand (offshore of outlet)

Location/Waypoint	June 12, 2019 Sample	N-S Substrate Classification
Line 2 / WP82	Sand	Sand/Silt/Clay
Line 4 / WP83	Sand	Sand/Silt/Clay
WP48	Mud	Silt/Clay
WP49	Pebbles and Cobbles	Cobble/Gravel
WP55	Sand	Sand/Silt/Clay
WP56	Sand	Sand/Silt/Clay
WP53	Sandy and Clay	Sand/Silt/Clay
WP50	Sand	Unclassified

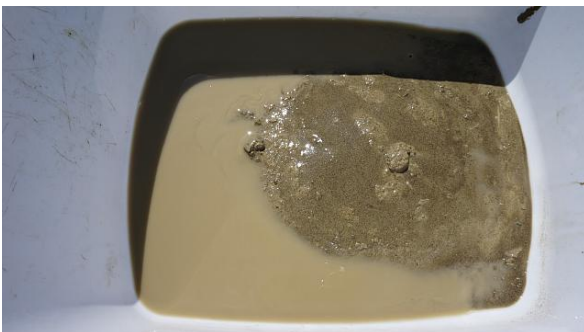
WP53 – Sand and Clay (Line 9)

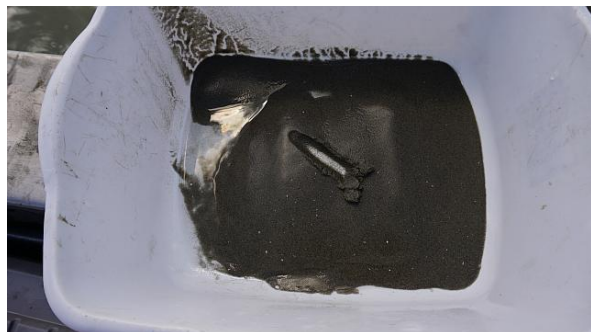
**Figure 2.32 Ponar Grab Samples of Surficial Lake Bottom Conditions**

WP50 – Sand (Channel to Sturgeon Bay Reserve)
