# Lake St. Martin Outlet Channel Baseline Shoreline Assessment

**The KGS Group**

July 22, 2020

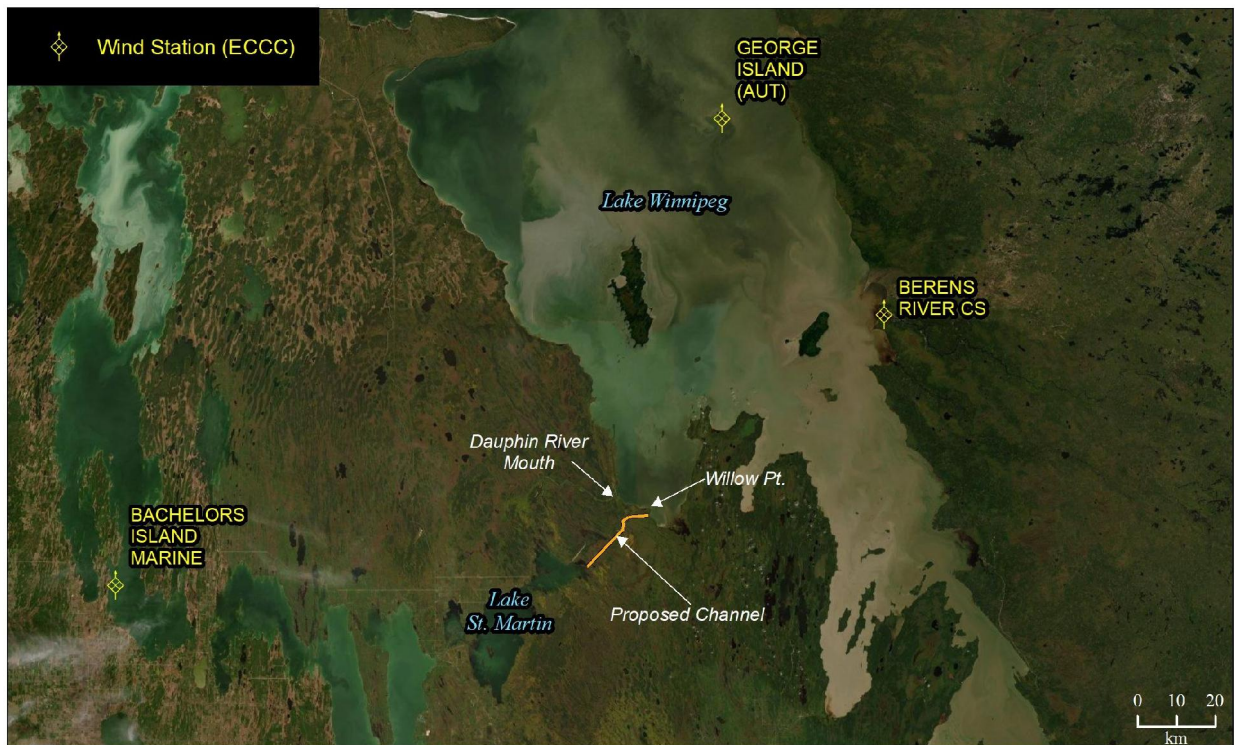
**Figure 3.10 Wind Stations Close to the Proposed Channel**

Historical data on storms and corresponding wave conditions at the proposed inlet and outlet are required for the regional sediment transport analysis and assessment of channel sedimentation potential. Figure 3.10 identifies three wind stations maintained by Environment Canada near the proposed inlet and outlet. Table 3.2 summarizes the start, end, and duration of the historical wind records at the three stations.

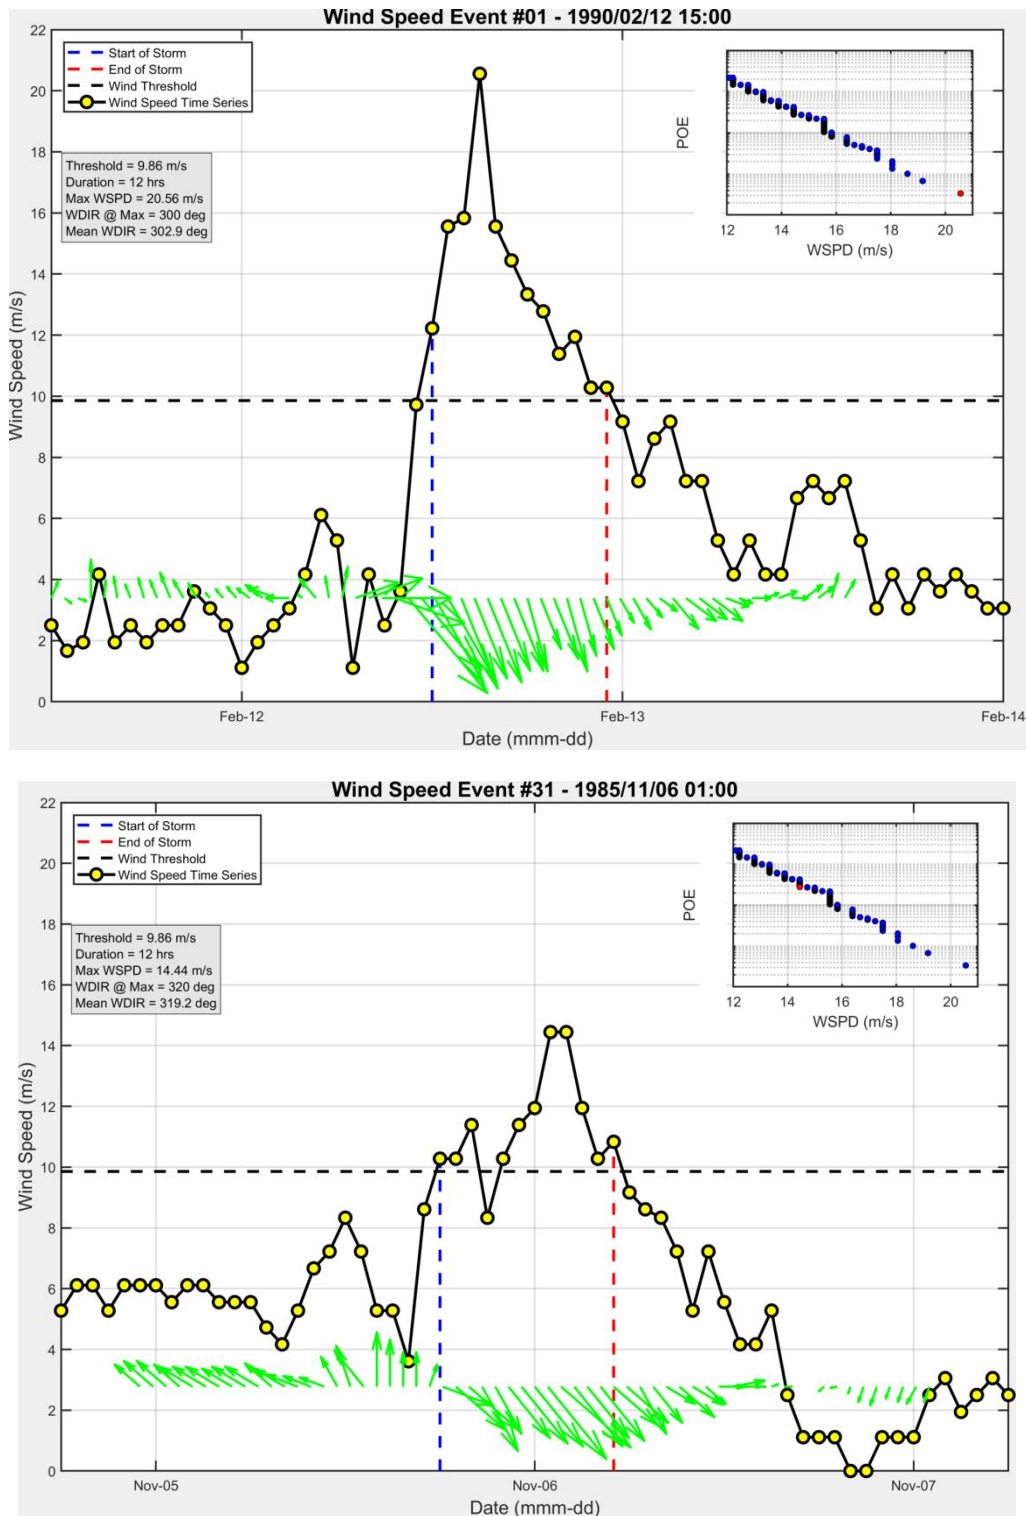
Figure 3.11 Storm Events from the Berens River Station

A sample of the windstorms from Berens Island is presented below in Figure 3.11. Event #1 features the largest speed (20.6 m/s) with winds from the north-west. A similar storm, Event #31, also features waves from the north-west but the peak speed was only 14.4 m/s.

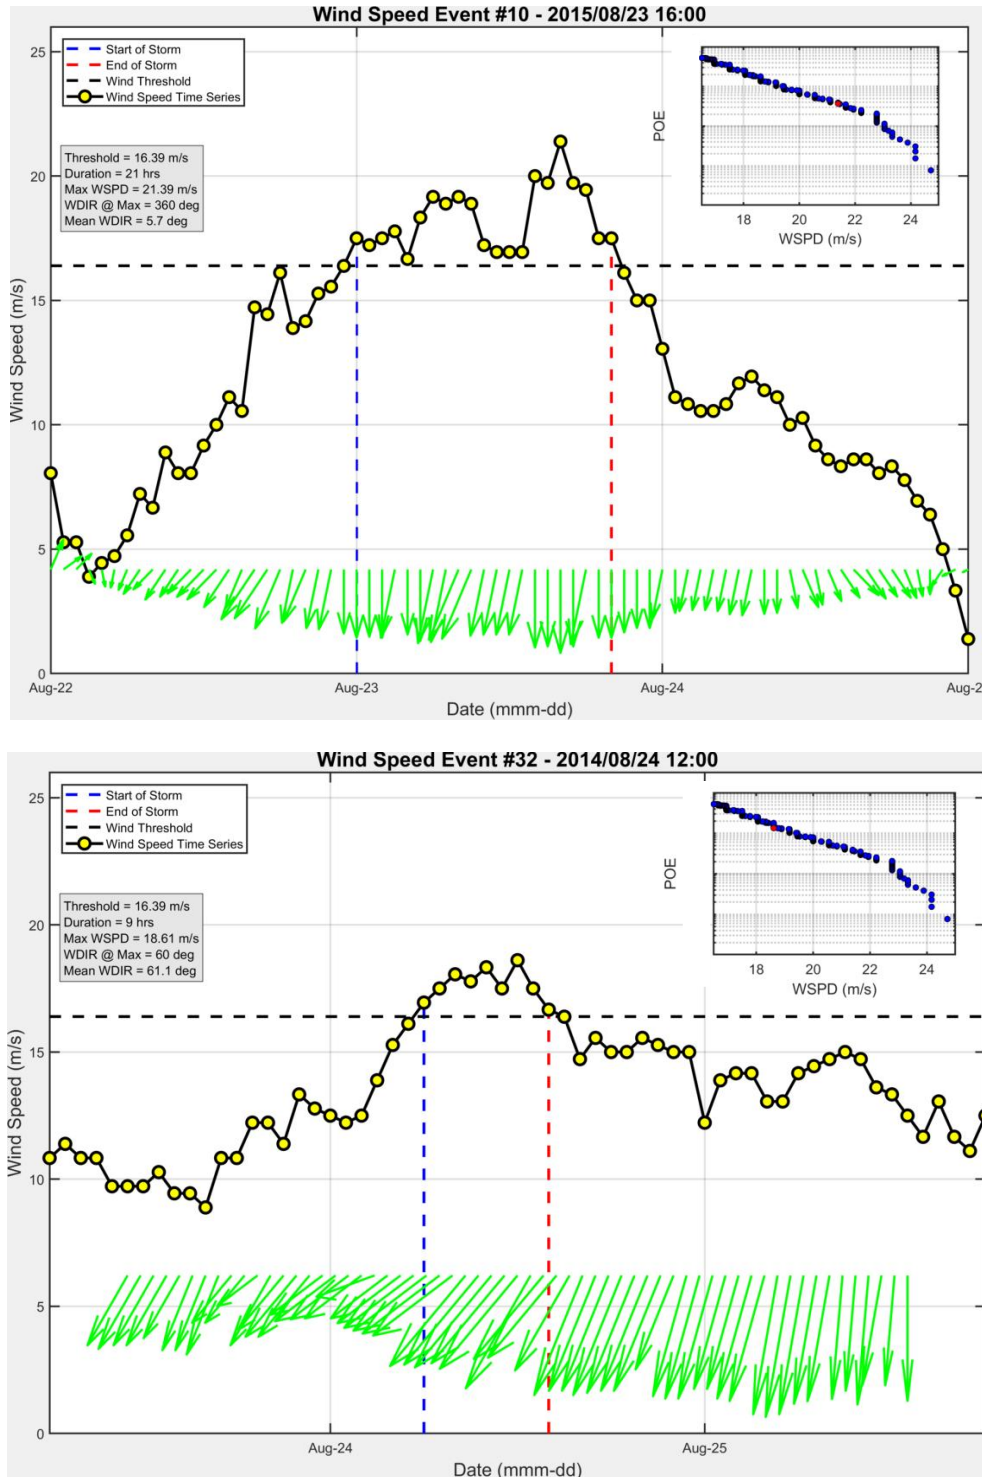
Figure 3.12 Storm Events from the George Island Station

The George Island station is more exposed to the north winds on Lake Winnipeg than the Berens River station and thus additional storms were selected to evaluate sediment transport for the existing shoreline conditions. Figure 3.12 presents Storm 10 which is a large storm with winds from the north at 21 m/s, and Storm 32 which features winds from the north north-east at 18 m/s.

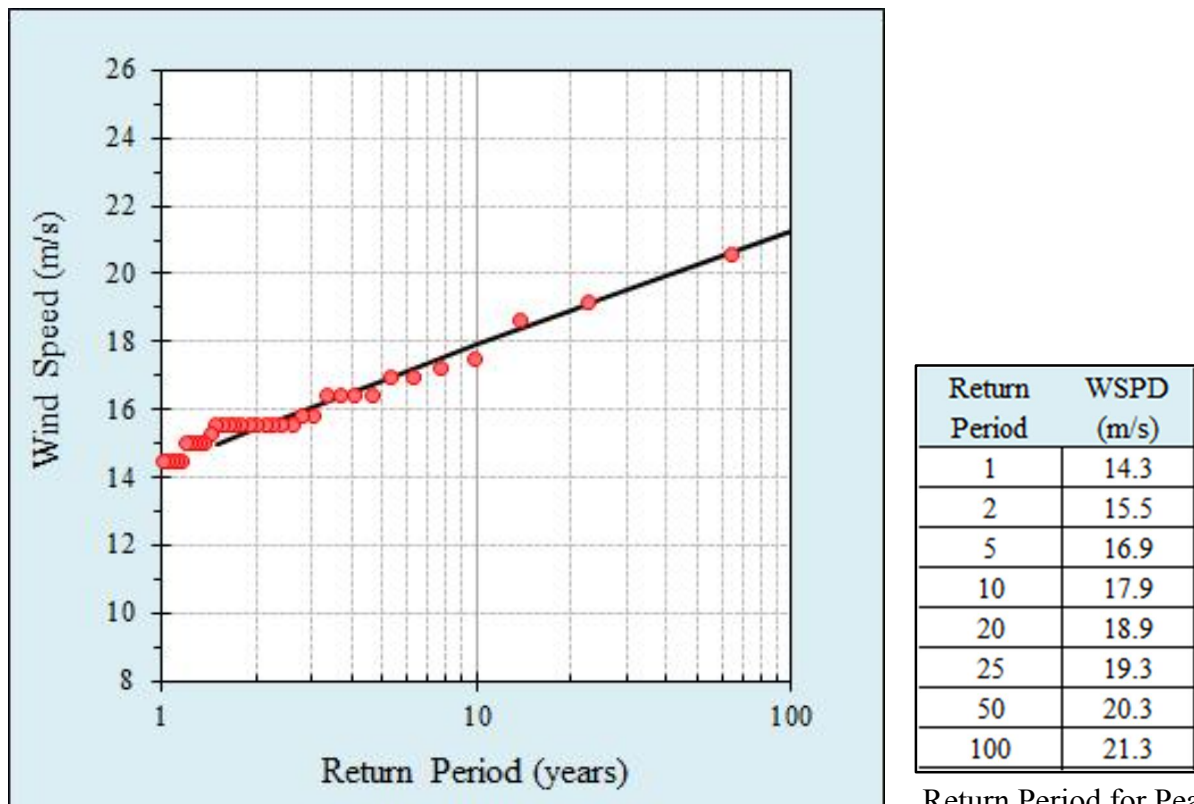
The return periods are presented in the table in Figure 3.13. A 10-year return period storm features wind speeds of 18 m/s, while a 100-year return period storm features wind speeds of 21.3 m/s.

Probability Distribution for Berens River Winds  
(Weibull Distribution, Correlation: 0.99)

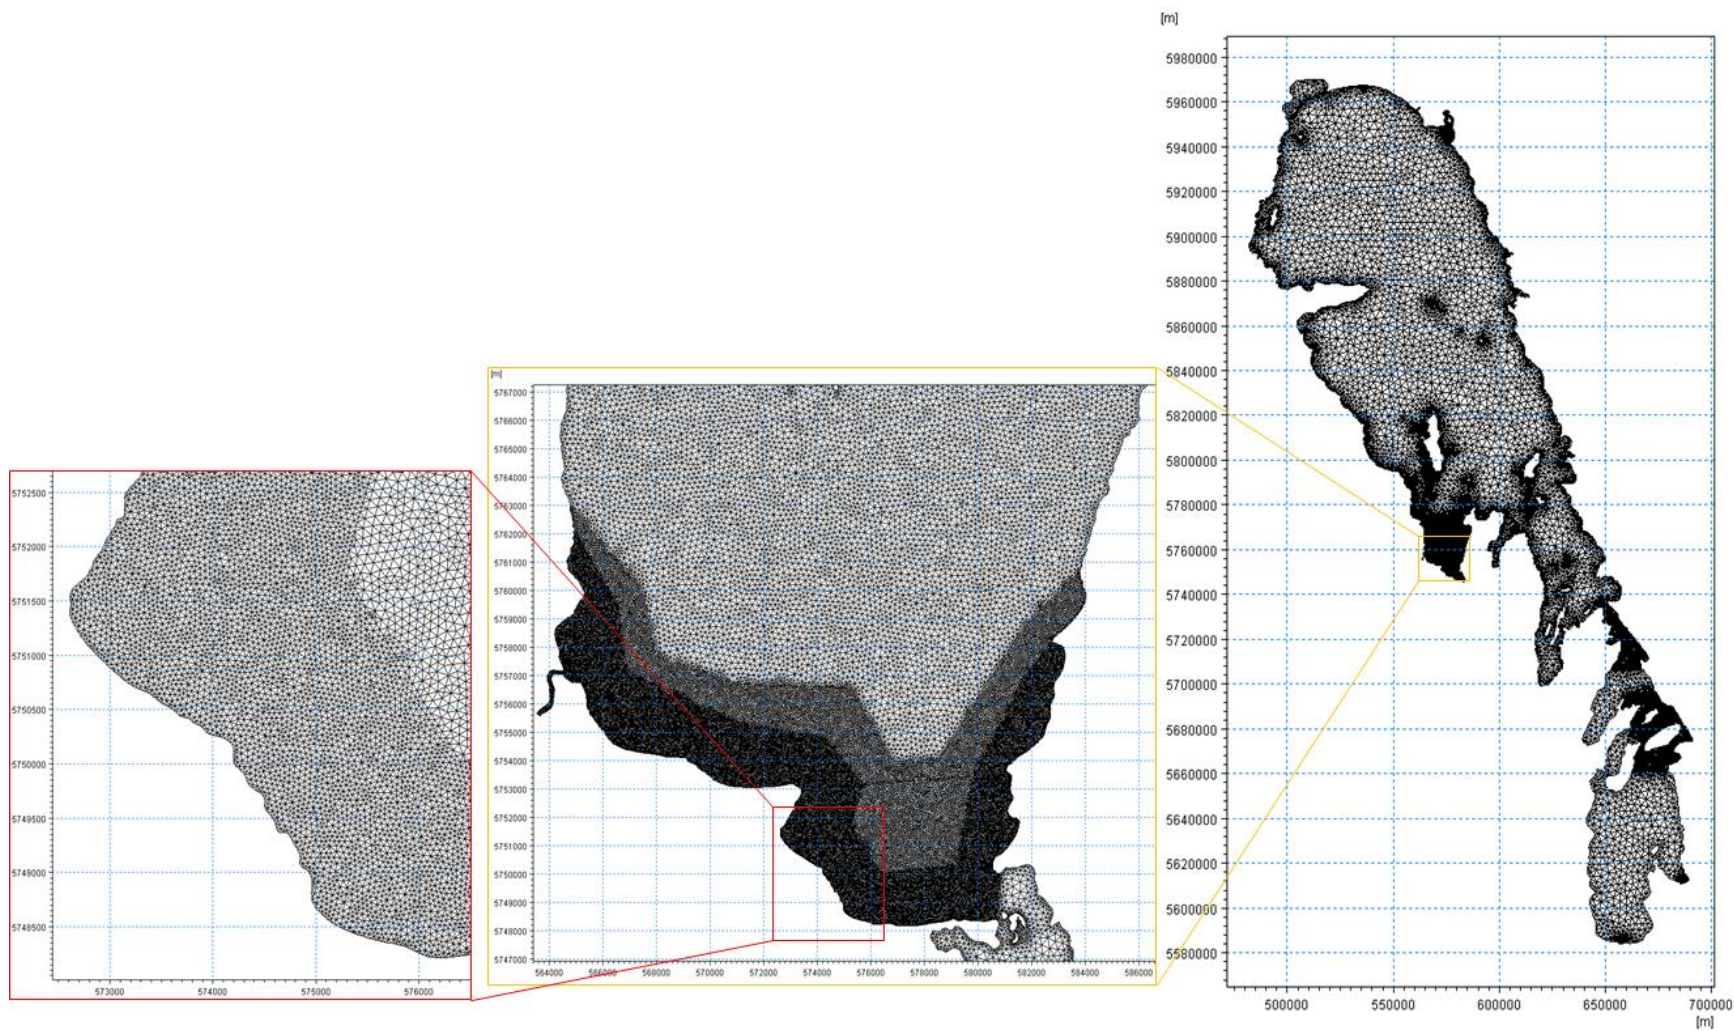
Figure 3.14 Lake Winnipeg MIKE21 Model Domain

In support of the shoreline morphology analysis, KGS Group developed two-dimensional lake models for both Lake Winnipeg and Lake St. Martin, which were used to assess flows, water levels, wave conditions and shoreline current. The models were developed using DHI's two-dimensional modelling software, MIKE 21, which contains a number of different modules. The modules used for this work included the hydrodynamic module, which was primarily used to assess flows and water levels in the lakes, and the spectral wave model which was used to simulate wave height, period and direction for use in the shoreline geomorphology assessment.

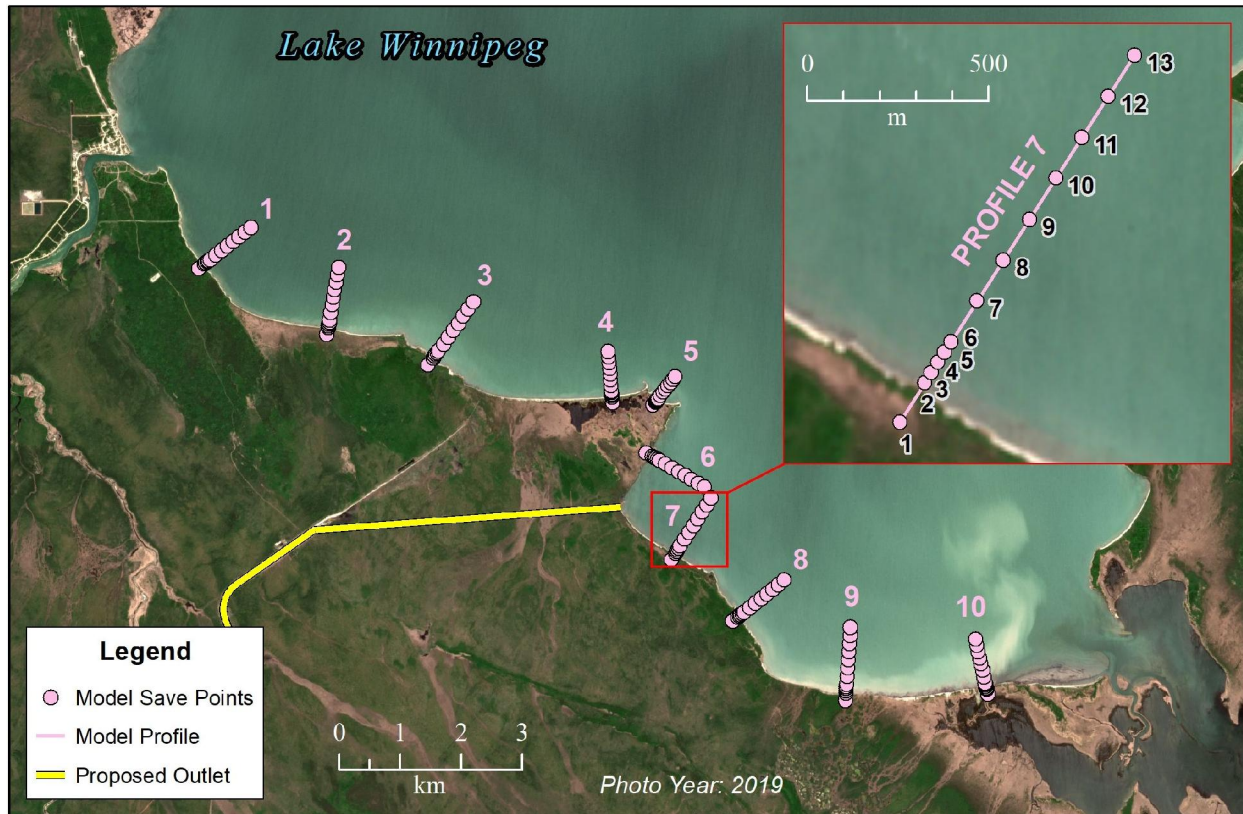
**Figure 3.17 Sediment Transport Profiles and the Location of the 13 Profile 7 Save-Points from the MIKE21 Model**

The potential for longshore sediment transport to move sand along the shoreline during storm events was evaluated in Sturgeon Bay at ten locations with the MIKE21 wave height predictions from the KGS Group, as described in Section 3.3. The 10 profile locations, extending from the Dauphin River Mouth to the Sturgeon Bay Park Reserve, are noted in Figure 3.17. At each of the 10 profile locations, hourly wave conditions were extracted at 13 save points across the profile during storms to characterize the changes in the wave conditions due to depth and wave refraction/diffraction. The location of the 13 save points for Profile 7 are noted on Figure 3.17.

To date, the focus for the sediment transport analysis has been three storms identified from the George Island Station; #10, 11, and 32, completed at three water levels (217.0 m, 217.5 m, and 2018 m CGVD). The CERC formula (CEM, 2002) was applied to the wave data to estimate potential sediment transport at each of the ten profiles. The CERC formula is an energy flux model and therefore requires breaking wave conditions to make estimates of longshore sediment transport for the hourly wave inputs. For each hour of data, the methodology checks for breaking waves from save point 13 to 1. The first occurrence of breaking waves is noted, and the equation is applied to predict potential sediment transport in cubic metres.

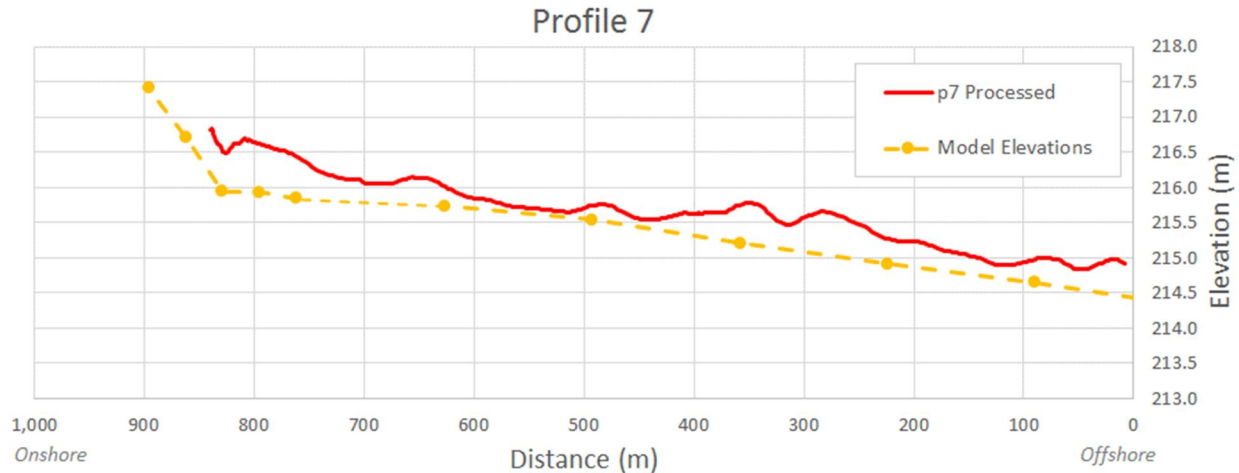
**Figure 3.18 Profile 7 SOLIX Bathymetry and Output from the MIKE21 Model**

It should be emphasized that the CERC formula calculates ‘potential’ sediment transport rates at a given beach profile, assuming there is an unlimited updrift sediment supply and the entire profile is covered in a thick layer of sand. Based on our observations from the field, Sturgeon Bay does not feature unlimited sediment supply and the locations of sandy substrate are typically limited to the shallow nearshore zone and often associated with sand bars. Therefore, the volumetric estimates from the equation must be carefully evaluated against substrate conditions, since breaking waves across a cobble-boulder substrate will not move sand along the shoreline.
