Lake Manitoba & Lake St. Martin Outlet Channels Project

Aquatic Environment Monitoring, 2021 - Aquatic Habitat

Aquatic Habitat in Birch Bay and The Narrows of Lake St. Martin

May 2022

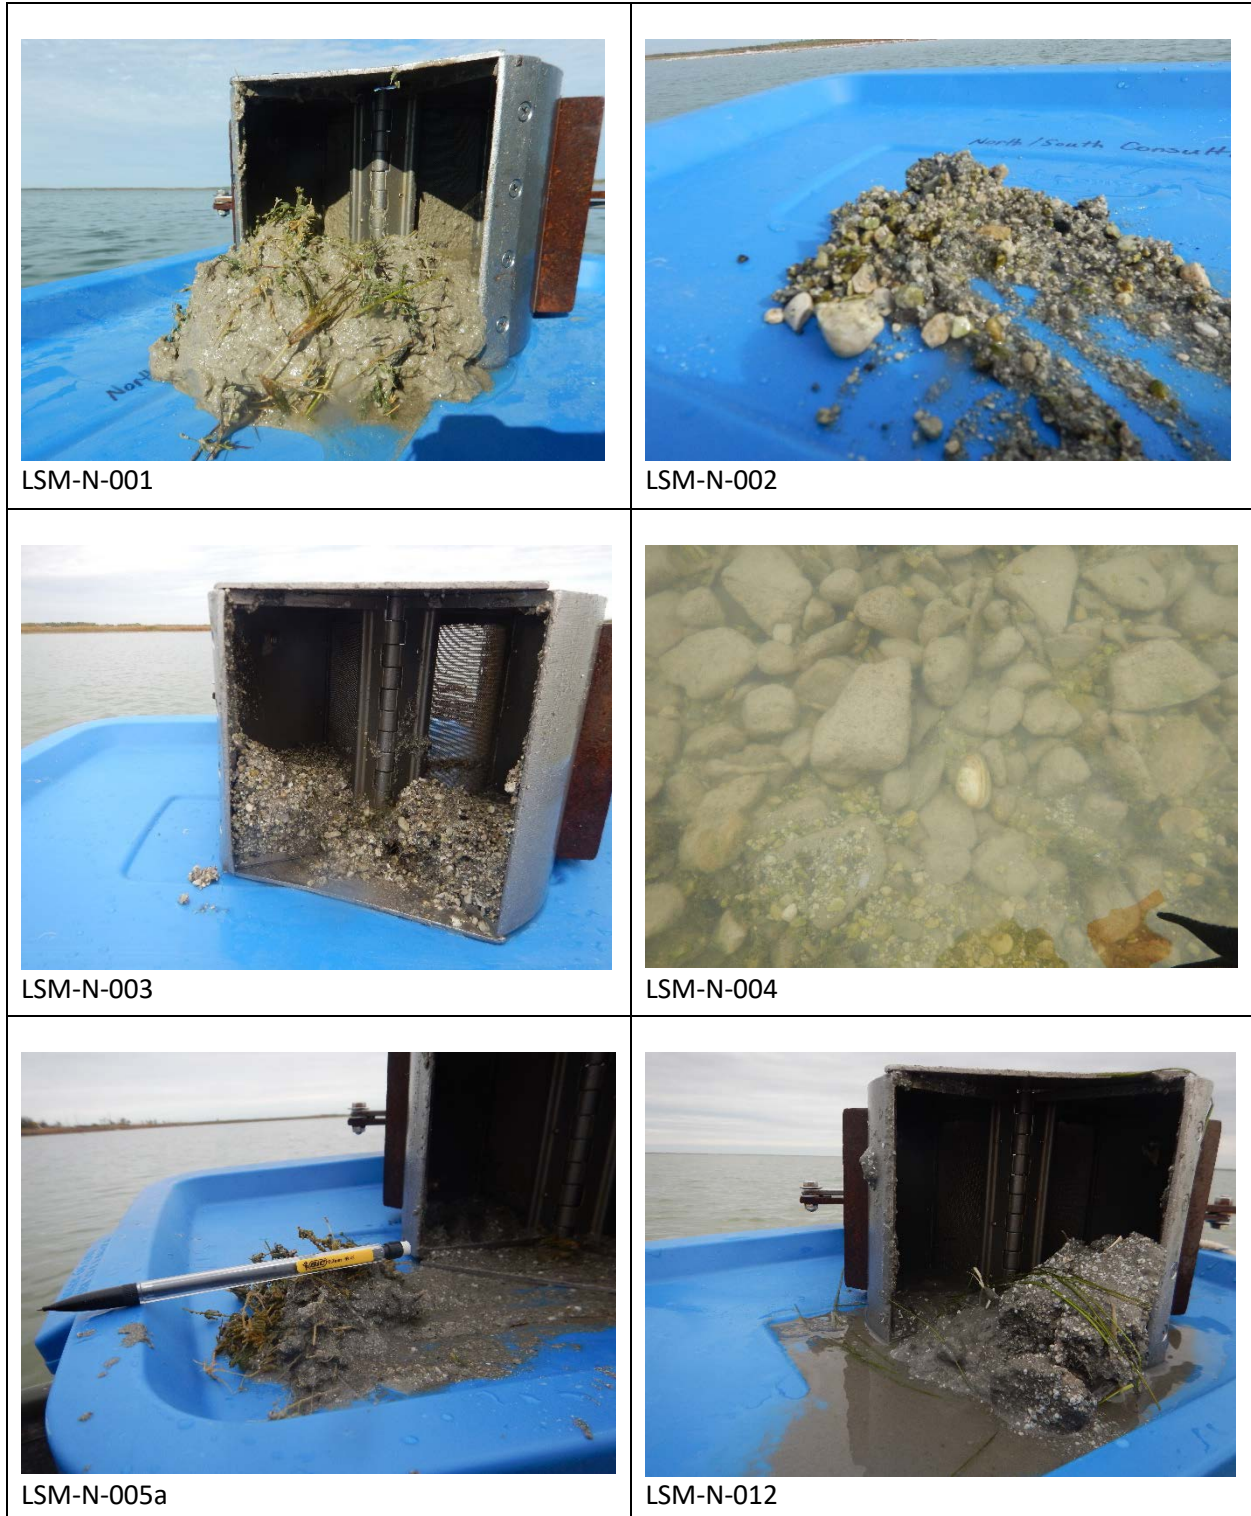
Figure 6. Selected photographs of substrate samples collected in The Narrows, September 25, 2021.

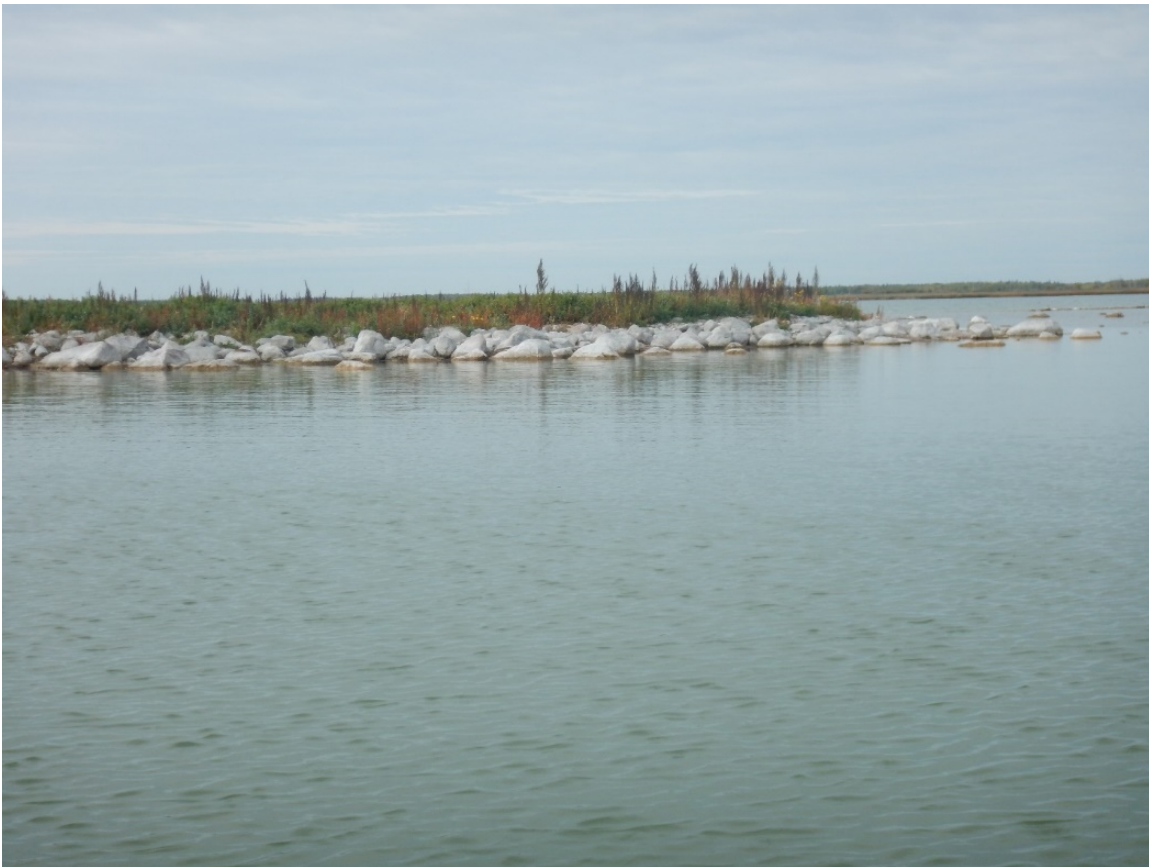
Figure 9. Photograph of exposed boulders along the shore at the entrance to The Narrows, September 25, 2021.

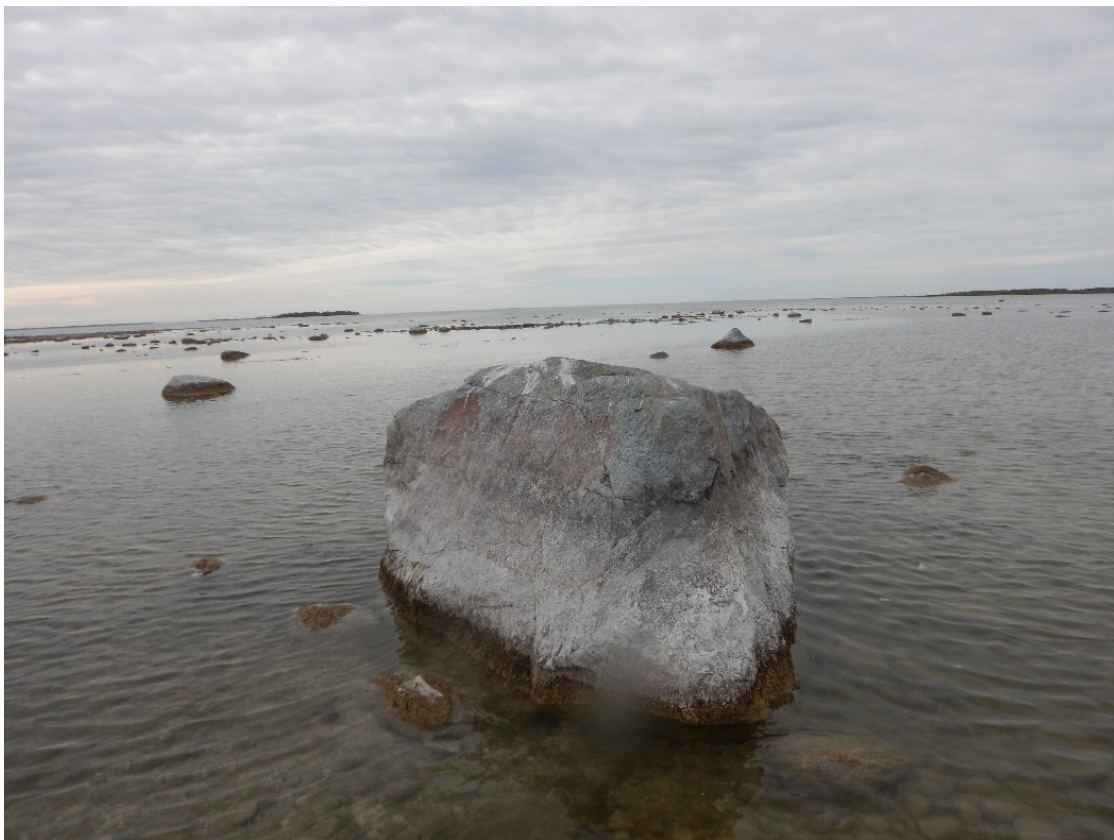
Figure 11. Photograph of large exposed boulders amongst predominantly cobble and large gravel substrate at site LSM-N-004, September 25, 2021. Note the watermark stain on the boulder in the foreground.

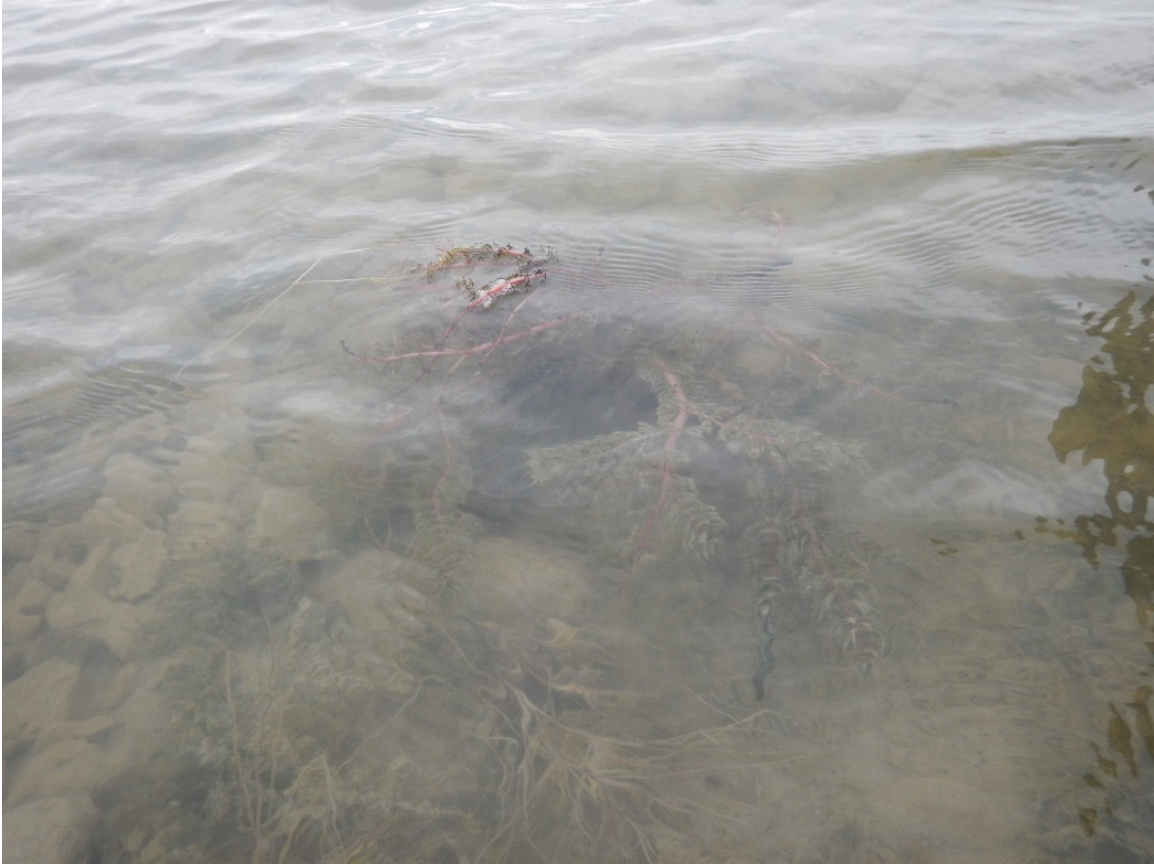
Figure 12. Photograph of aquatic vegetation growing in the interstitial space of compact cobble and gravel substrate on the leeward side of large boulder substrate near site LSM-N-004.

LSM-N-004, located north of Snake Island and south of the shoreline of the south basin of Lake St. Martin, was under approximately 0.3 m of water at the time of survey. The entire area was flat with compact cobble, gravel and boulder. Large boulders were scattered throughout the area (Figure 11). Sand was present in interstitial spaces of the rocky substrate and on the leeward side of some larger rocks. Sparse aquatic vegetation was also found on the leeward side of some larger boulders (Figure 12). Larger clams and clam shells were noted at this site.

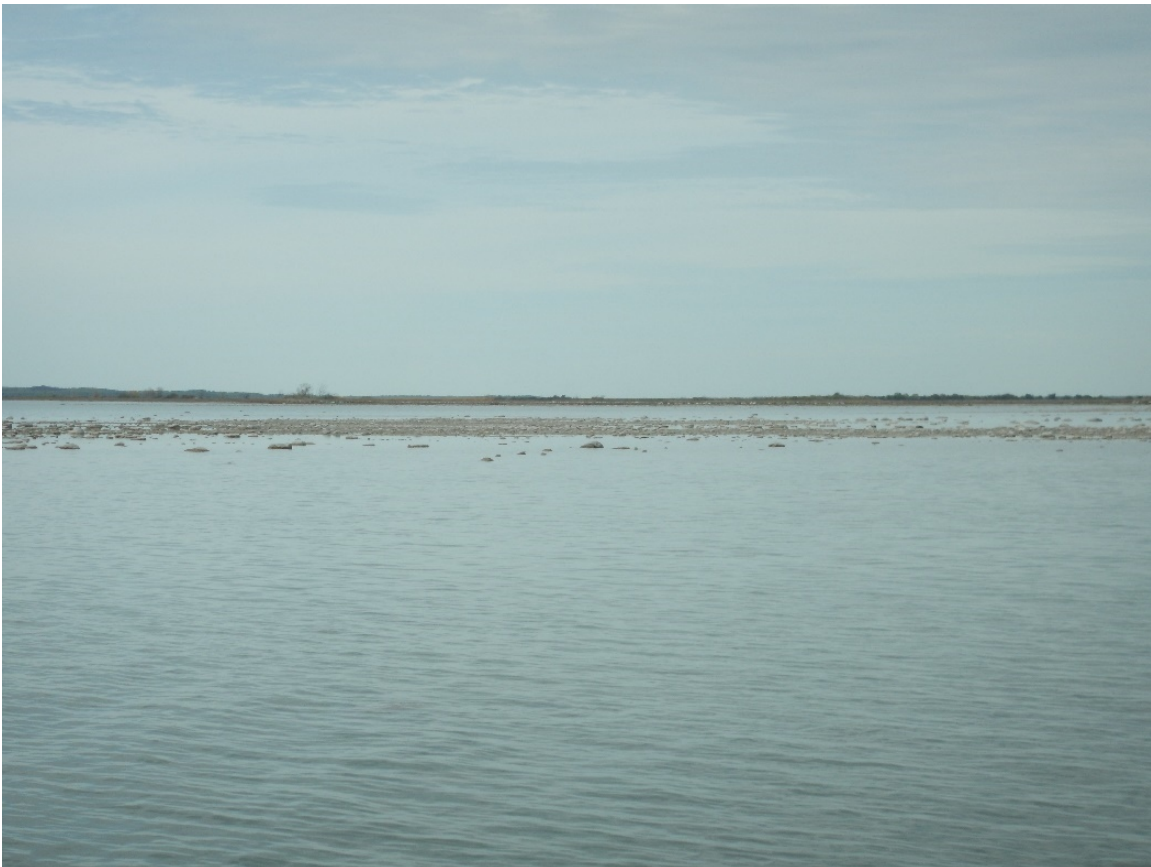
Figure 15. Photograph of flat boulder and cobble shoal area between LSM-N-013 and LSM-N-014 at the downstream constriction of The Narrows.

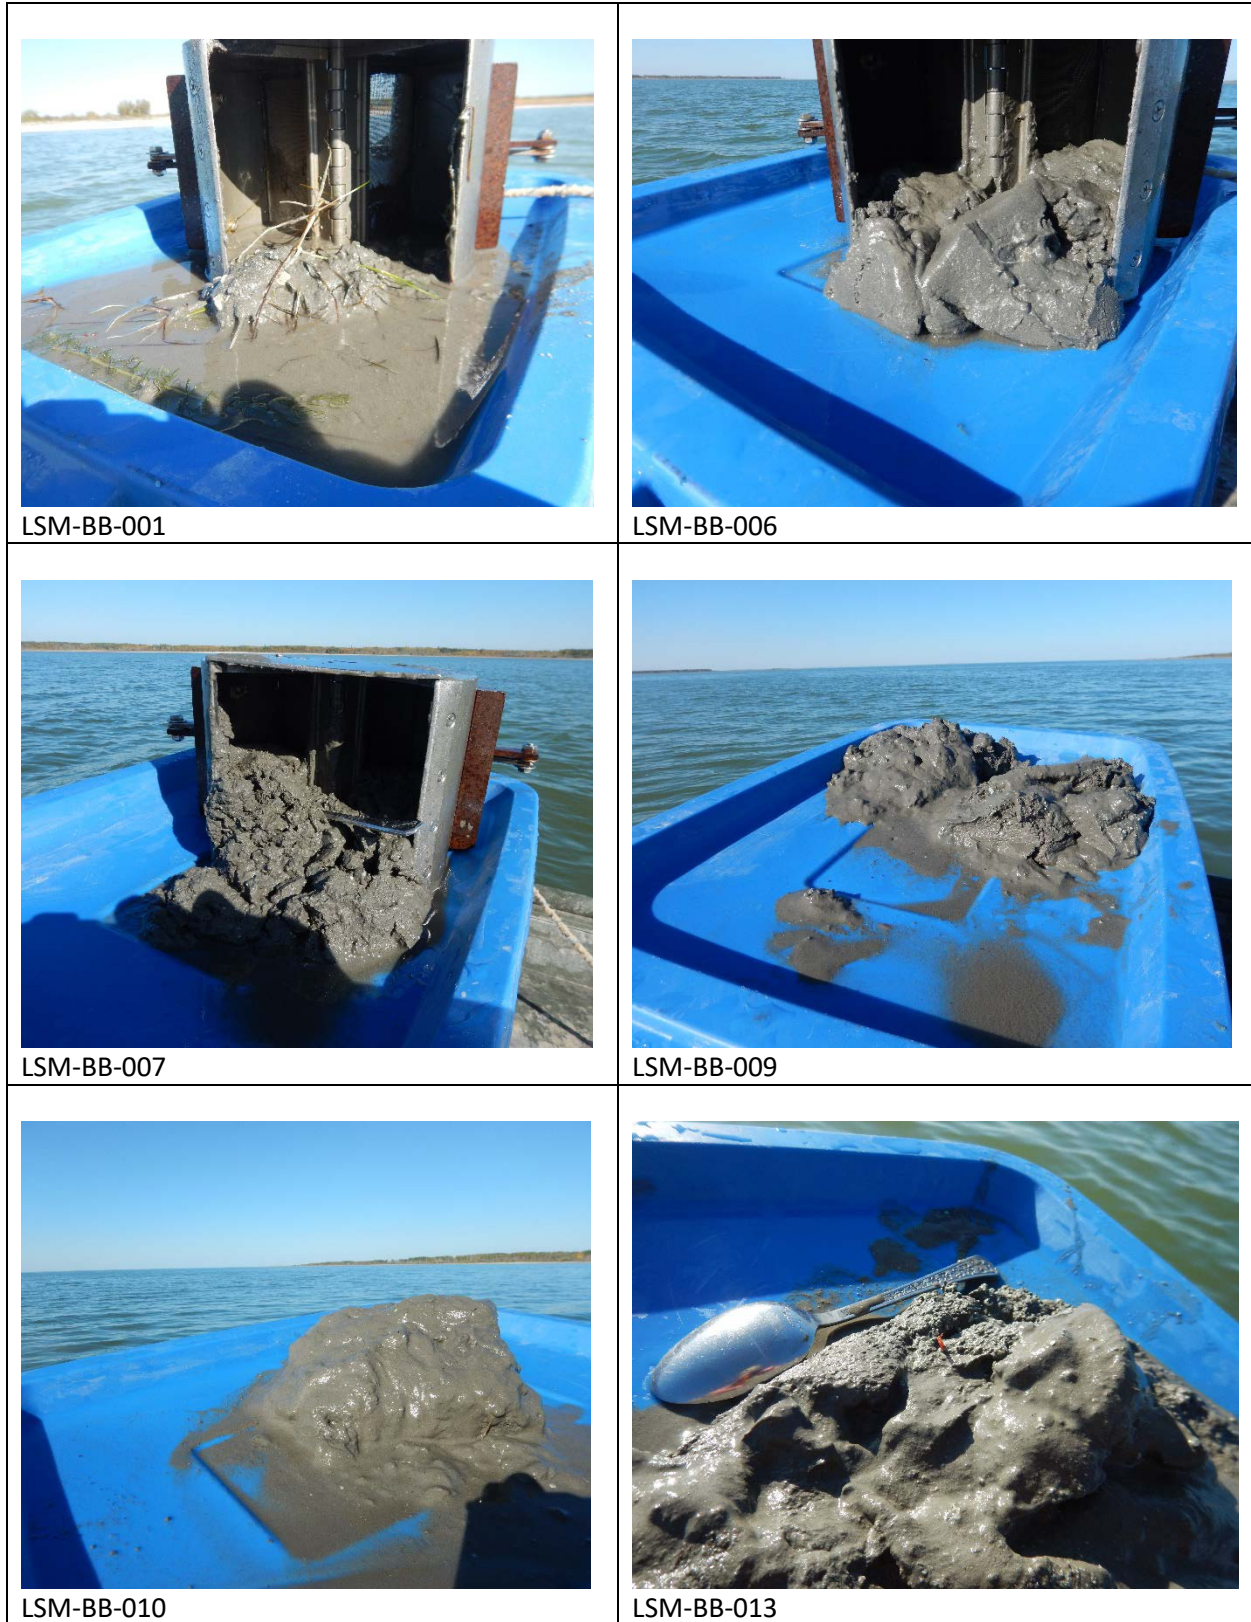
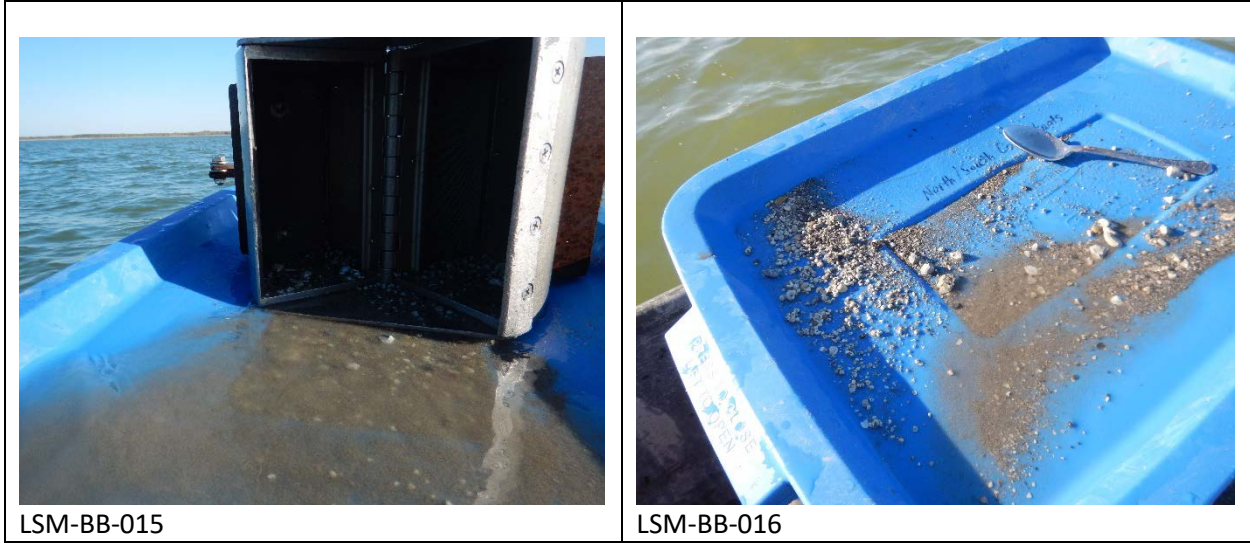
Figure 17. Selected photographs of substrate samples collected in Birch Bay, September 28, 2021.

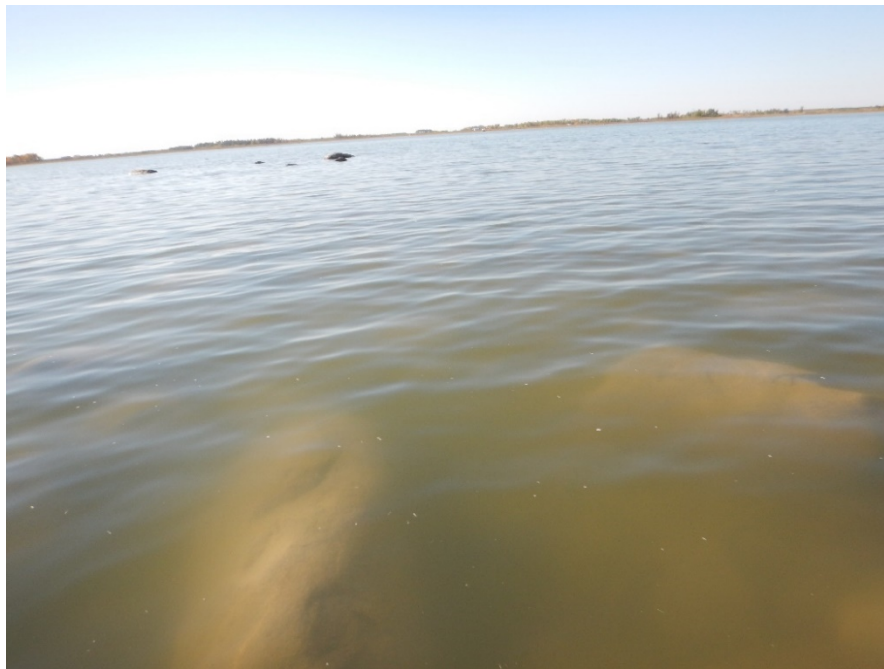
Figure 22. Photograph of large boulders breaking the surface in the middle of the South Shoal Area of Birch Bay.

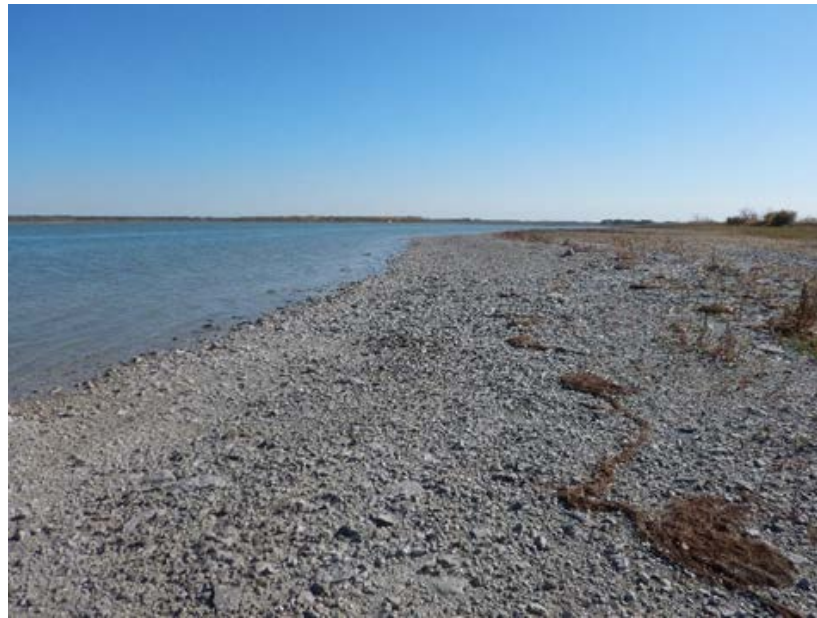
Figure 24. Photograph of exposed compact gravel and cobble shoreline at the LMOC Outlet Area of Birch Bay.

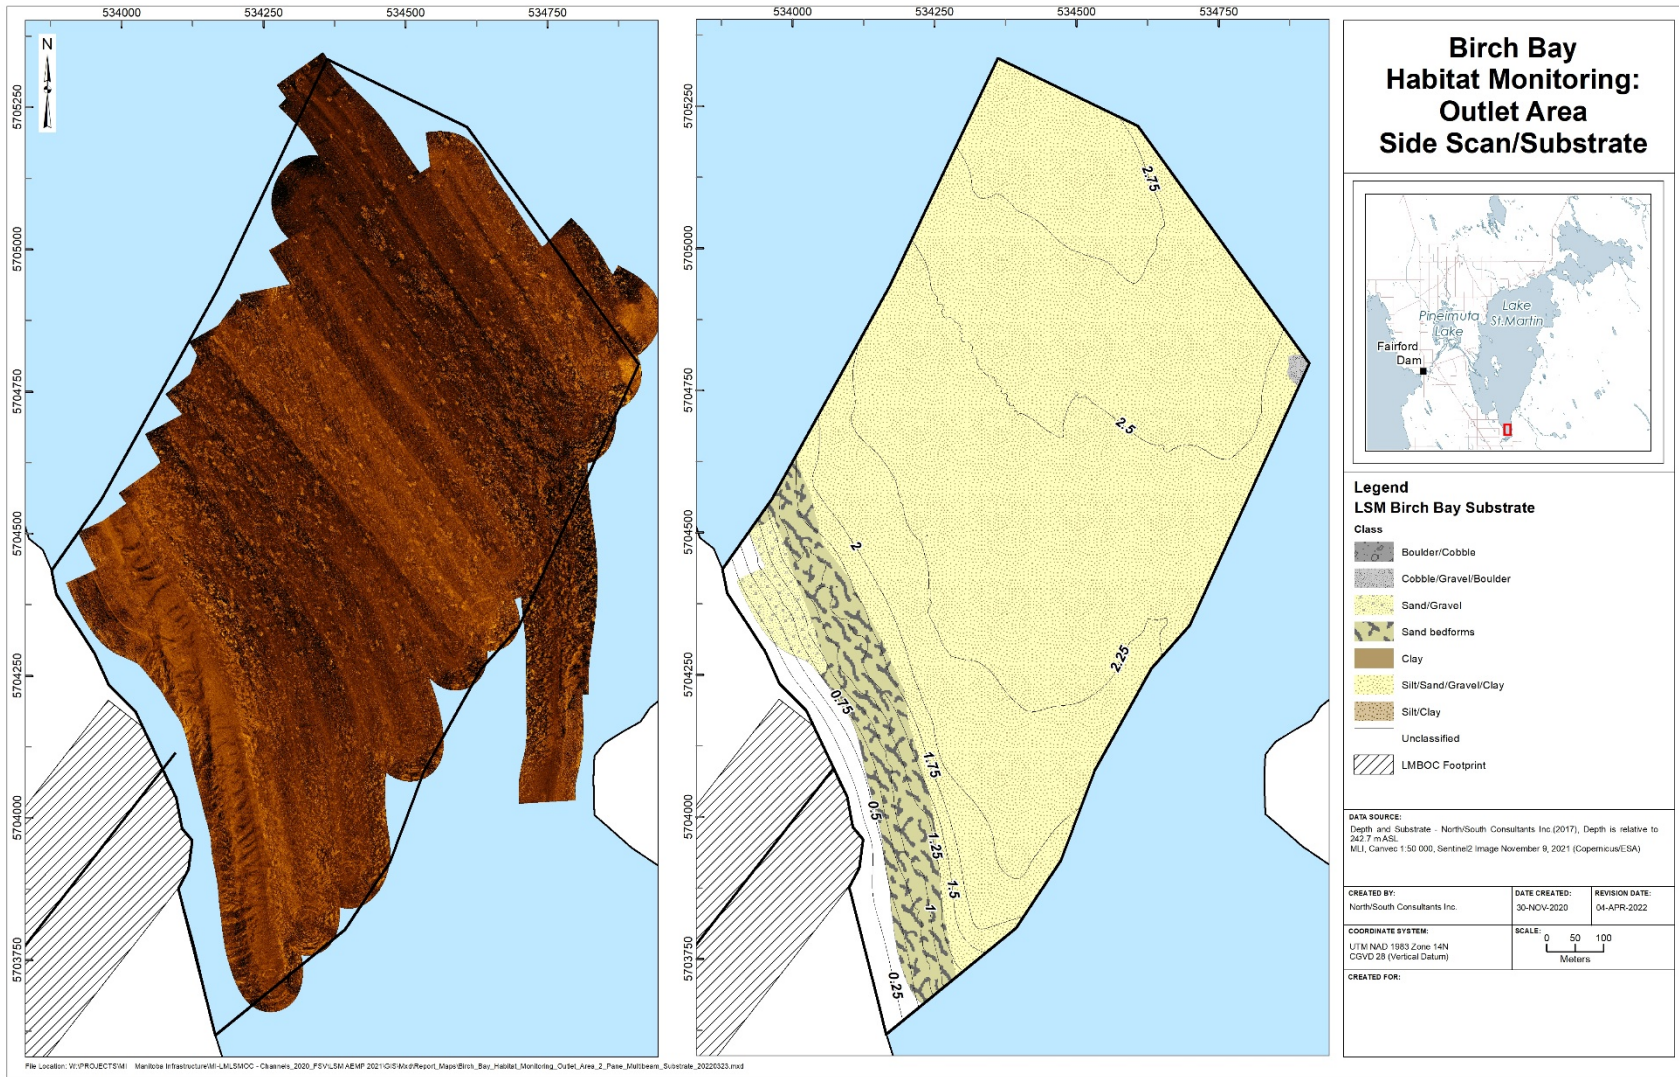
Figure 26. Map of the processed sidescan image mosaic showing patches of dense aquatic vegetation throughout (left), and classified substrate with 0.25m depth contours (right) in the Outlet Area of Birch Bay.

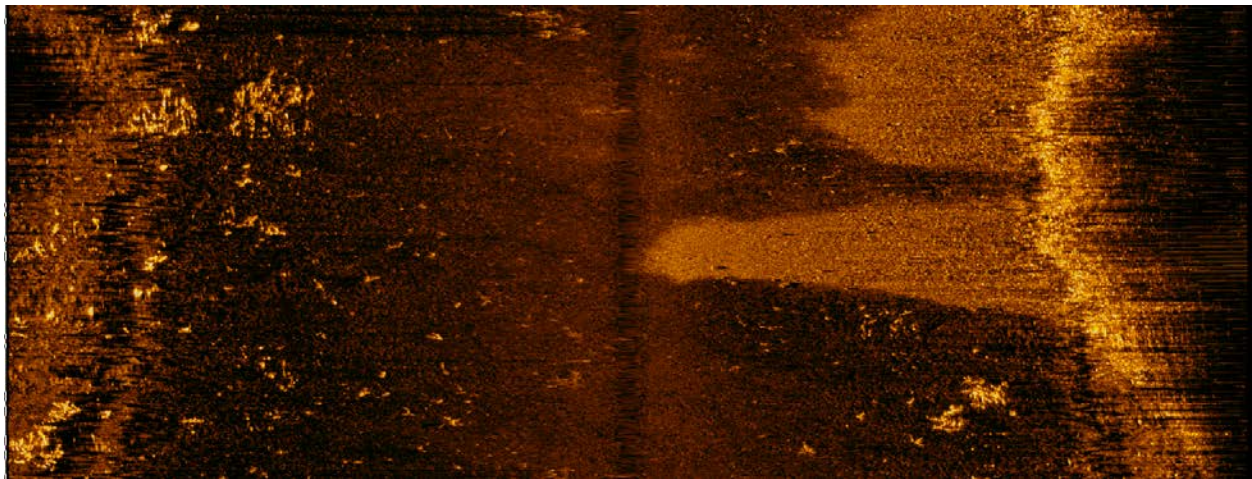
Figure 28. A high-resolution Ping 3DSS-IDX-450 sidescan 'waterfall' image of the transition from cobble, gravel, and boulder substrate to finer sand, silt, clay and mixed gravels in the northeast corner of the West Shore Area. Note the intermittent patches of aquatic vegetation against the dark toned fine substrates.

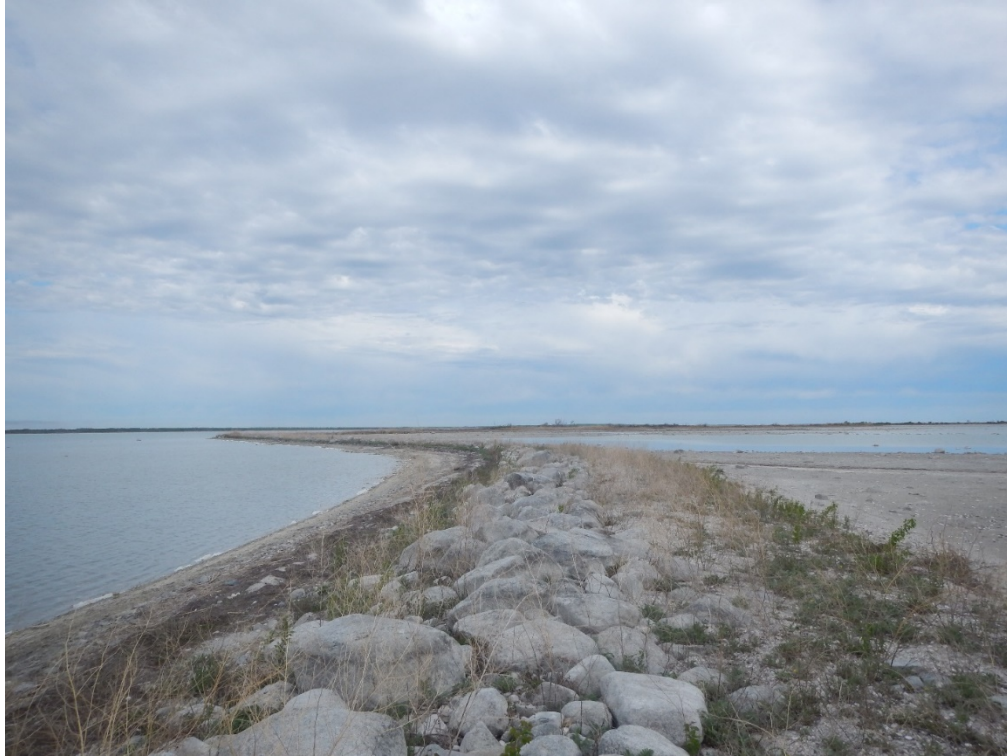
Photograph A1-1. Looking west along the top of a boulder pile at Site 1.

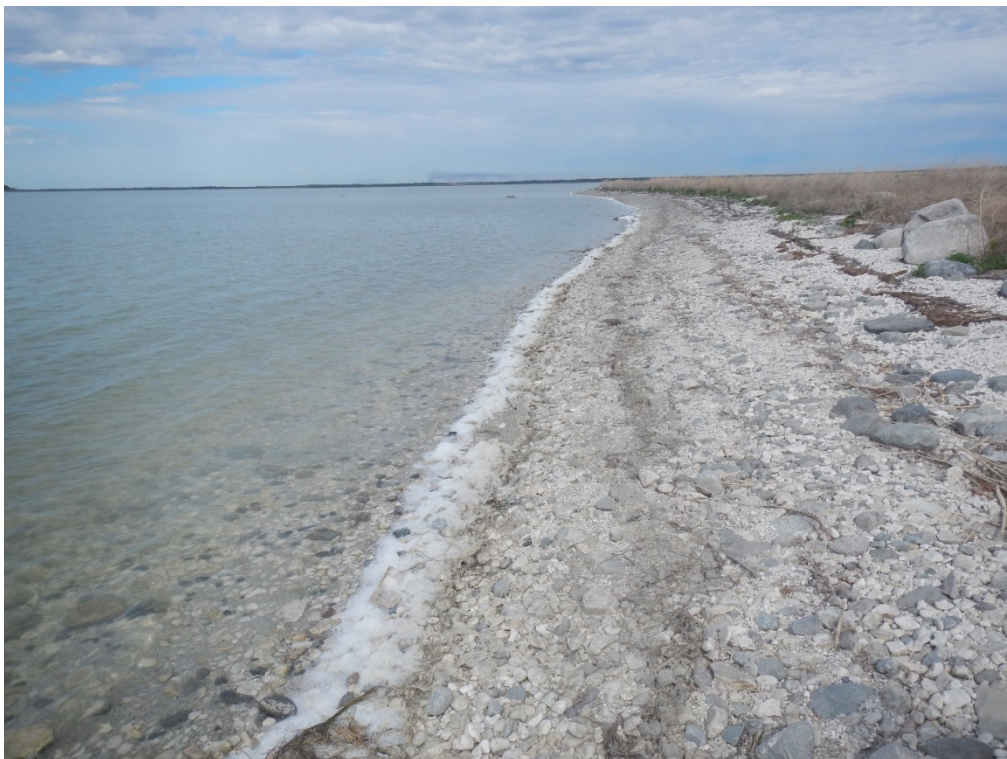
Photograph A1-2. Compact cobble and gravel beach at Site 1.

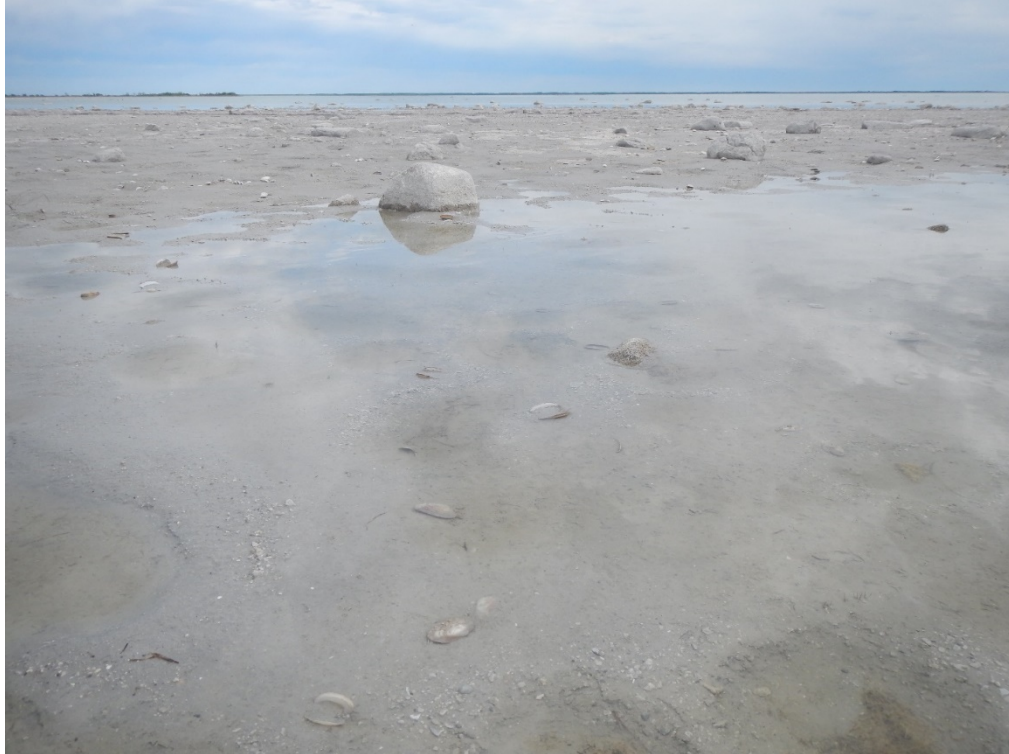
Photograph A1-3. Exposed sand and gravel substrate with intermittent boulder at Site 1.

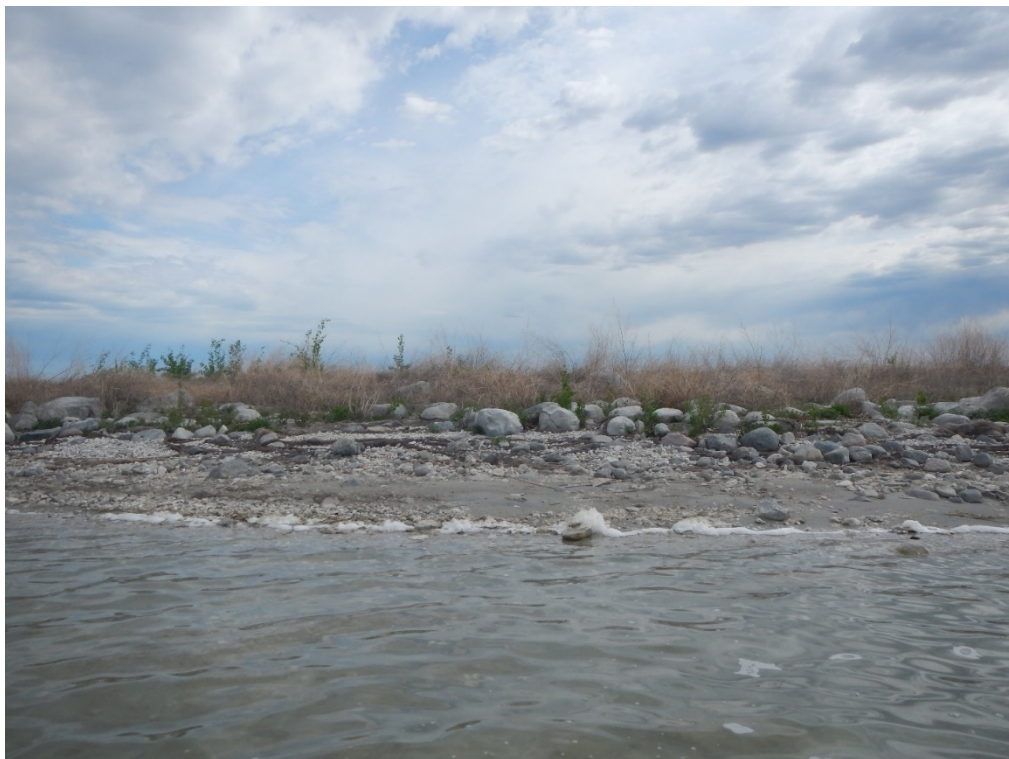
Photograph A1-4. Exposed gravel, sand, and cobble/boulder substrate at Site 2.

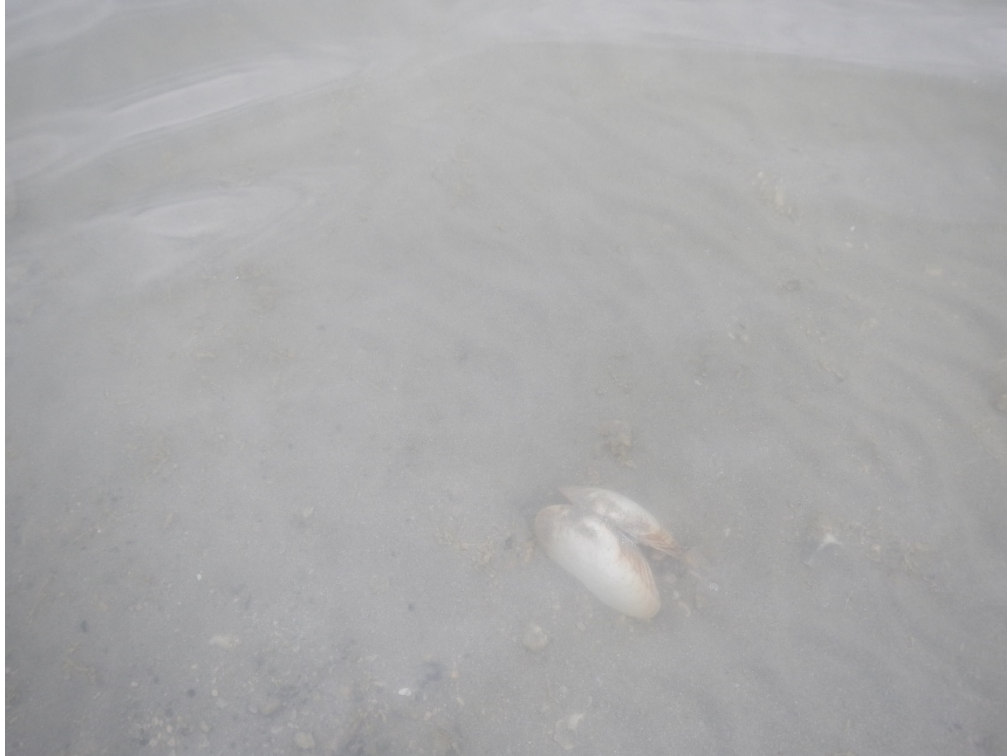
Photograph A1-5. Close up of sand ripples, gravel and clam shell at Site 2.

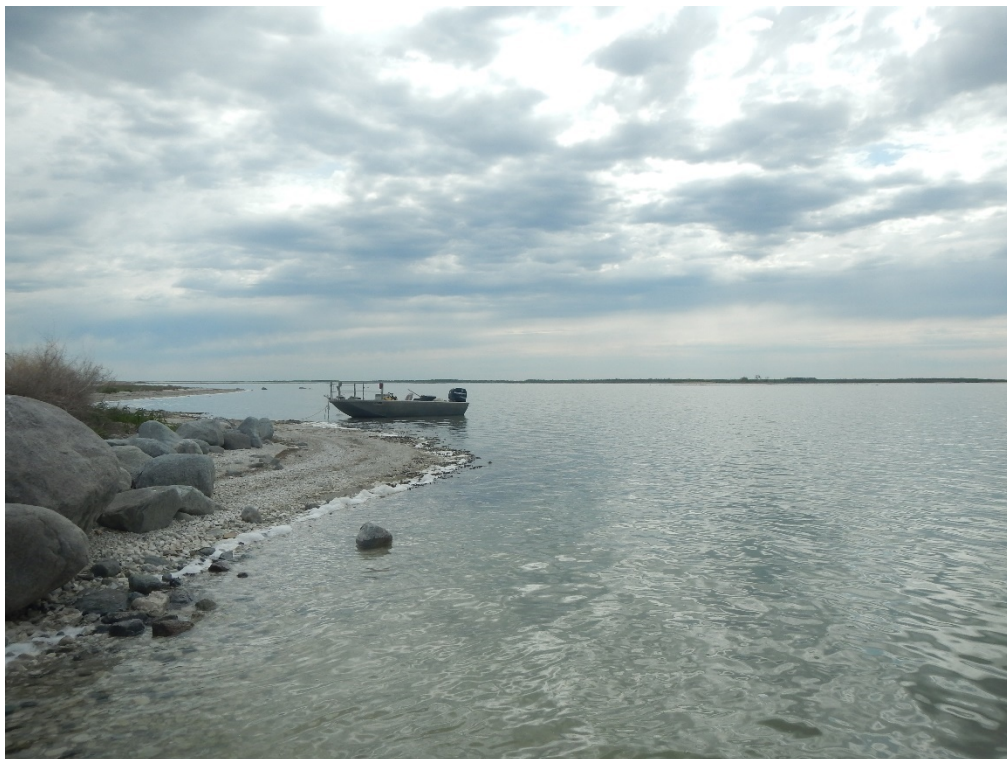
Photograph A1-6. Boulder and exposed gravel and cobble at Site 3.

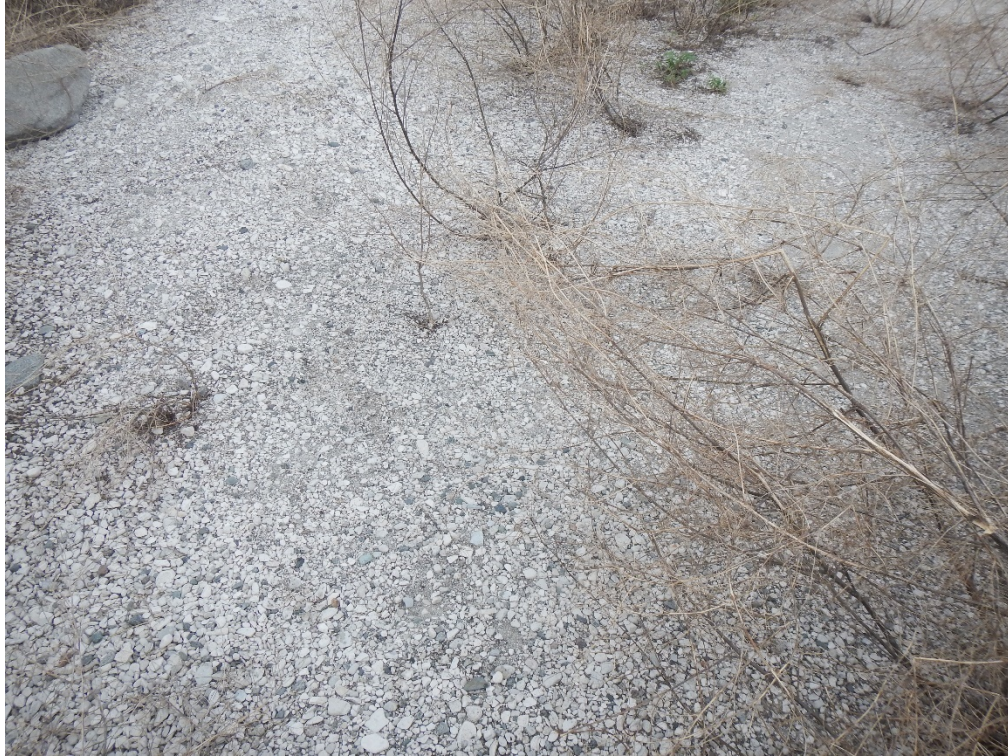
Photograph A1-7. Compact gravel substrate at Site 3.

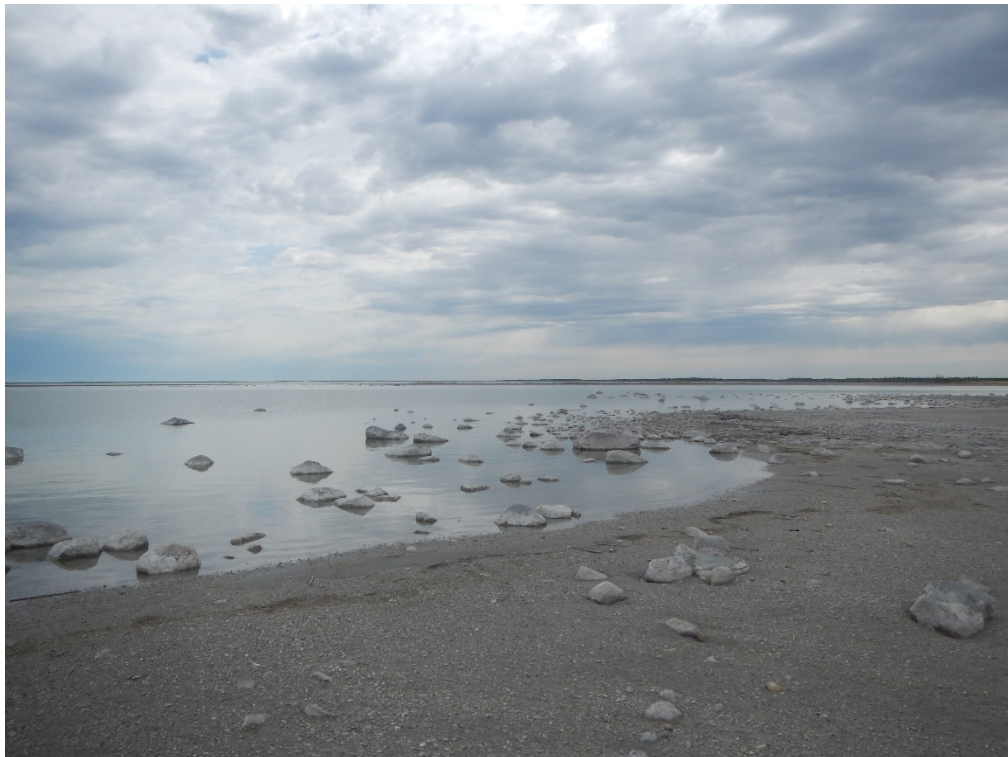
Photograph A1-8. Intermittent boulder and exposed gravel and sand substrate at Site 5.

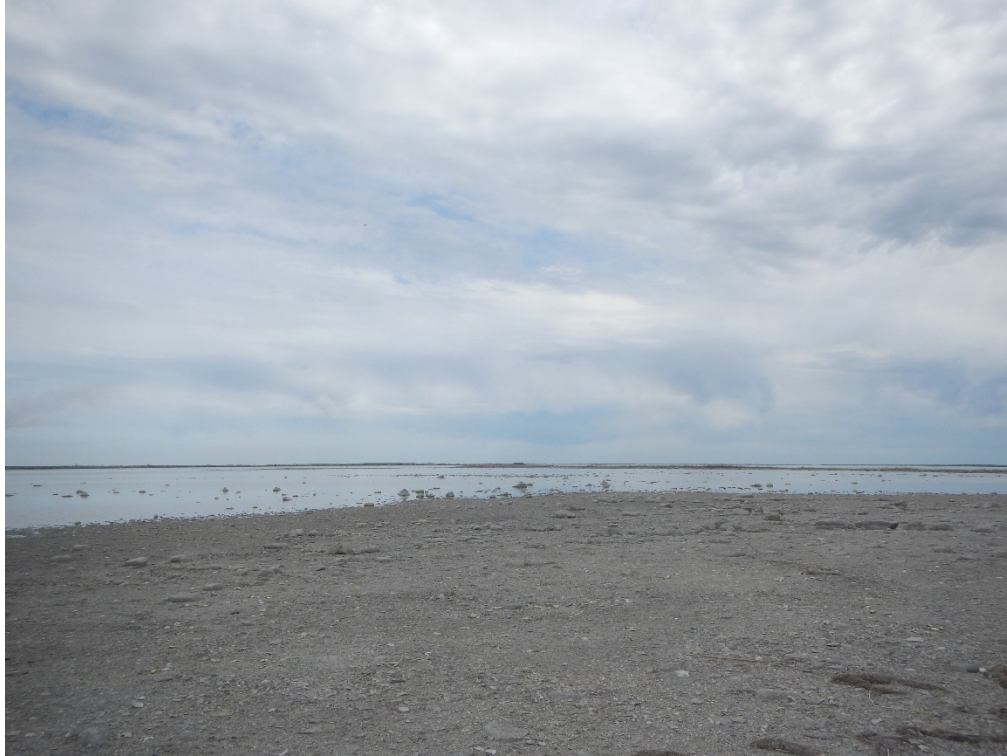
Photograph A1-9. Exposed gravel, cobble and intermittent boulder at Site 6

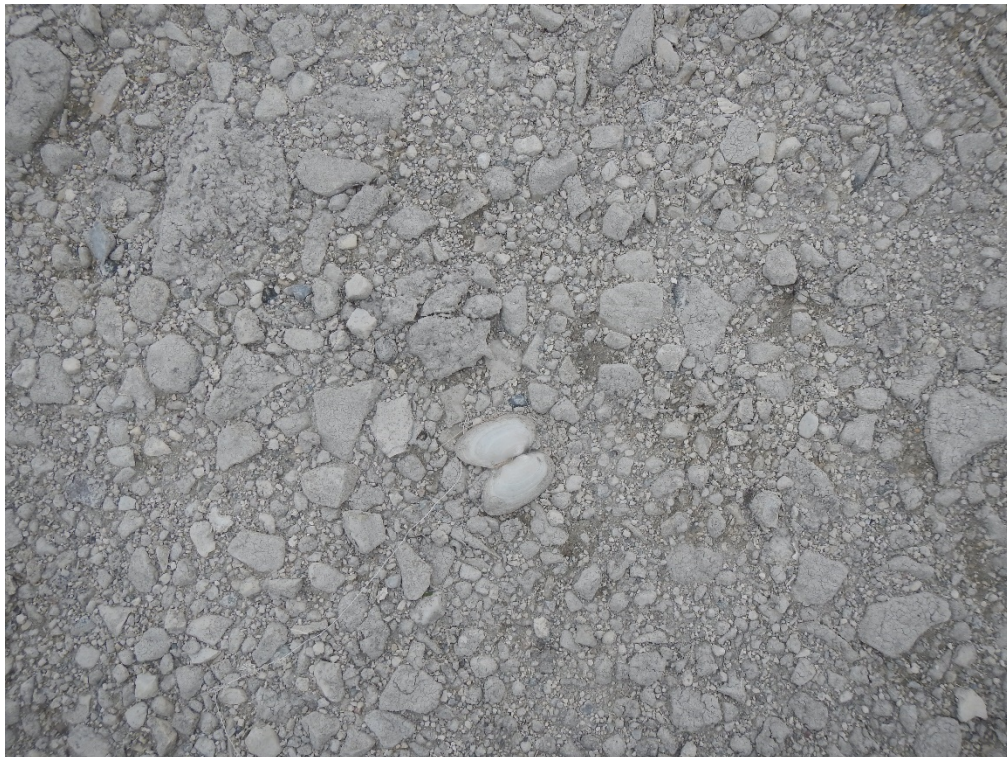
Photograph A1-10. Compact gravel and cobble substrate at Site 6.

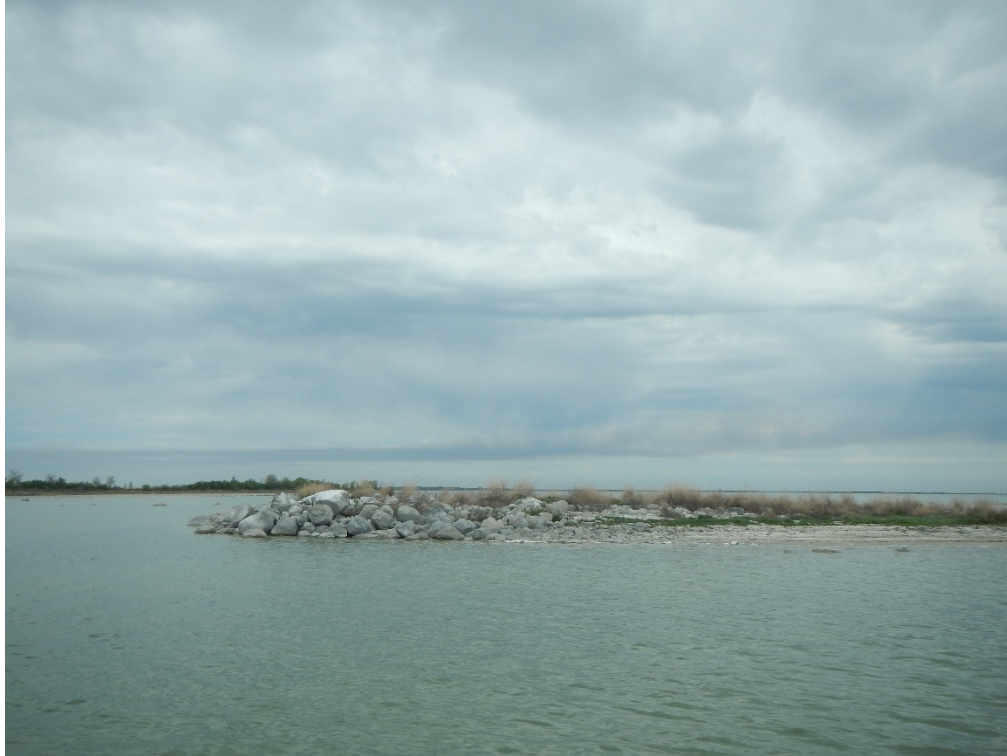
Photograph A1-11. Exposed boulder and cobble shoal at Site 7.

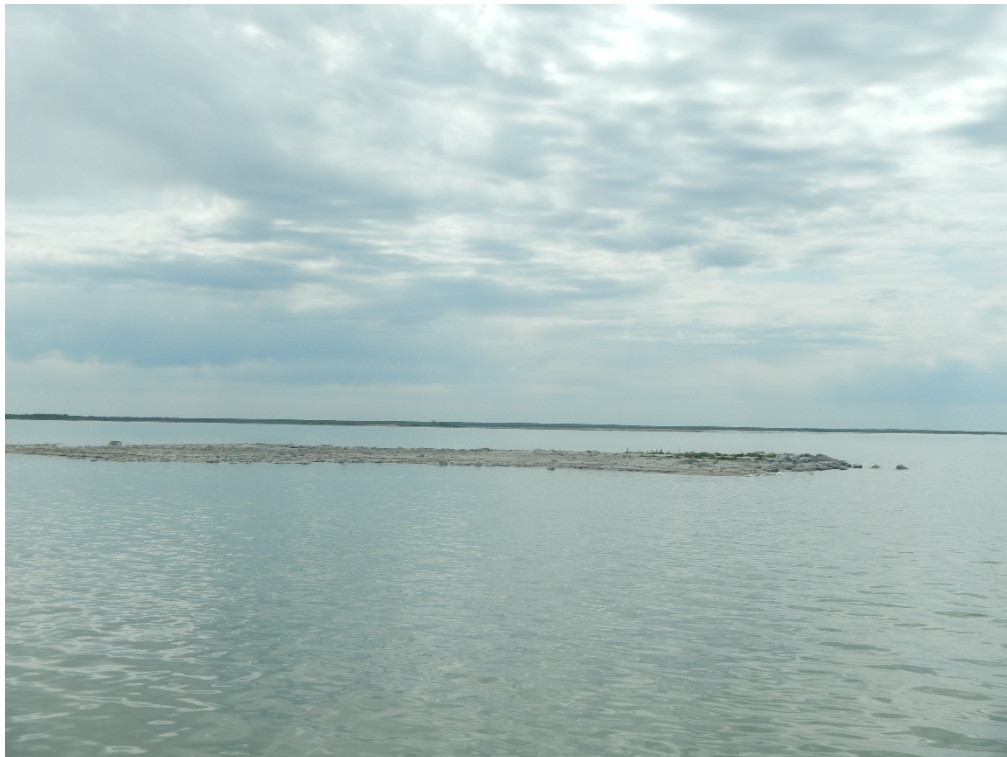
Photograph A1-12. Exposed cobble and gravel shoal at Site 8.

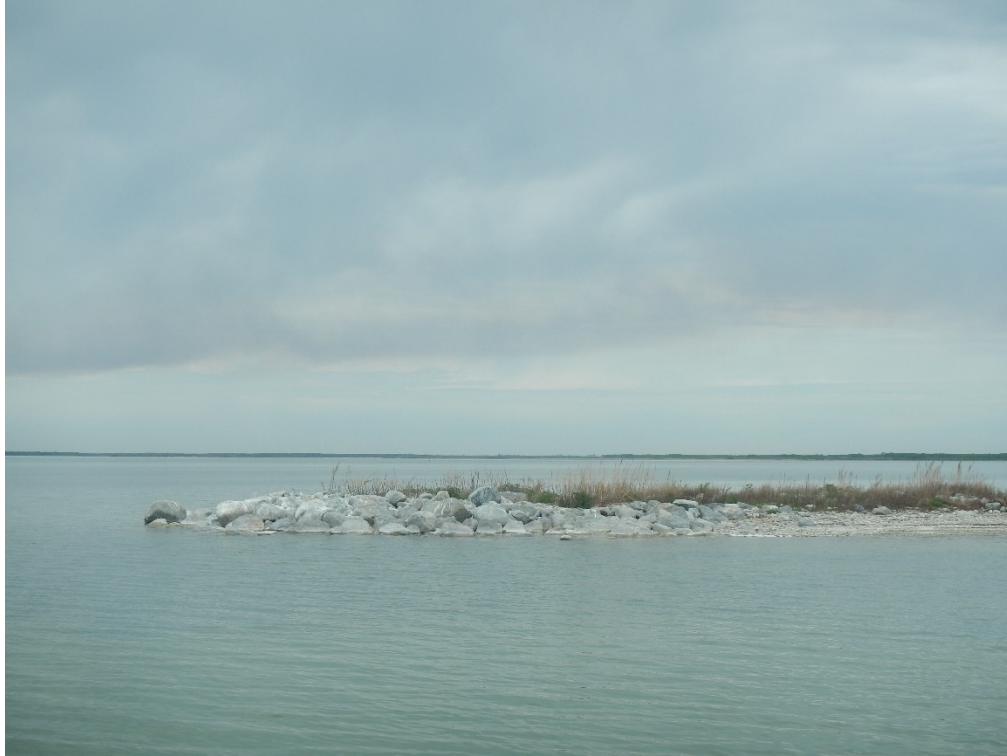
Photograph A1-13. Exposed boulder and cobble shoal at Site 9.
