Lake Manitoba & Lake St. Martin Outlet Channels Project

Aquatic Environment Monitoring, 2021 - Aquatic Habitat

Aquatic Habitat in Birch Bay and The Narrows of Lake St. Martin

May 2022

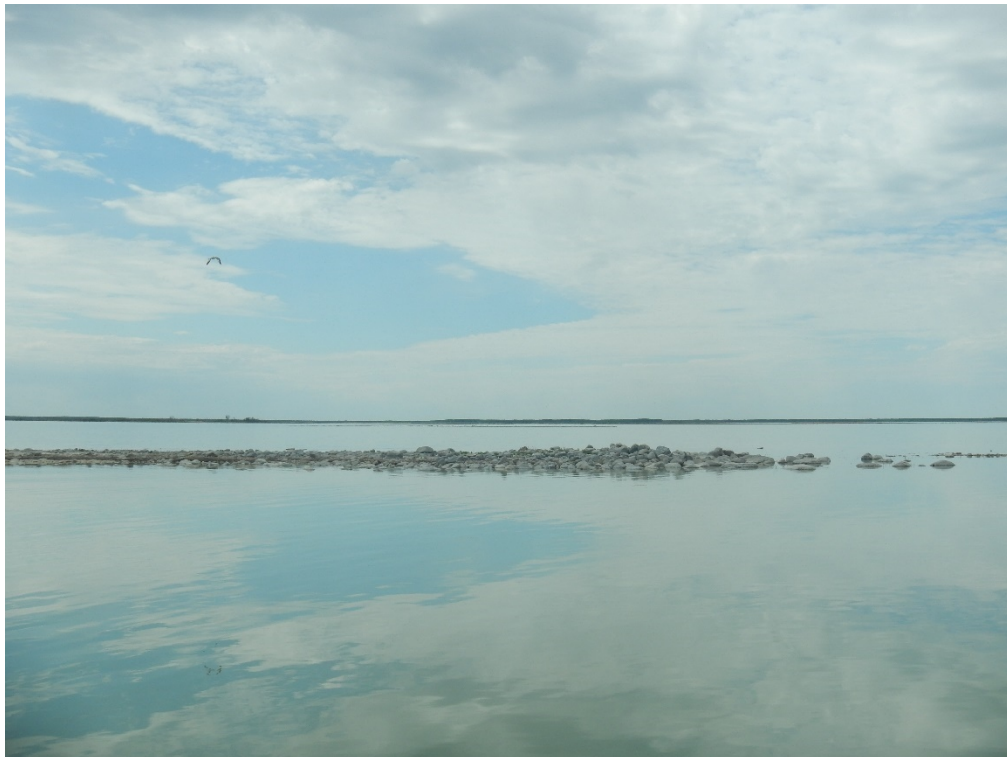
Photograph A1-14. Exposed boulder and cobble shoal at Site 10.
