Great Bear

Great Bear Gold Project Impact Statement

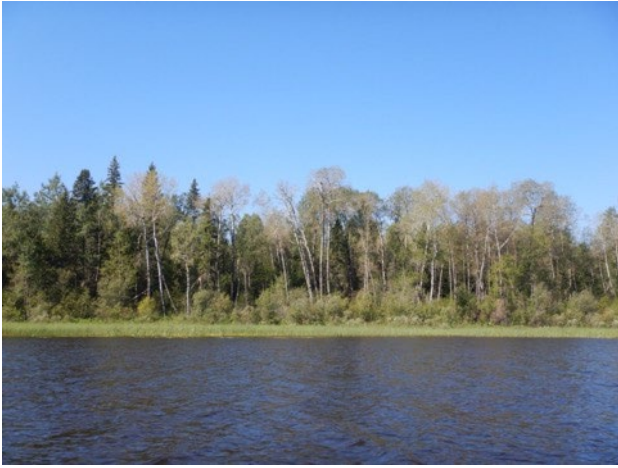
Figure 5: View west from Chukuni River showing moist to fresh bank area supporting poplar-spruce-fir mixedwood forest cover.

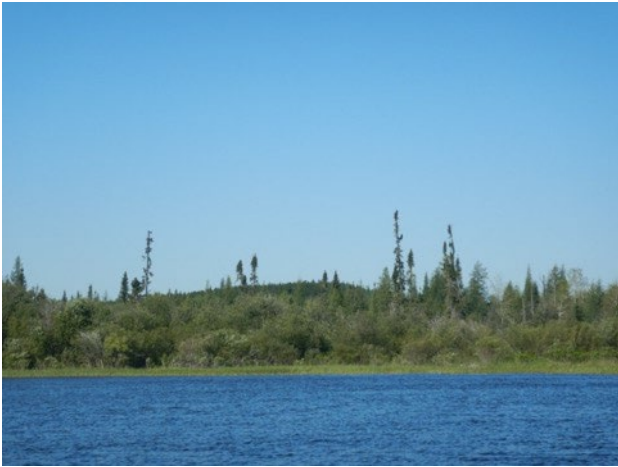
Figure 6: View northwest from Chukuni River showing open spruce / shrub cover in foreground and an area of high ground in distance.

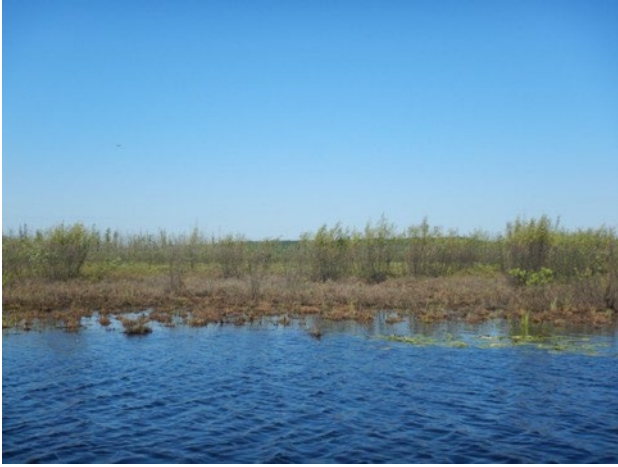
Figure 8: View north from Dixie Creek showing typical bank conditions with grass-sedge-shrub cover in varying combinations with patches of open water.

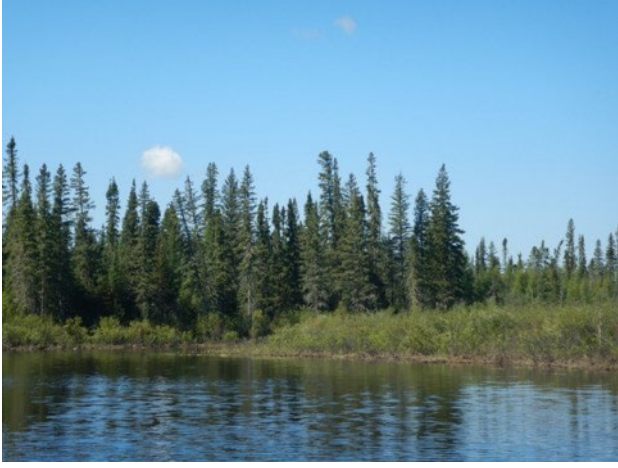
Figure 9: View south from Dixie Creek showing slight elevation rise supporting mature conifer growth.

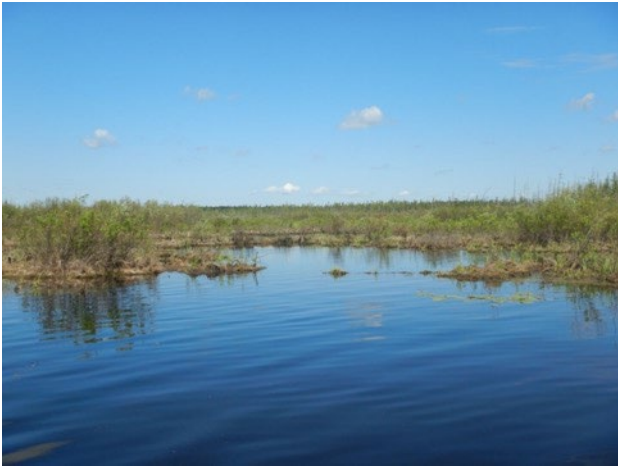
Figure 13: View north showing typical bank conditions in lower part of the stream. Note the low ridge in distance and the seasonal high water line on the vegetation.

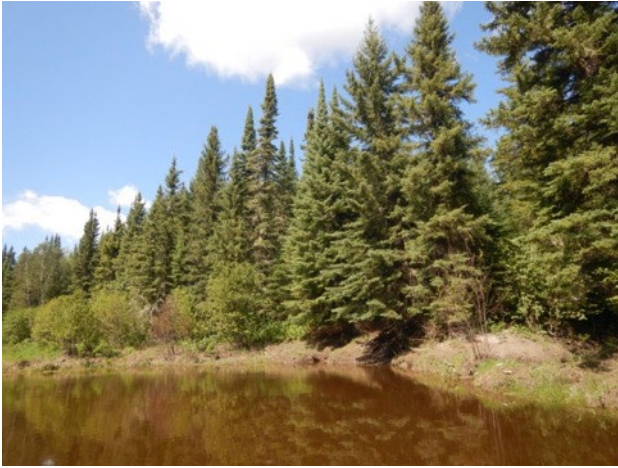
Figure 14: View northwest showing high bank on Dixie creek supporting mature conifers.

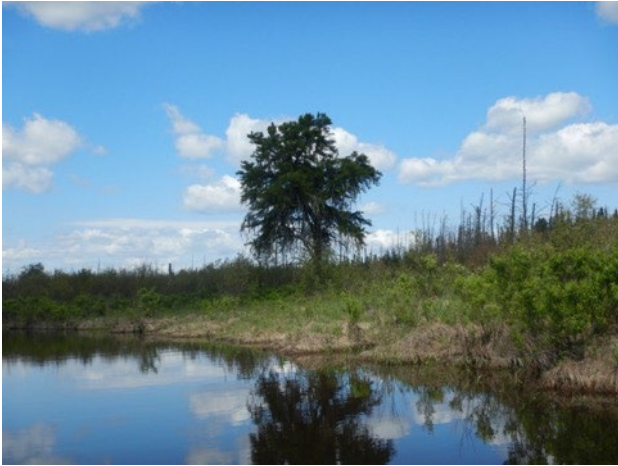
Figure 15: View east showing moderate bank area adjacent to Dixie Creek supporting lone jackpine. Jackpine do not usually favour wet conditions.

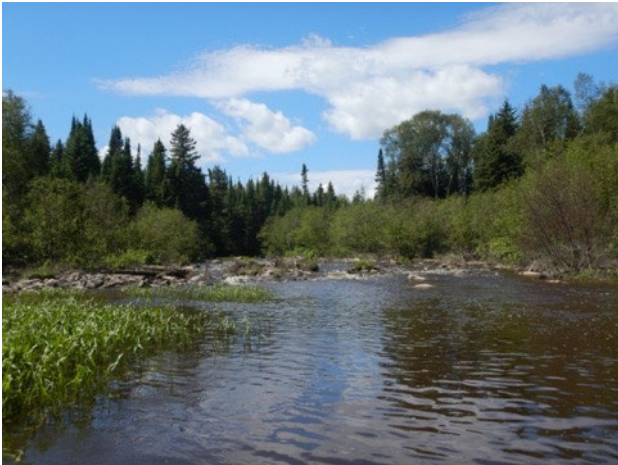
Figure 16: View west showing the navigable limit on Dixie Creek. Upstream, the creek occupies a narrower channel with regular banks set back from the stream.

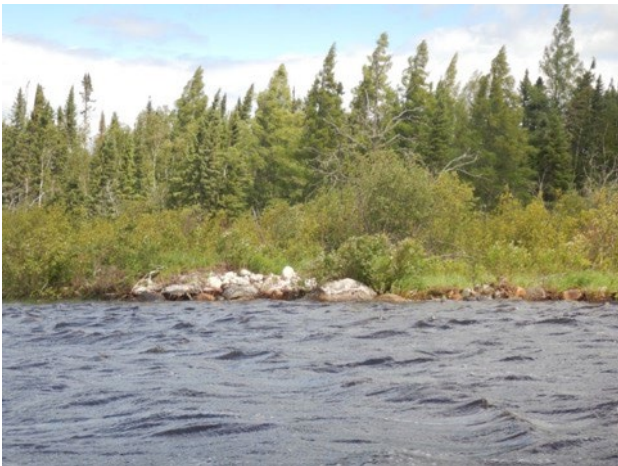
Figure 17: View north showing typical shore conditions on Rice Lake. Note boulder at shore, extensive area of low shrub in front of closed spruce forest.

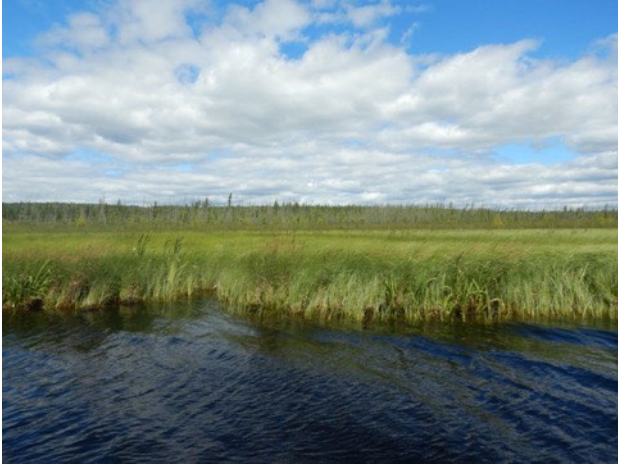
Figure 18: View west showing typical shore conditions on Rice Lake. Note extensive grass beds. Currently little wild rice is present, but the lake name suggests abundant rice in the past.

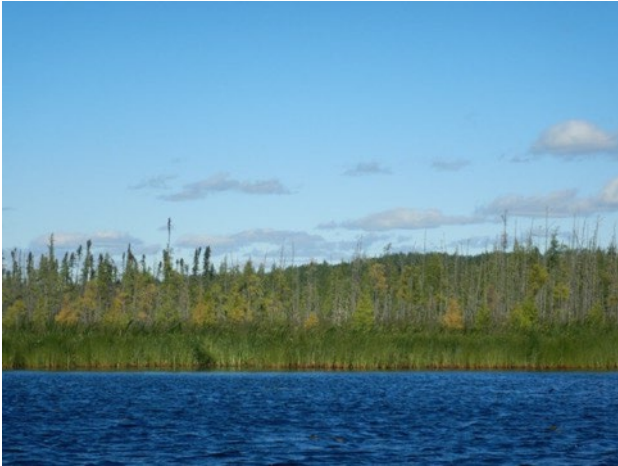
Figure 19: View southwest showing area of the mouth of the creek draining into Rice Lake. The creek flows through an extensive grass bed.

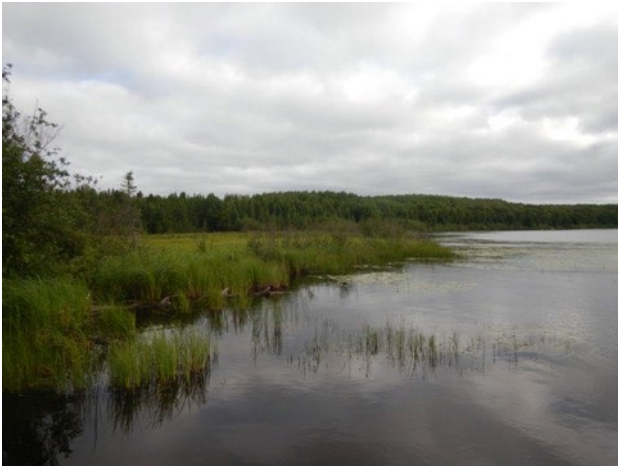
Figure 26: View north showing general conditions along shore Genesee Lake. Shoreline varies between marsh over cobble and steeply sloped bedrock.

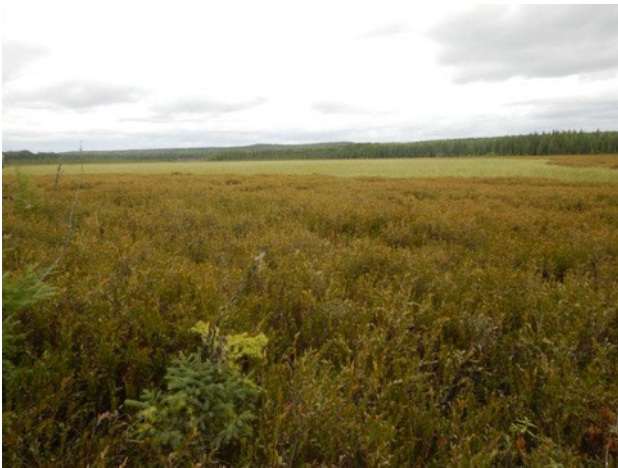
Figure 27: View north showing Teardrop Lake. Foreground shows woody herbaceous shrub cover in level wet area, with extensive rice beds beyond.

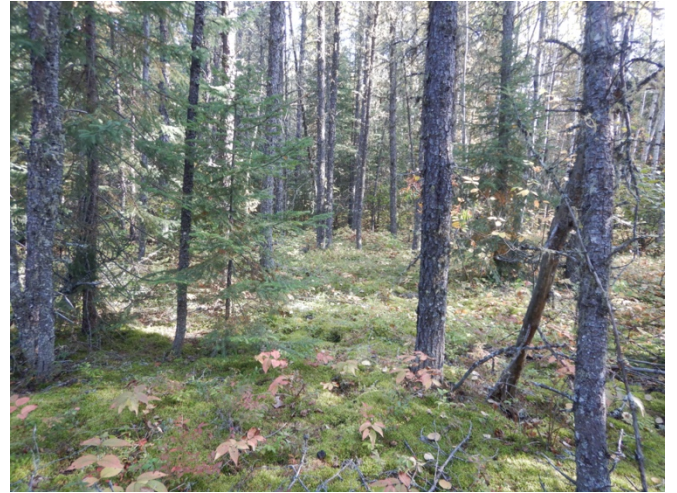
Figure 3: View south showing general terrain and forest conditions within the subject property. Conifer dominated mixedwood forest over silt sand soil. Level terrain.

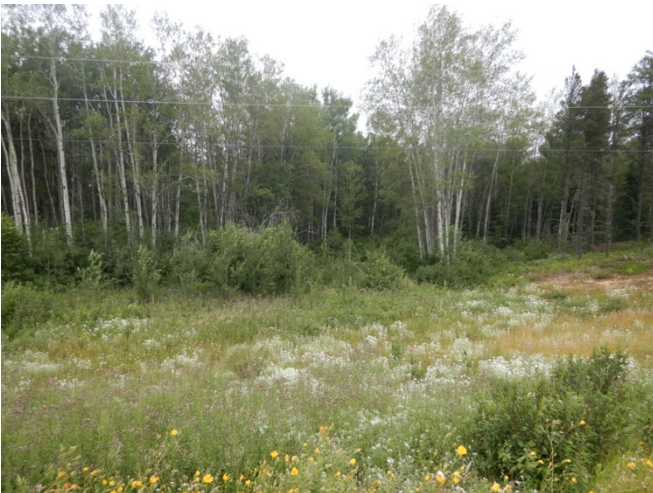
Figure 2: View south showing the mixedwood forest at the north edge of the GBR property where the proposed pipeline will be constructed. The foreground is MTO right-of-way and is extensively disturbed.

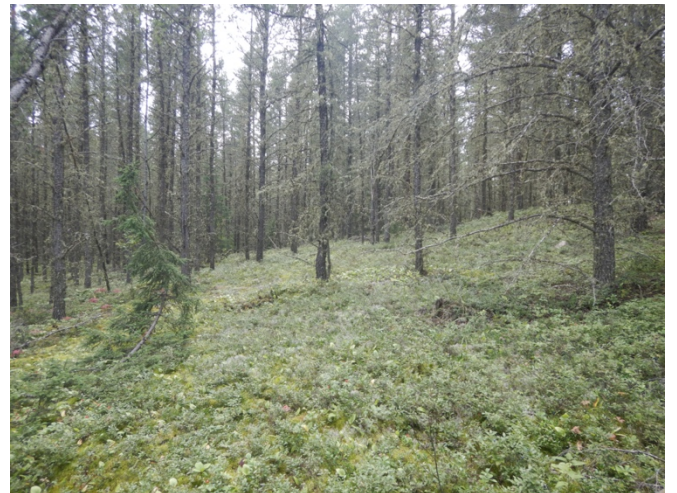
Figure 4: View north showing general terrain conditions within the subject property. While an esker is mapped in the NOEGTS mapping, terrain is relatively level with a few gently sloping sections.

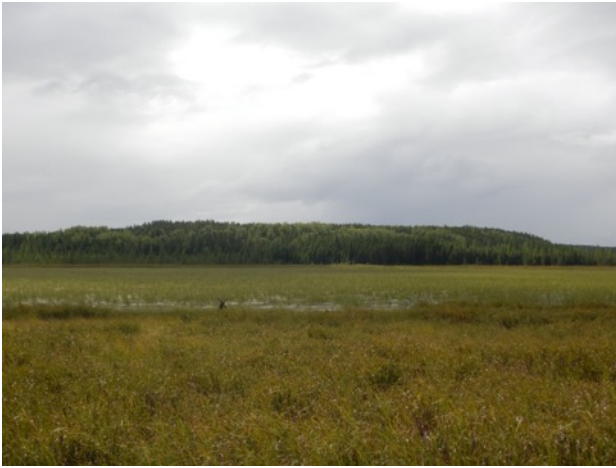
Figure 1: View west across Teardrop Lake showing terrain and vegetation conditions.

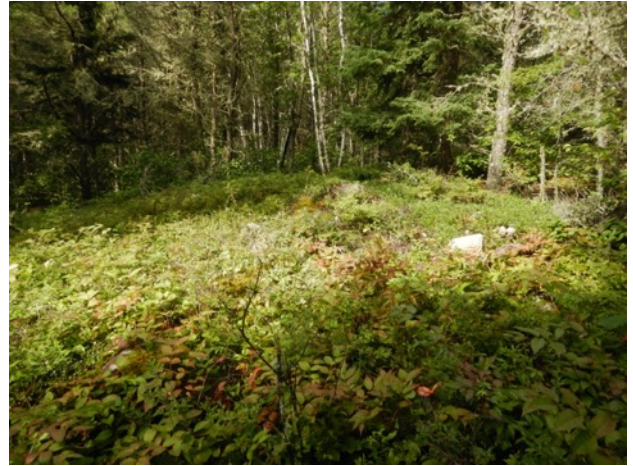
Figure 3: View north showing conditions at archaeological site EfKj-1.

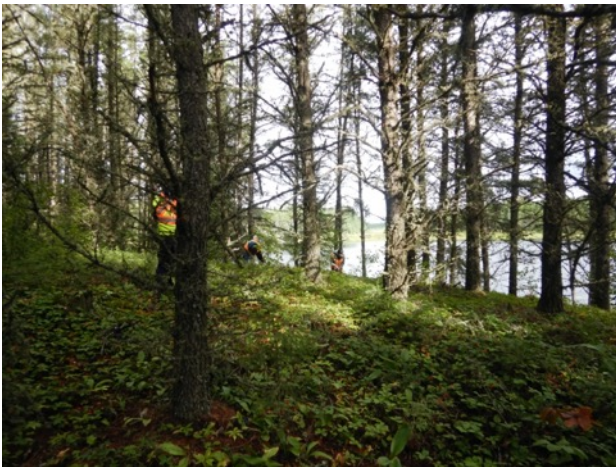
Figure 2: View north showing terrain conditions west side of the southern part of Teardrop Lake.

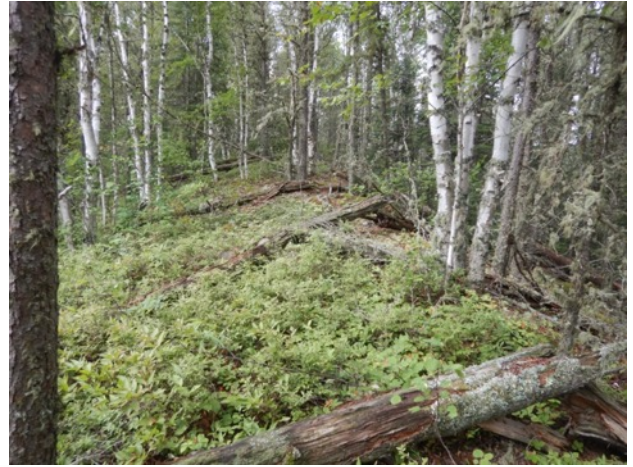
Figure 4: View south showing terrain at the narrow, steep sided esker running south from Teardrop Lake.

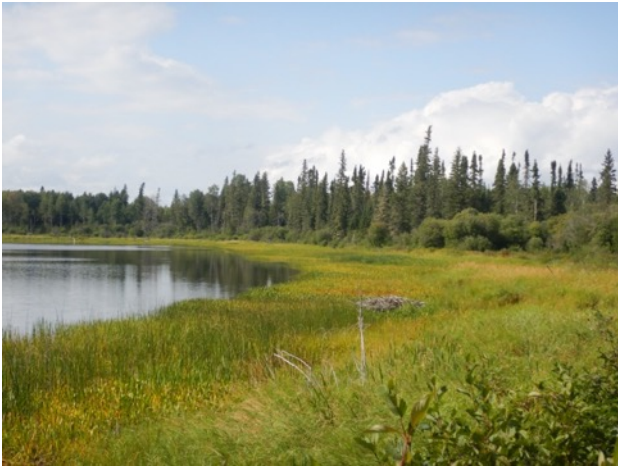
Figure 5: View south on Chukuni River showing marsh conditions at shore, and moist to fresh bank area supporting alder-willow and spruce-fir mixedwood forest.

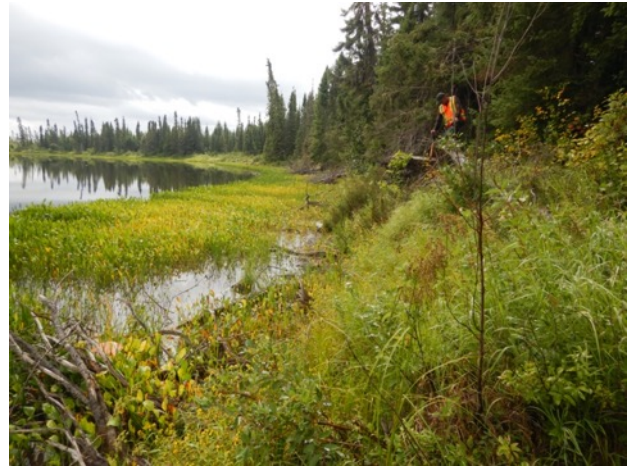
Figure 7: View south showing steep bank at location of contemporary camp.

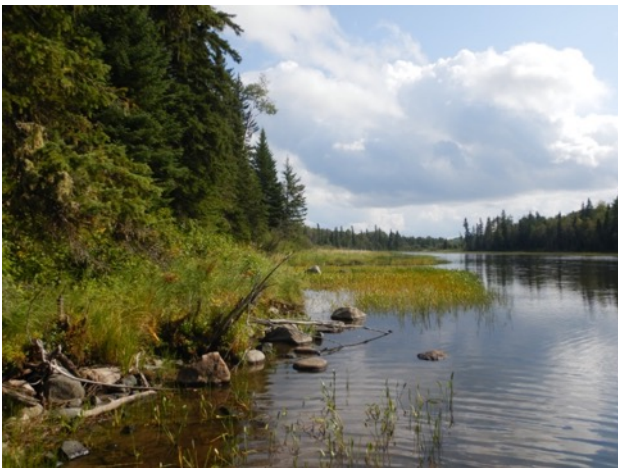
Figure 6: View east on Chukuni River showing rocky conditions at shore, and steep slope up to level terrain.

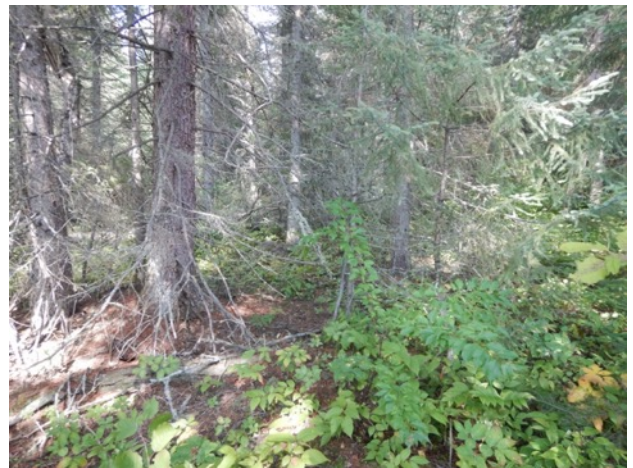
Figure 8: View east along Chukuni River showing typical dry to fresh interior terrain. Tested at 5m interval.

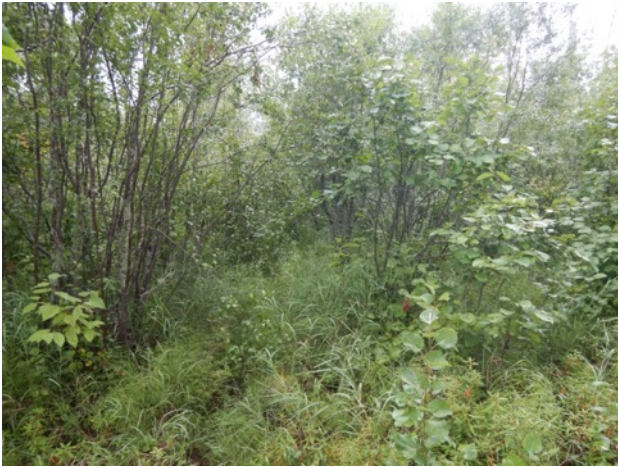
Figure 9: View south along Chukuni River showing typical moist to wet terrain. Not tested at Stage 2.

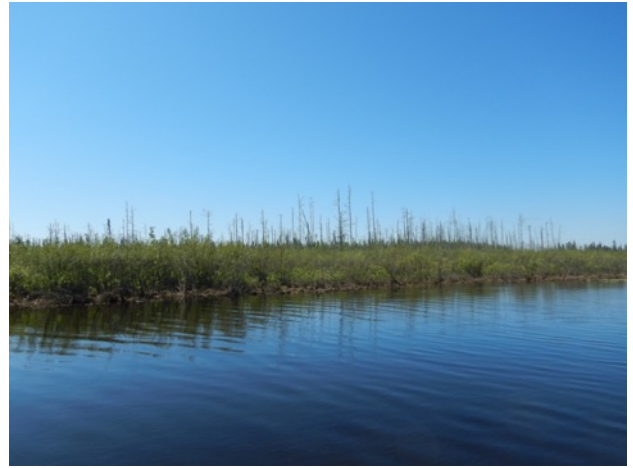
Figure 11: View north showing typical terrain conditions along lower Dixie Creek. Not tested at Stage 2.

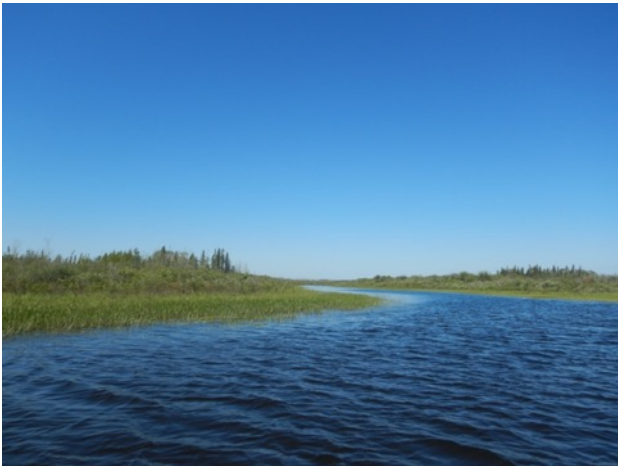
Figure 10: View west showing confluence of Dixie Creek and Chukuni River. Low and wet. Not tested at Stage 2.

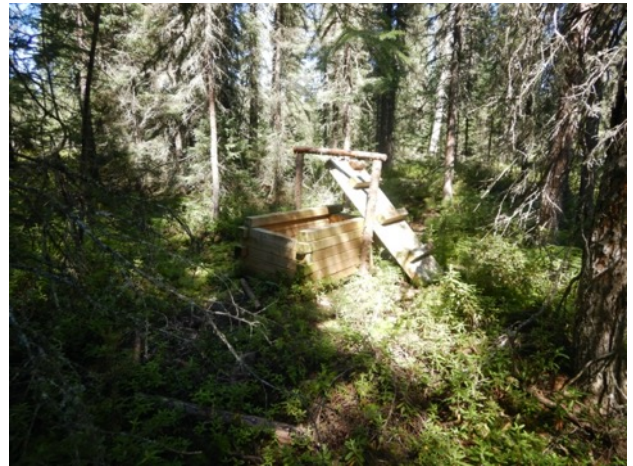
Figure 16: View east showing a food cache box, one element of the trapper's camp noted on the south bank opposite EfKj-2.

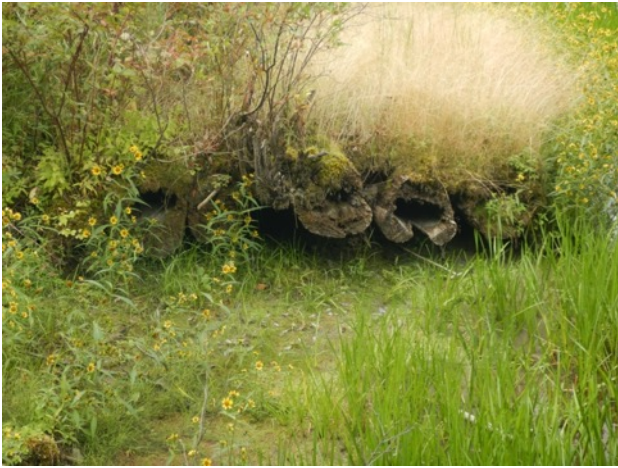
Figure 17: View west showing the log 'ramp' leading to the south bank of Dixie Creek, east of the forestry operations bridge.

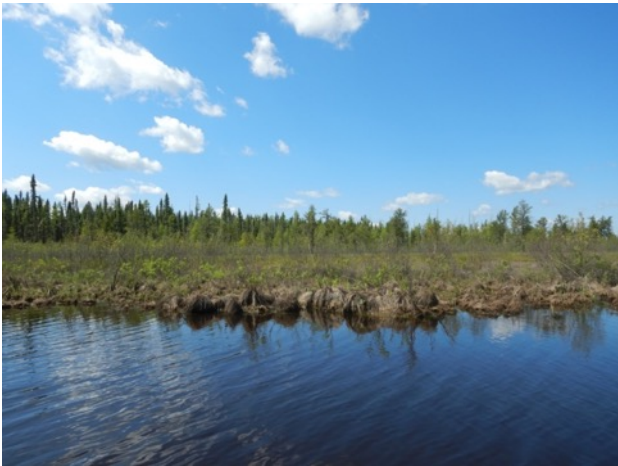
Figure 18: View south showing typical shore conditions on Dixie Creek upstream from the bridge. Note that the tufts of grass are in standing water.

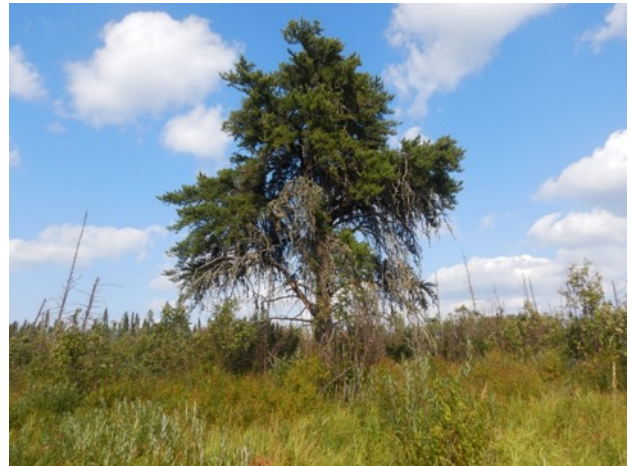
Figure 20: View north showing isolated jack pine. This species generally prefers dry, well-drained soils. Testing at this and similar locations identified soils as organic and moist to wet.

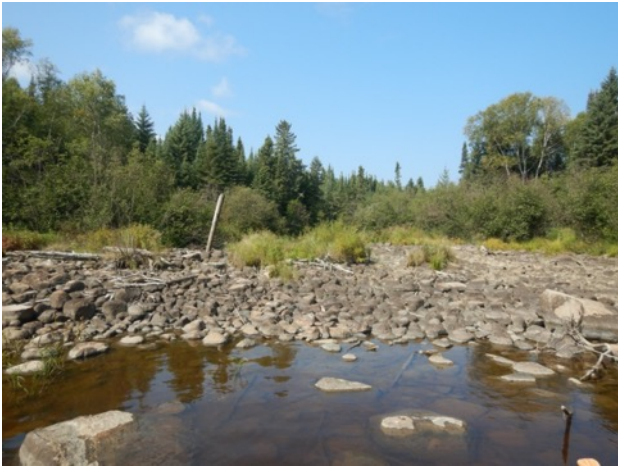
Figure 21: View northwest showing the low water levels at the rapids on Dixie Creek. Testing was completed in areas of level, dry terrain adjacent to the rapids.

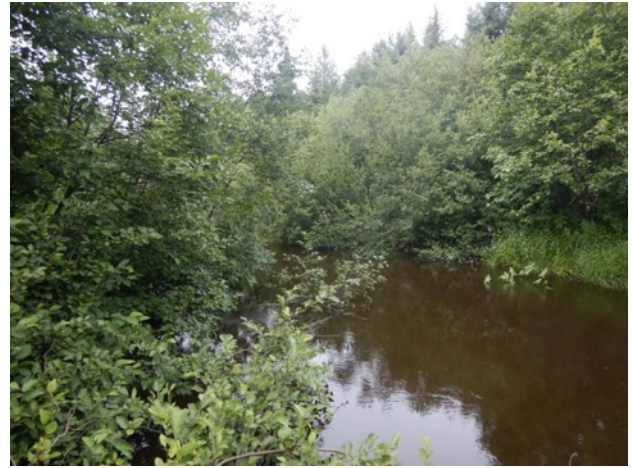
Figure 23: View southeast showing typical bank conditions at Dixie Creek above the rapids. Dense growth of grass and alder signalled moist to wet conditions.

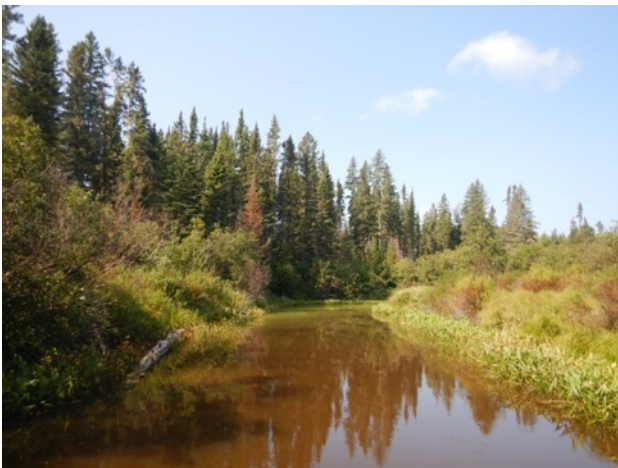
Figure 22: View west showing typical bank conditions at Dixie Creek above the rapids. Testing in areas of level, dry terrain was completed. Access was via trails.

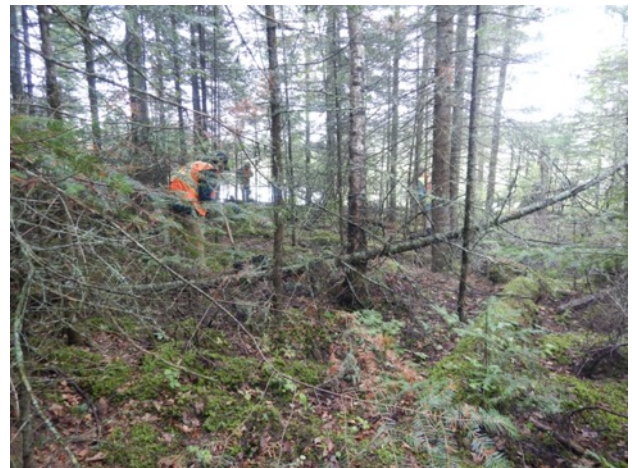
Figure 24: View east showing testing inland from the beach at Pakwash Lake. Terrain varied between level and moist to sloped and irregular and fresh.

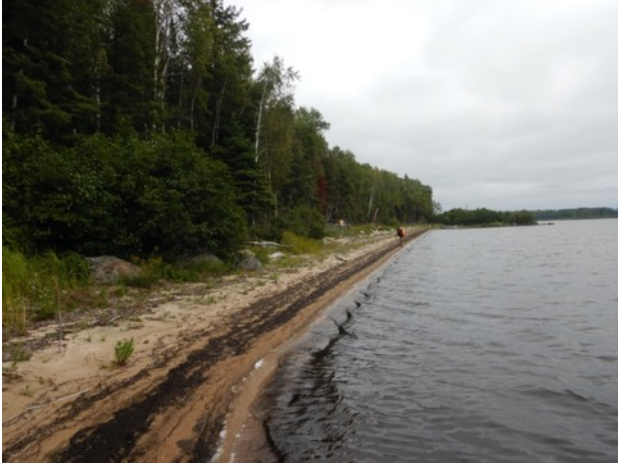
Figure 25: View east showing the wide sand beach at EeKi-4. The rocky point separating the east and west beach areas is in the distance, beyond the crew member completing a surface survey of the beach.

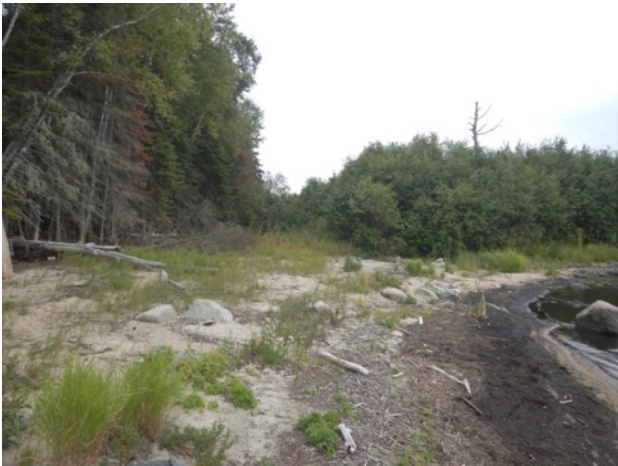
Figure 26: View east showing the rocky point separating the east and west beach areas. Cobbles and boulders were frequently noted in test pits inland from the shore.

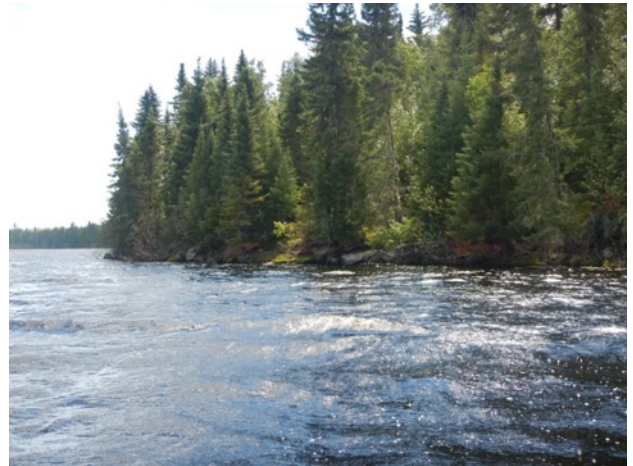
Figure 28: View east showing shoreline conditions along the south shore of Rice Lake. Cobbles and boulders at shore, land slopes steeply up to moraine ridge under dense conifer canopy.

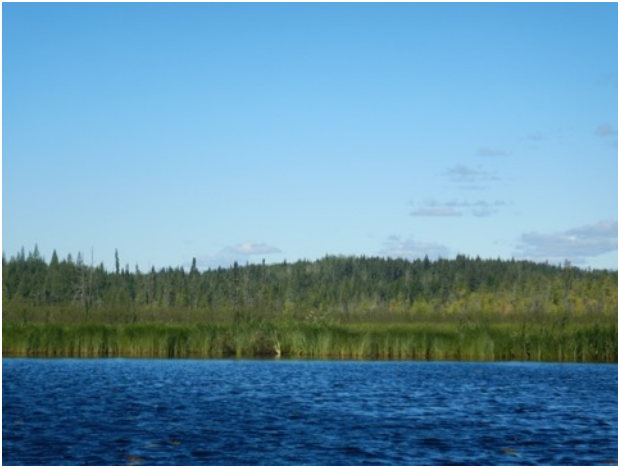
Figure 29: View northeast showing typical shoreline conditions on Rice Lake with aquatic vegetation in foreground rising to slight ridge in distance.

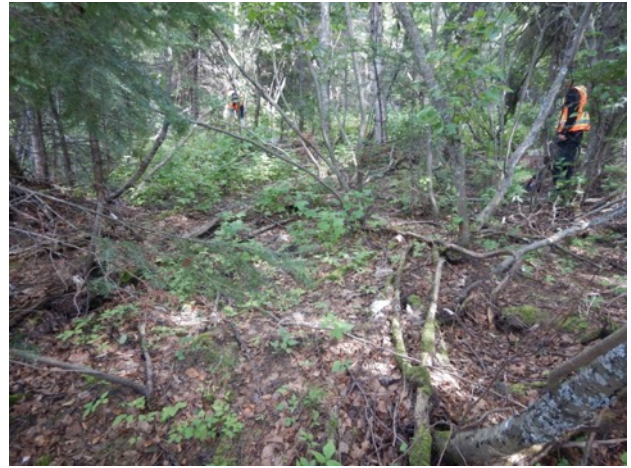
Figure 31: View west showing area of level, well-drained terrain between adjacent steeply sloped, or low and wet areas. Pockets of level terrain were tested at Stage 2.

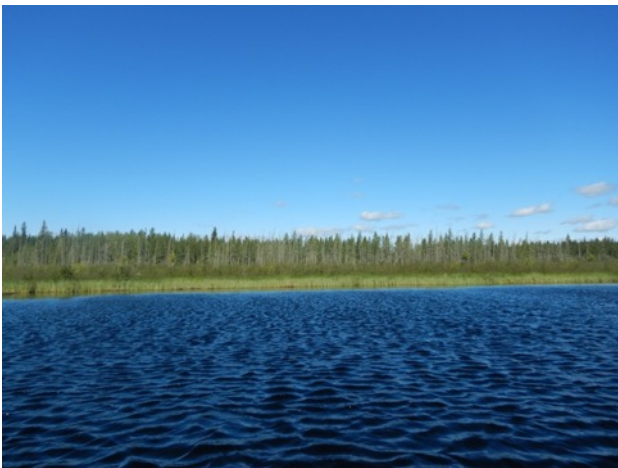
Figure 30: View west showing typical shoreline conditions on Rice Lake with extensive grass, sedge area.

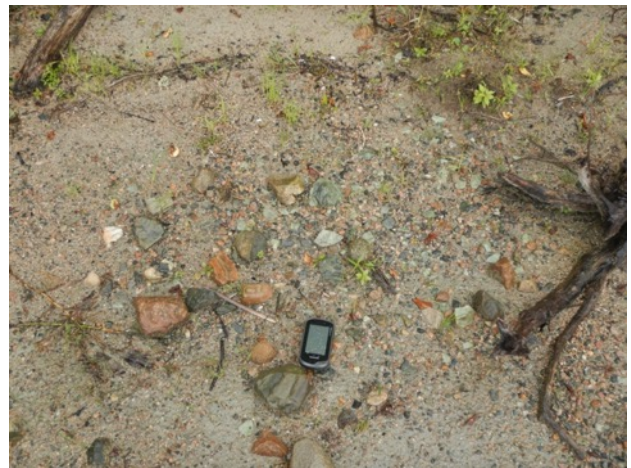
Figure 32: View down showing cluster of lithic artifacts at EfKj-4. The greenish rhyolite shows against the tan backdrop of the beach sand.

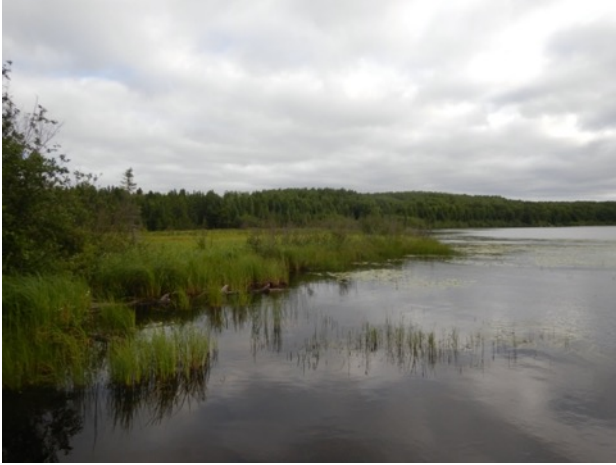
Figure 33: View east showing typical shoreline conditions at Genesee Lake. Shallow water at shore with marsh vegetation backed by steeply sloped inland terrain.

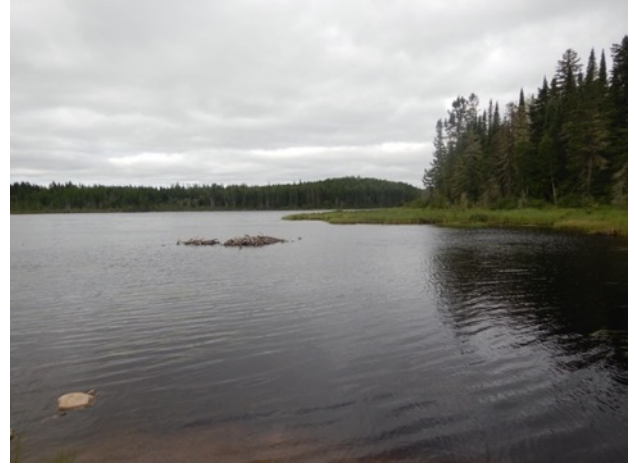
Figure 35: View west showing typical shoreline conditions at Stone Lake. Low slope shore leads to hummocky terrain inland. Limited testing where conditions warranted.

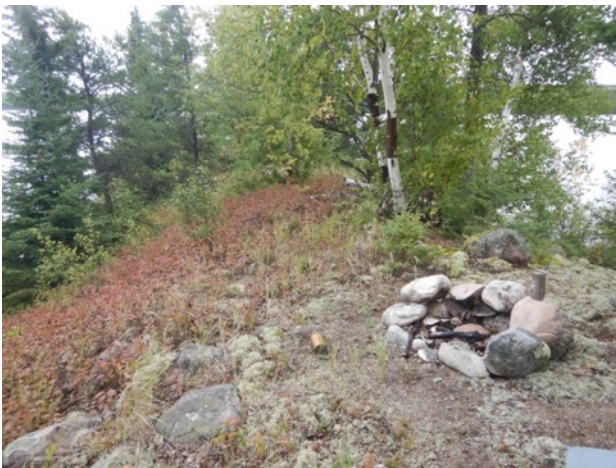
Figure 34: View southwest showing contemporary camp site on steep-sided bedrock ridge, Genesee Lake. Tested at Stage 2, no recoveries.

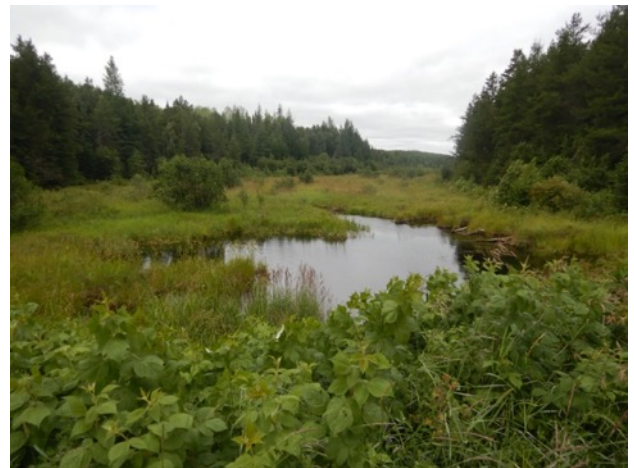
Figure 36: View west showing stream flowing into Stone Lake. Dense aquatic vegetation at stream and wet conditions inland.

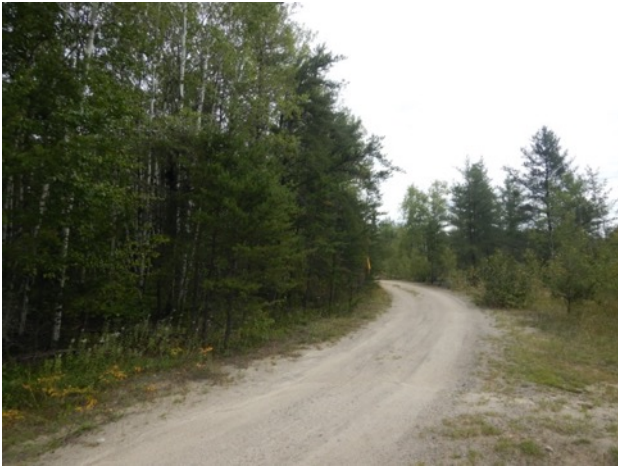
Figure 37: View south showing typical conditions along esker-based roads crossing the GBR lease area. Soils generally sandy, supporting jackpine stands with limited elevation difference between esker and surrounding area.

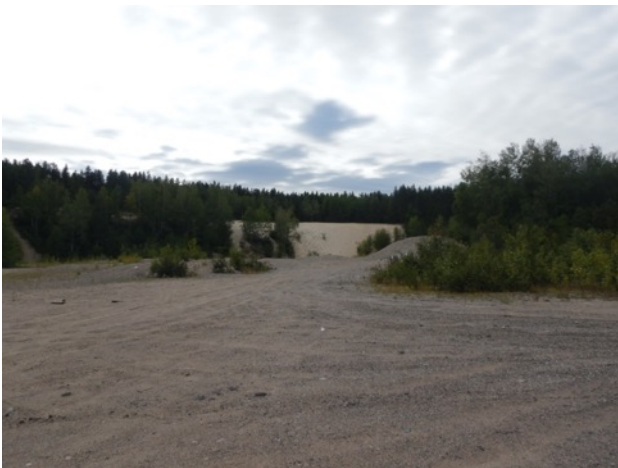
Figure 38: View west showing typical aggregate source area associated with eskers.

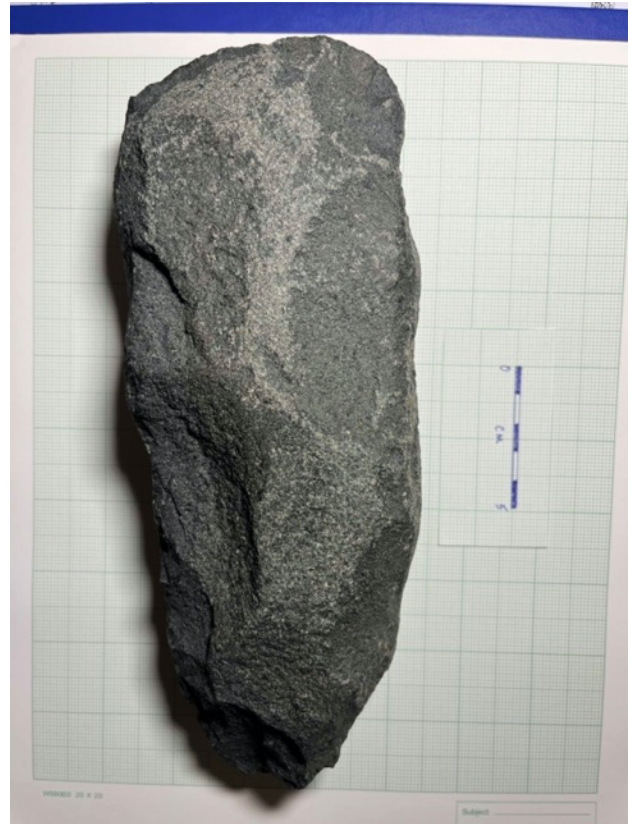
Figure 39: Large 'adze' from basalt EeKi-4. Evidence of flake removal along edges and wear from being in active beach area can be observed.

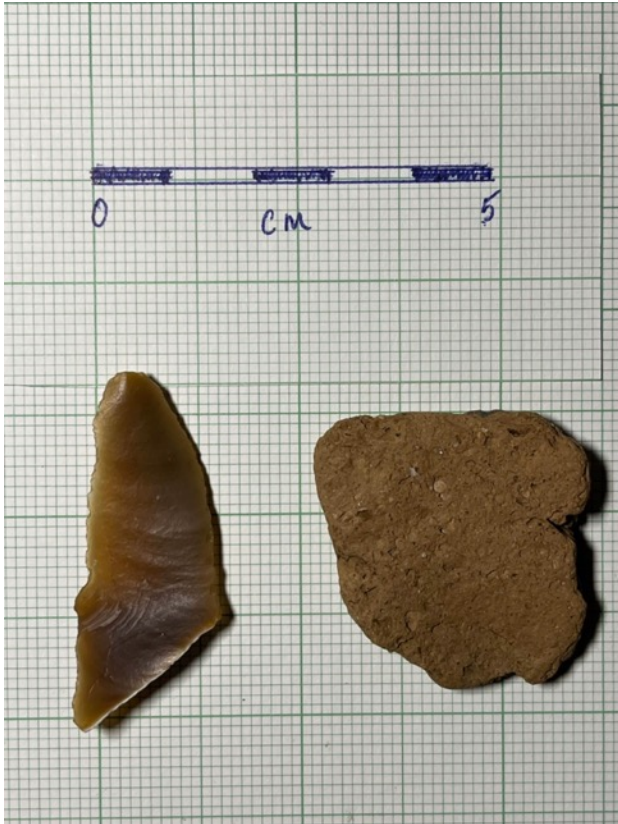
Figure 40: View of 'HBL' utilized flake (left) and Late Woodland 'Selkirk' ceramic body sherd (right) from EeKi-4. The flake shows evidence of use as a cutting implement along both long edges.

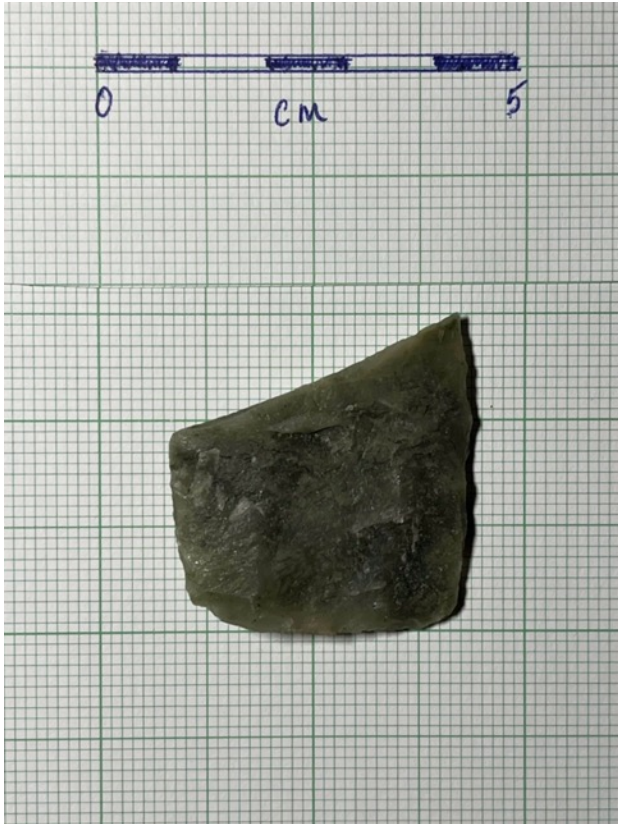
Figure 42: View of late palaeo spear point base from EfKj-4. The point has broken on a diagonal, but enough physical evidence remains to identify grinding along both lateral edges and the base, basal thinning by removal of small flakes on both faces, and parallel oblique flaking, all traits of 'early' projectile points.

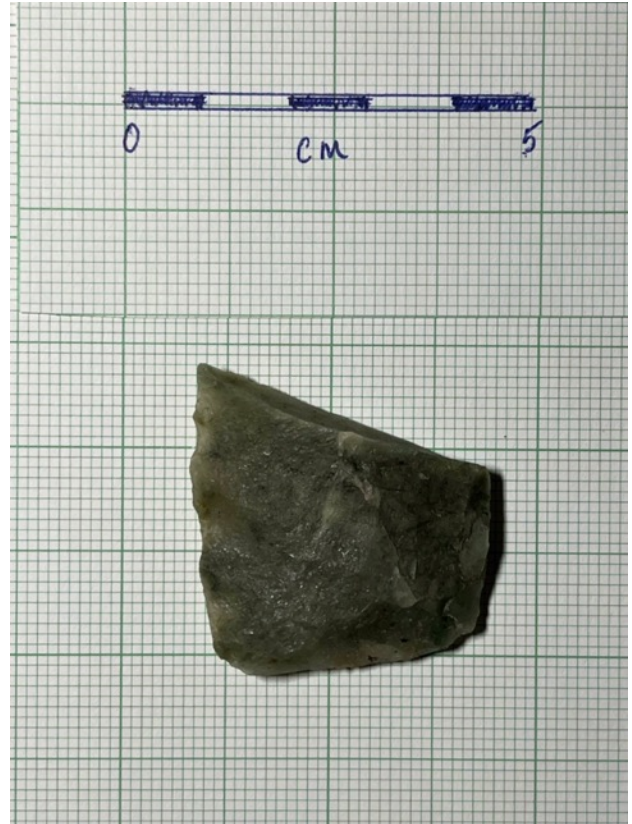
Figure 43: Obverse view of late palaeo spear point base from EfKj-4. The parallel oblique flaking is clear in this image, as are the small basal thinning flake scars.
