APPENDIX A1

TASKS 13 & 18 – FLOW METERINGS, PRESSURE LOGGERS, TURBIDITY LOGGERS, AND BEDLOAD SAMPLING

PROJECT: **Lake St. Martin Channel Monitoring - 2015**

FILE NO.: **13-0431-001 Task 13 & 18**

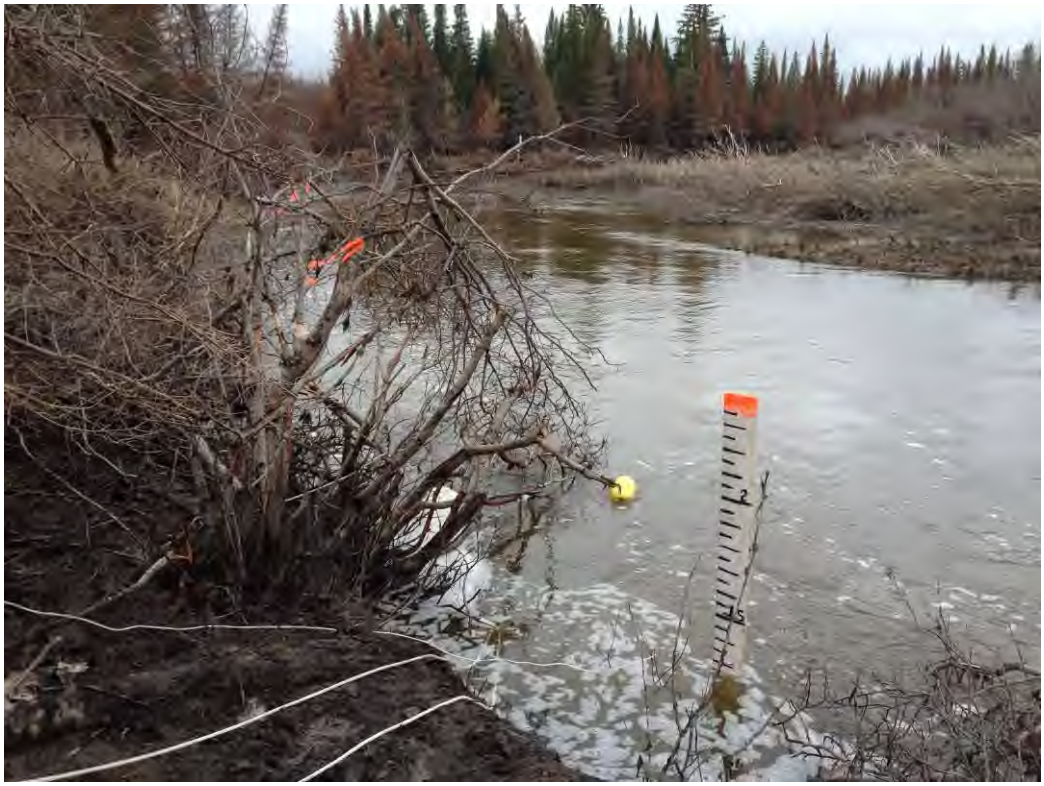
Photo 1: Turbidity Probe with Float, Pressure Logger and Staff Gauge

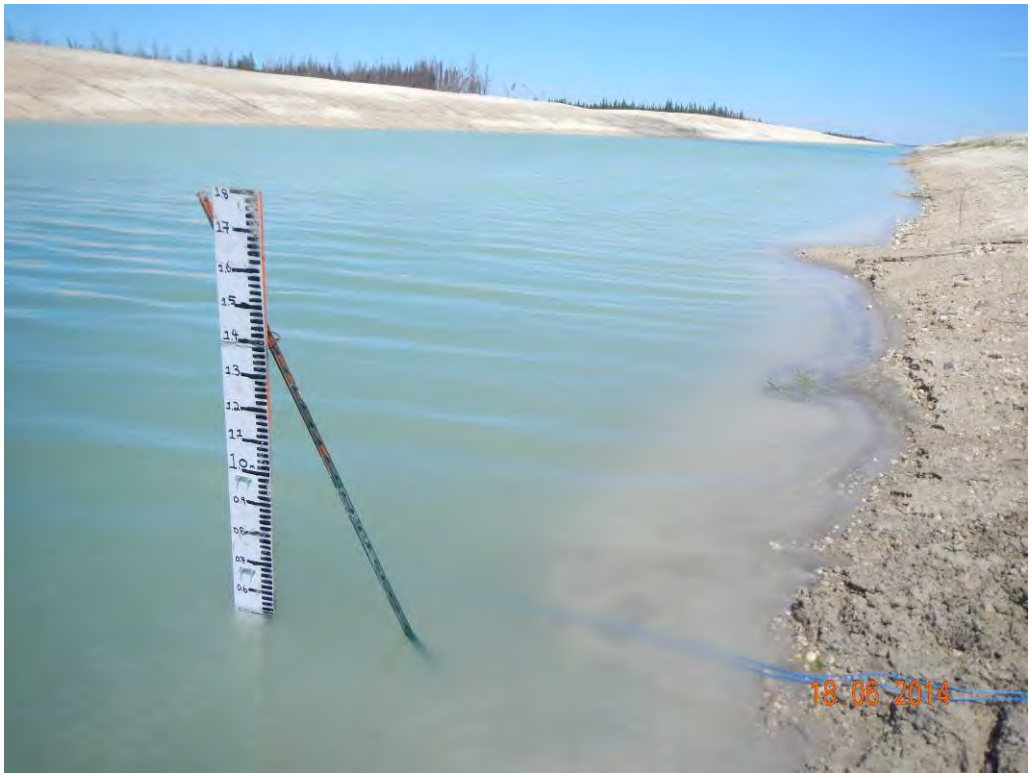
Photo 9. Rebar, gauge board and pressure logger install at R1-Cableway

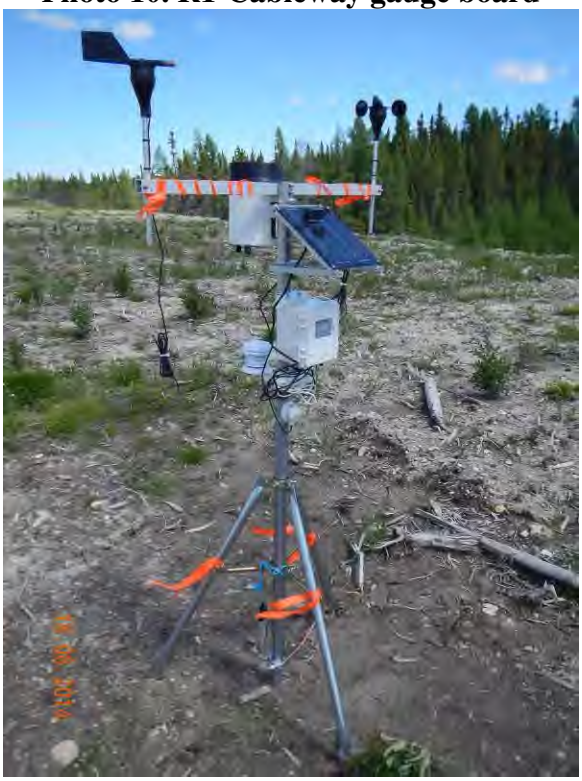
Photo 9. Weather station at R1-Cableway

Photo 10. Barometric loggers on weather station at R1-Cableway

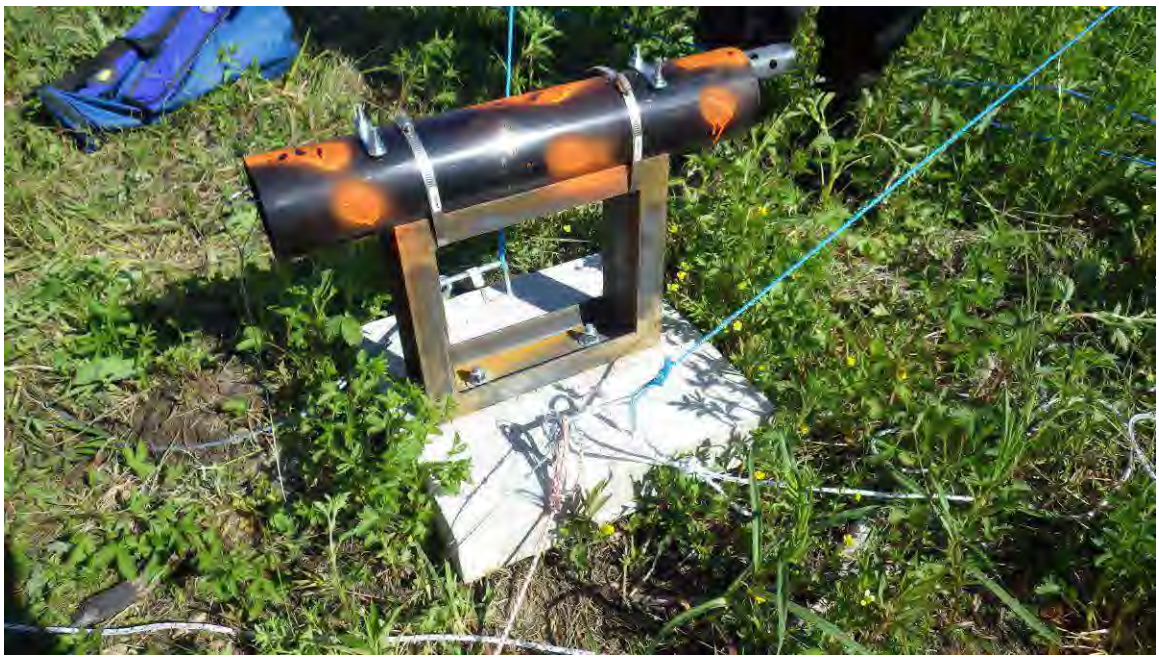
Photo 1. BC1 turbidity logger.

Photo 2: Location of BC1 turbidity meter. Ropes attached to large spruce.

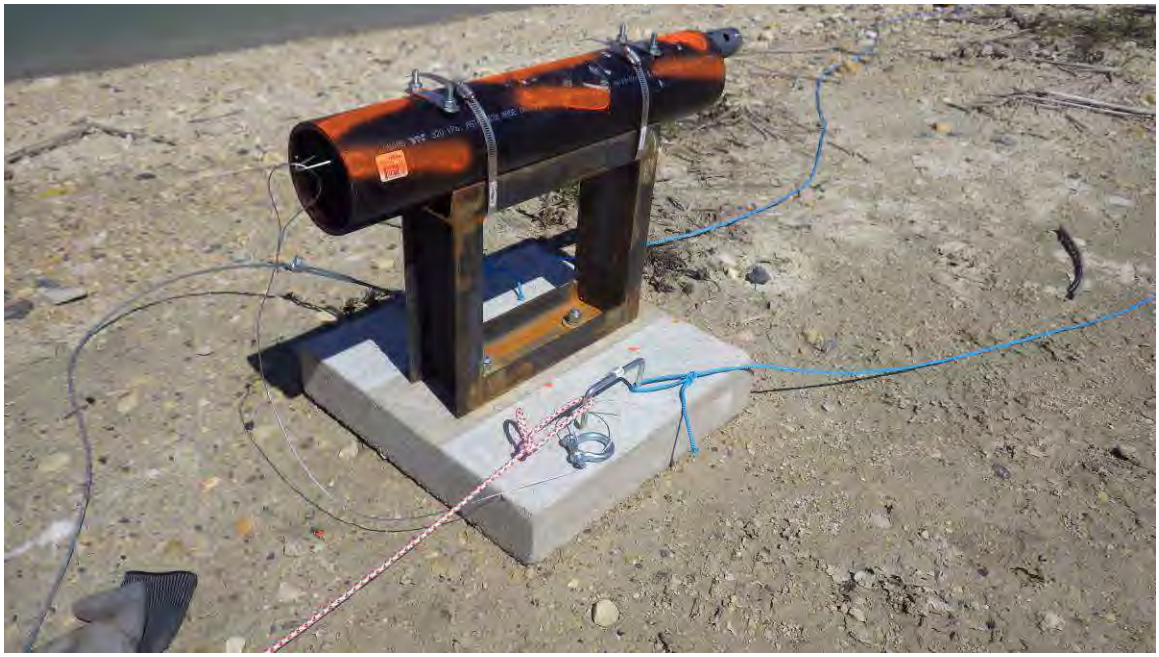
Photo 6. EC2 turbidity logger.

Photo 7. EC2 turbidity logger location – looking downstream.

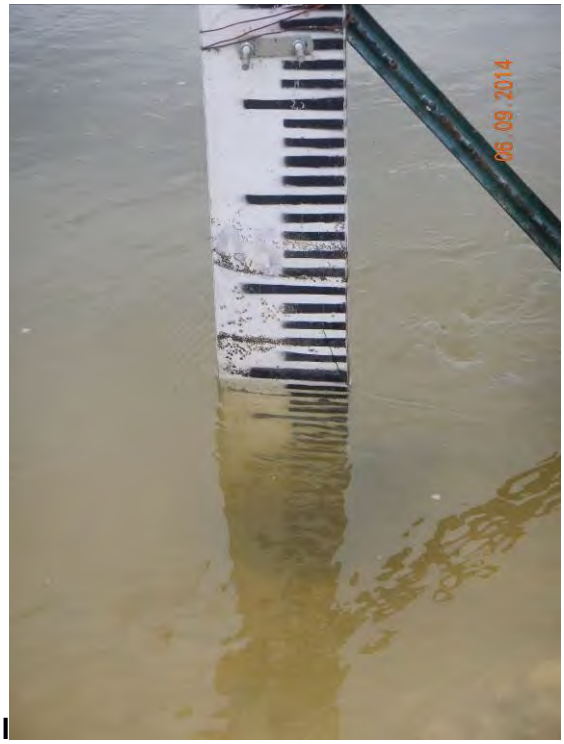
- A gauge board reading was taken on site prior to the start of the flow metering – The reading was 0.39 on the “high” gauge board. The “low” gauge board is submerged and damaged.

Photo 3. Gauge board Reading of 0.39

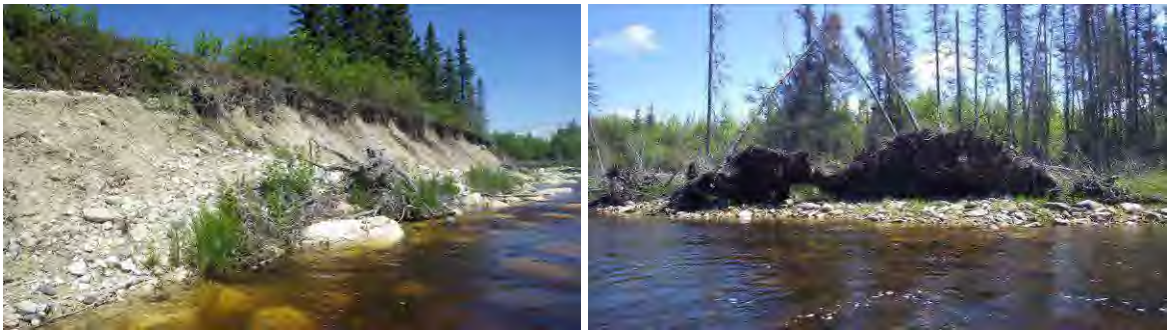
15+000: Erosion approximately 150 m upstream from 15+000 (2014).

15+000: Erosion on right bank approximately 200 m downstream from 15+000 (2014).
