**NEW GOLD RAINY RIVER MINE  
APPENDIX K  
EXCEEDANCE LETTERS  
SUBMITTED TO MECP**

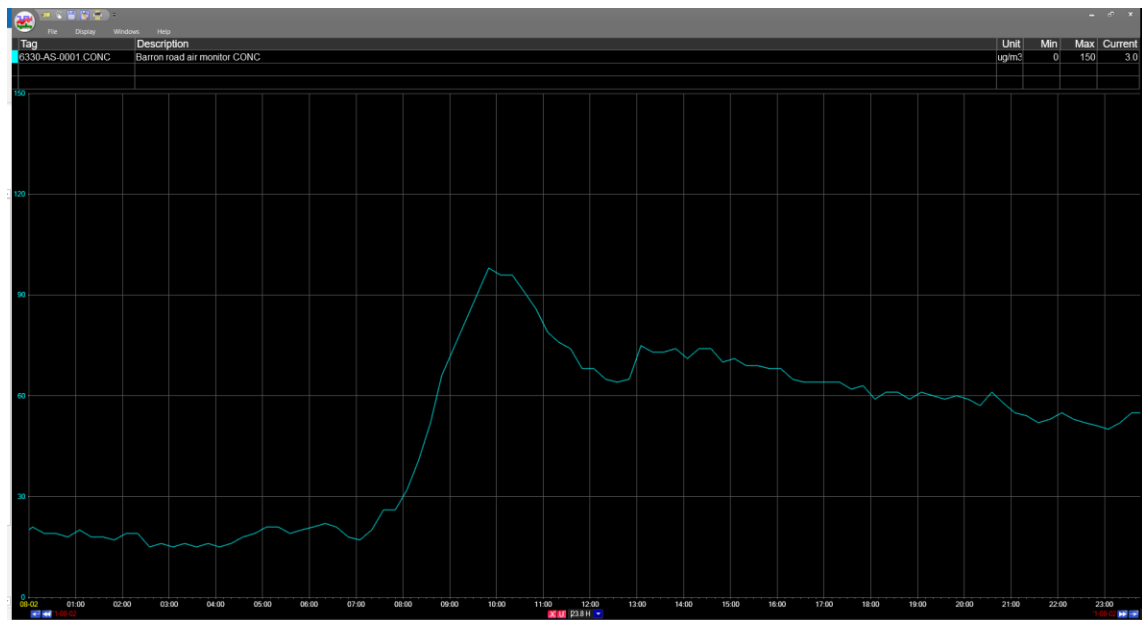
Figure 1 Barron Site E-Sampler readings for July 15, 2021 ( $\mu\text{g}/\text{m}^3$ )

The cause of the exceedance is due to the increased smoke in the area from local wildfires. The third air quality station, Tait Road Monitoring Station, also reported a high sample reading of 53.38  $\mu\text{g}/\text{m}^3$  but was deemed to be an invalid sample due to exceeding the total volume limit. Below I have also attached the E-Sampler readings for the day which show consistently elevated total suspended particulate readings over the 24 hours as well as an Air Quality Advisory for International Falls for August 2, 2021. I have also included the Coarse Ore Stockpile height during those 24 hours.
