Red Mountain Geophysical Baseline

Red Mountain Geophysical Base Line

Final Report

March 29, 2017

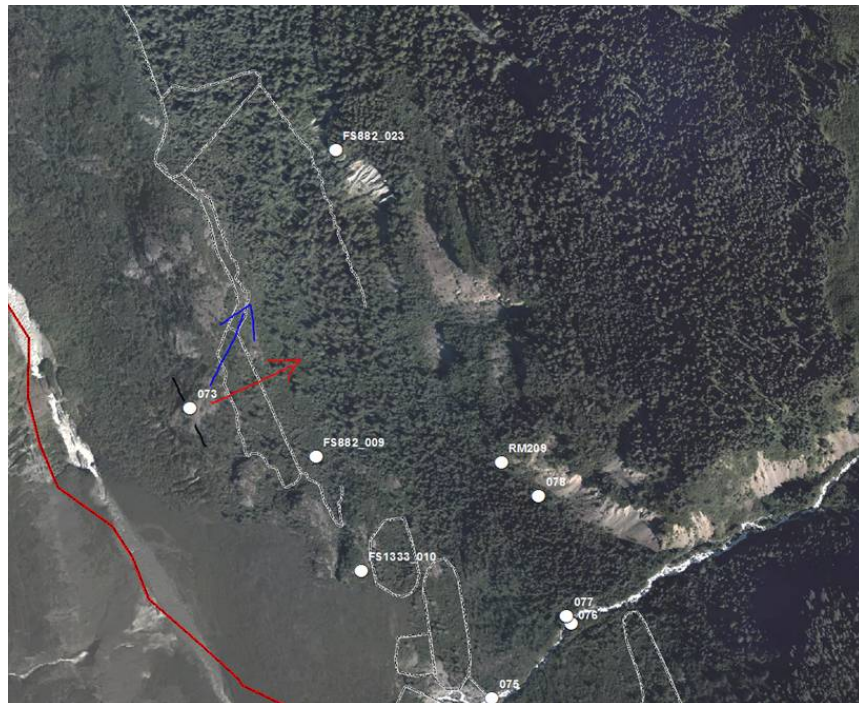
Figure 3-4: Bromley Humps and Otter Creek field sites. Blue arrow is the aspect of left photo below, red arrow is the aspect of right photo below, and black line shows the approximate trend of glacial striae and fluting at site.

Slow mass movements were observed in proximity to proposed infrastructure in several locations. Rotational sliding in unconsolidated material was observed in the lower valley along the Bitter Creek banks which may undermine the stability of the access road (e.g., Figure 3-1). Two features with the appearance of deep-seated sliding in bedrock were observed near the Tailings Storage Facility (Figure 3-3) and near Red Mountain (Figure 3-4). The activity state of these features is not currently known.
