The purpose of this document is to provide a detailed assessment of the effects of pit dewatering on water levels in and beneath the South Extension Wetlands (Figure 3). These effects are assessed over the period of April 2006 through November, 2012.

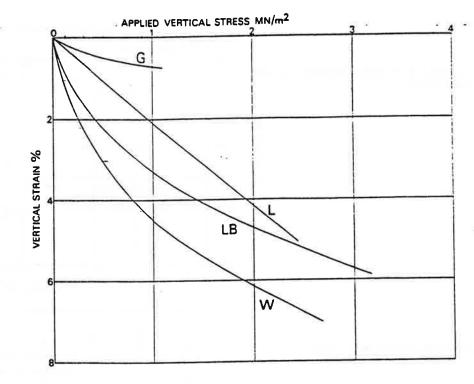
Fig. 3.2 OEDOMETER COMPRESSION TESTS ON COMPACTED ROCKFILL

Symbol	Dam	Rock type	Strength index (I _A) (*) of rock	Initial dry density	Water content as placed	Porosity
Symbole	Barrage	Type de roche	Indice de résistance des rocs	Densité initiale à sec	Teneur en eau en place	Porosité
_			(MN/m ¹)	(Mg/m ³)	(%)	(%)
LB	Llyn Brianne	Palaeozoic mudstone	57 (**)	2.34	4.5	15
w	Winscar	Carboniferous sandstone	120	2.06	7	21
L	Lefkara	Sheeted diabase	252	1.85	3	30
G	-	Thames gravel	-	2.06	2	22

-1m DIAM.SAMPLES-(PENMAN & CHARLES, 1976)

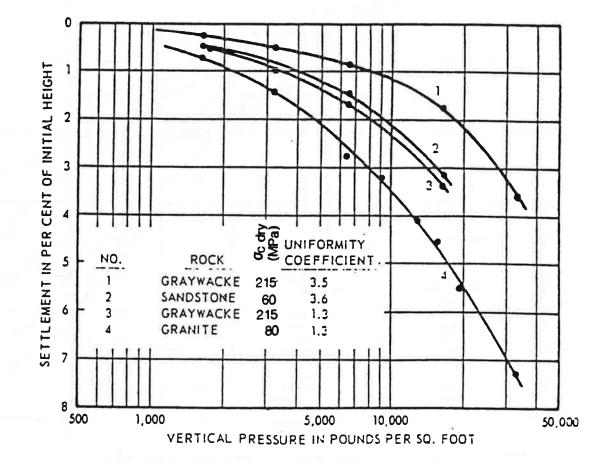
Fig.3.3 SETTLEMENT-LOG PRESSURE CURVES FOR LABORATORY CONFINED COMPRESSION TESTS ON DRY BROKEN ROCK 200mm DIAM.SAMPLES (from SOWERS et al, 1965)

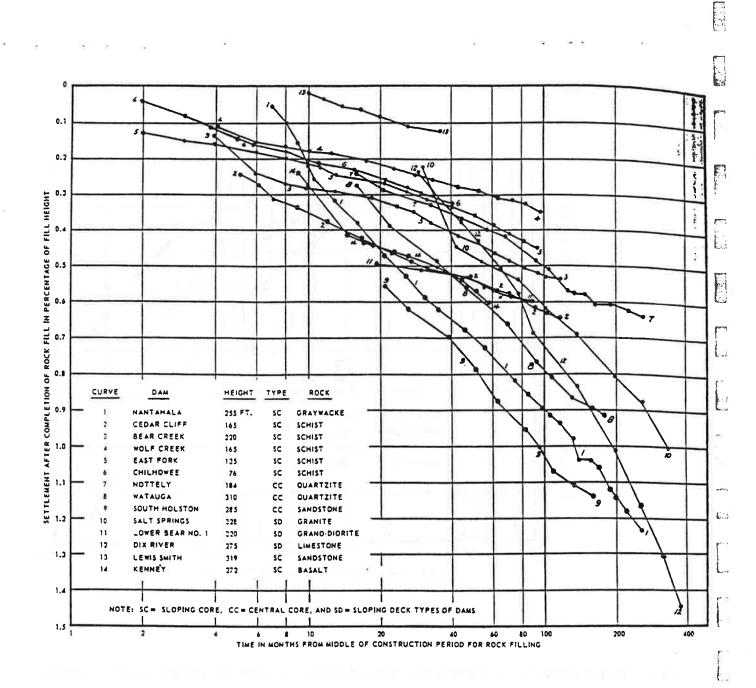
Fig.3.4 OBSERVED SETTLEMENT OF ROCKFILL DAMS AFTER COMPLETION OF CONSTRUCTION

(from SOWERS et al, 1965)

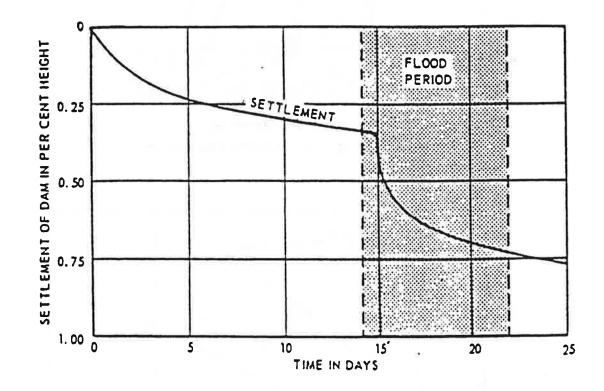
Fig.3.5 EFFECT OF FLOOD ON THE SETTLEMENT OF THE DIX RIVER DAM

(from SOWERS et al, 1965)

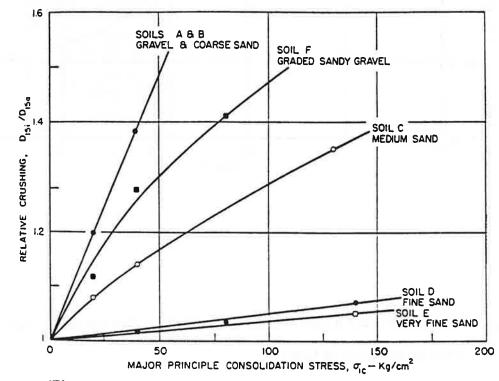
Fig. 3.6 PARTICLE BREAKAGE IN COMPRESSION TESTS ON SAND AND SAND AND GRAVEL (from LEE and FARHOOMAND, 1967)

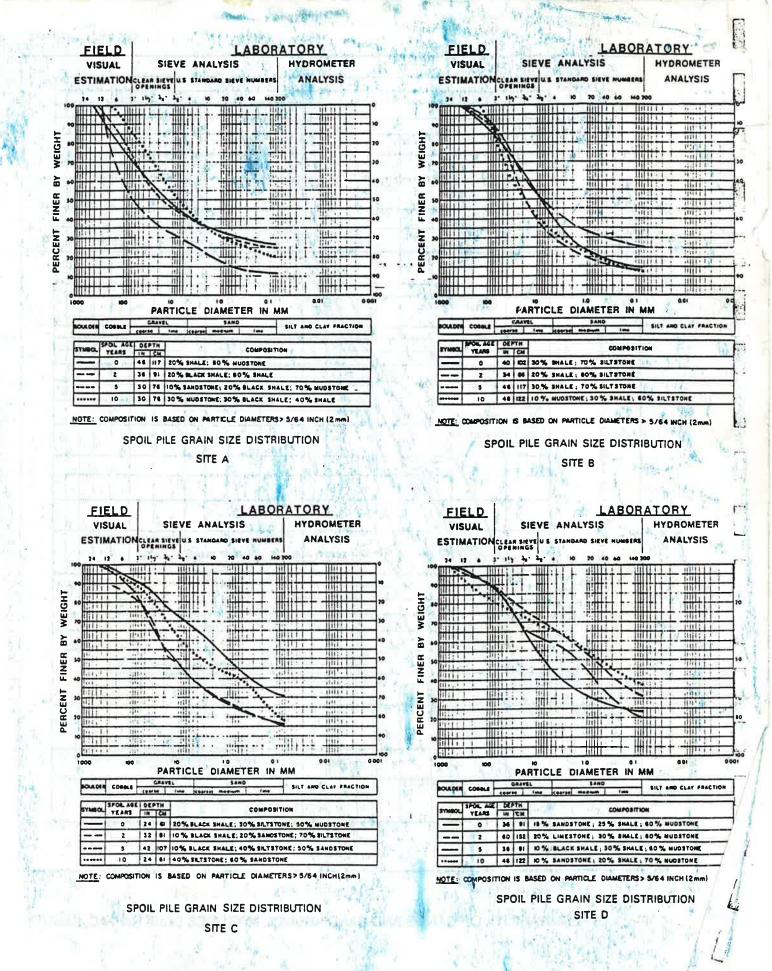
Fig. 4.1 GRADATIONS OF APPALACHIAN COAL MINE SPOIL (from ANDREWS et al. 1980)

Gradations showing the differences between fresh, 2, 5, and 10 year old spoils for sites B and D are shown in Figure 4.1. The spoils at Site B were largely shale and siltstone that displayed a chip type degradation mode. The negligible change in gradation indicates that material breakdown with time was insignificant at this site. At Site D where the spoils contained a high proportion of slake prone materials, the effects of time on material breakdown was more apparent. It can be seen that the fines content (silt/clay sizes) in the 10 year old spoil was 40 percent compared with 25 percent in fresh spoil.

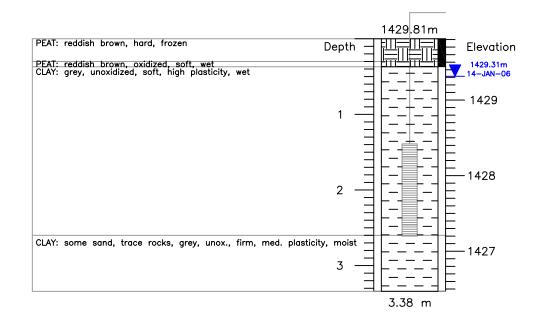
TESTHOLE TH-A835-03 COAL VALLEY RESOURCES INC. COAL VALLEY MINE 2006

4961.47 N 12621.43 E MINE GRID
