## Undertaking #23: Clarification of trellis-style drainage

**Response:** The request was made to search out a definition of “trellis” drainage that would apply to the style of drainage noted in the Project area. The original definition provided in CIAR #553 pdf pg. 72, (from the Oxford dictionary) is shown below from CIAR #875, slide presentation pdf pg. 7:

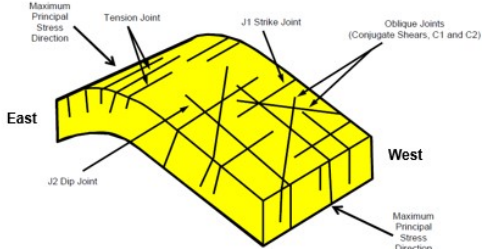
**From PDF pg. 573 of Appendix B in Appendix 9 of CIAR #42**

### Complex geological setting

Benga has indicated that the Project area is geologically and structurally complex, with fault and fracture control on groundwater flow, including west-east faults (as reinforced by AQ#5 - Coalition - Cooley\_veins\_AAPG - Water Topics.pdf, now marked as Exhibit CIAR 892). This type of conditions is nearly impossible to mimic accurately within a modelling framework.
