**LAKE MANITOBA AND LAKE ST. MARTIN OUTLET CHANNELS PROJECT  
RESPONSE TO IAAC TECHNICAL INFORMATION REQUESTS**

**Question IAAC-59**

**Appendix IAAC-59-1    MEMORANDUM: PRELIMINARY  
SUMMARY OF CONSEQUENCES ASSOCIATED  
WITH FAILURE OF VARIOUS COMPONENTS OF  
THE LAKE MANITOBA OUTLET CHANNEL, DRAFT,  
HATCH**

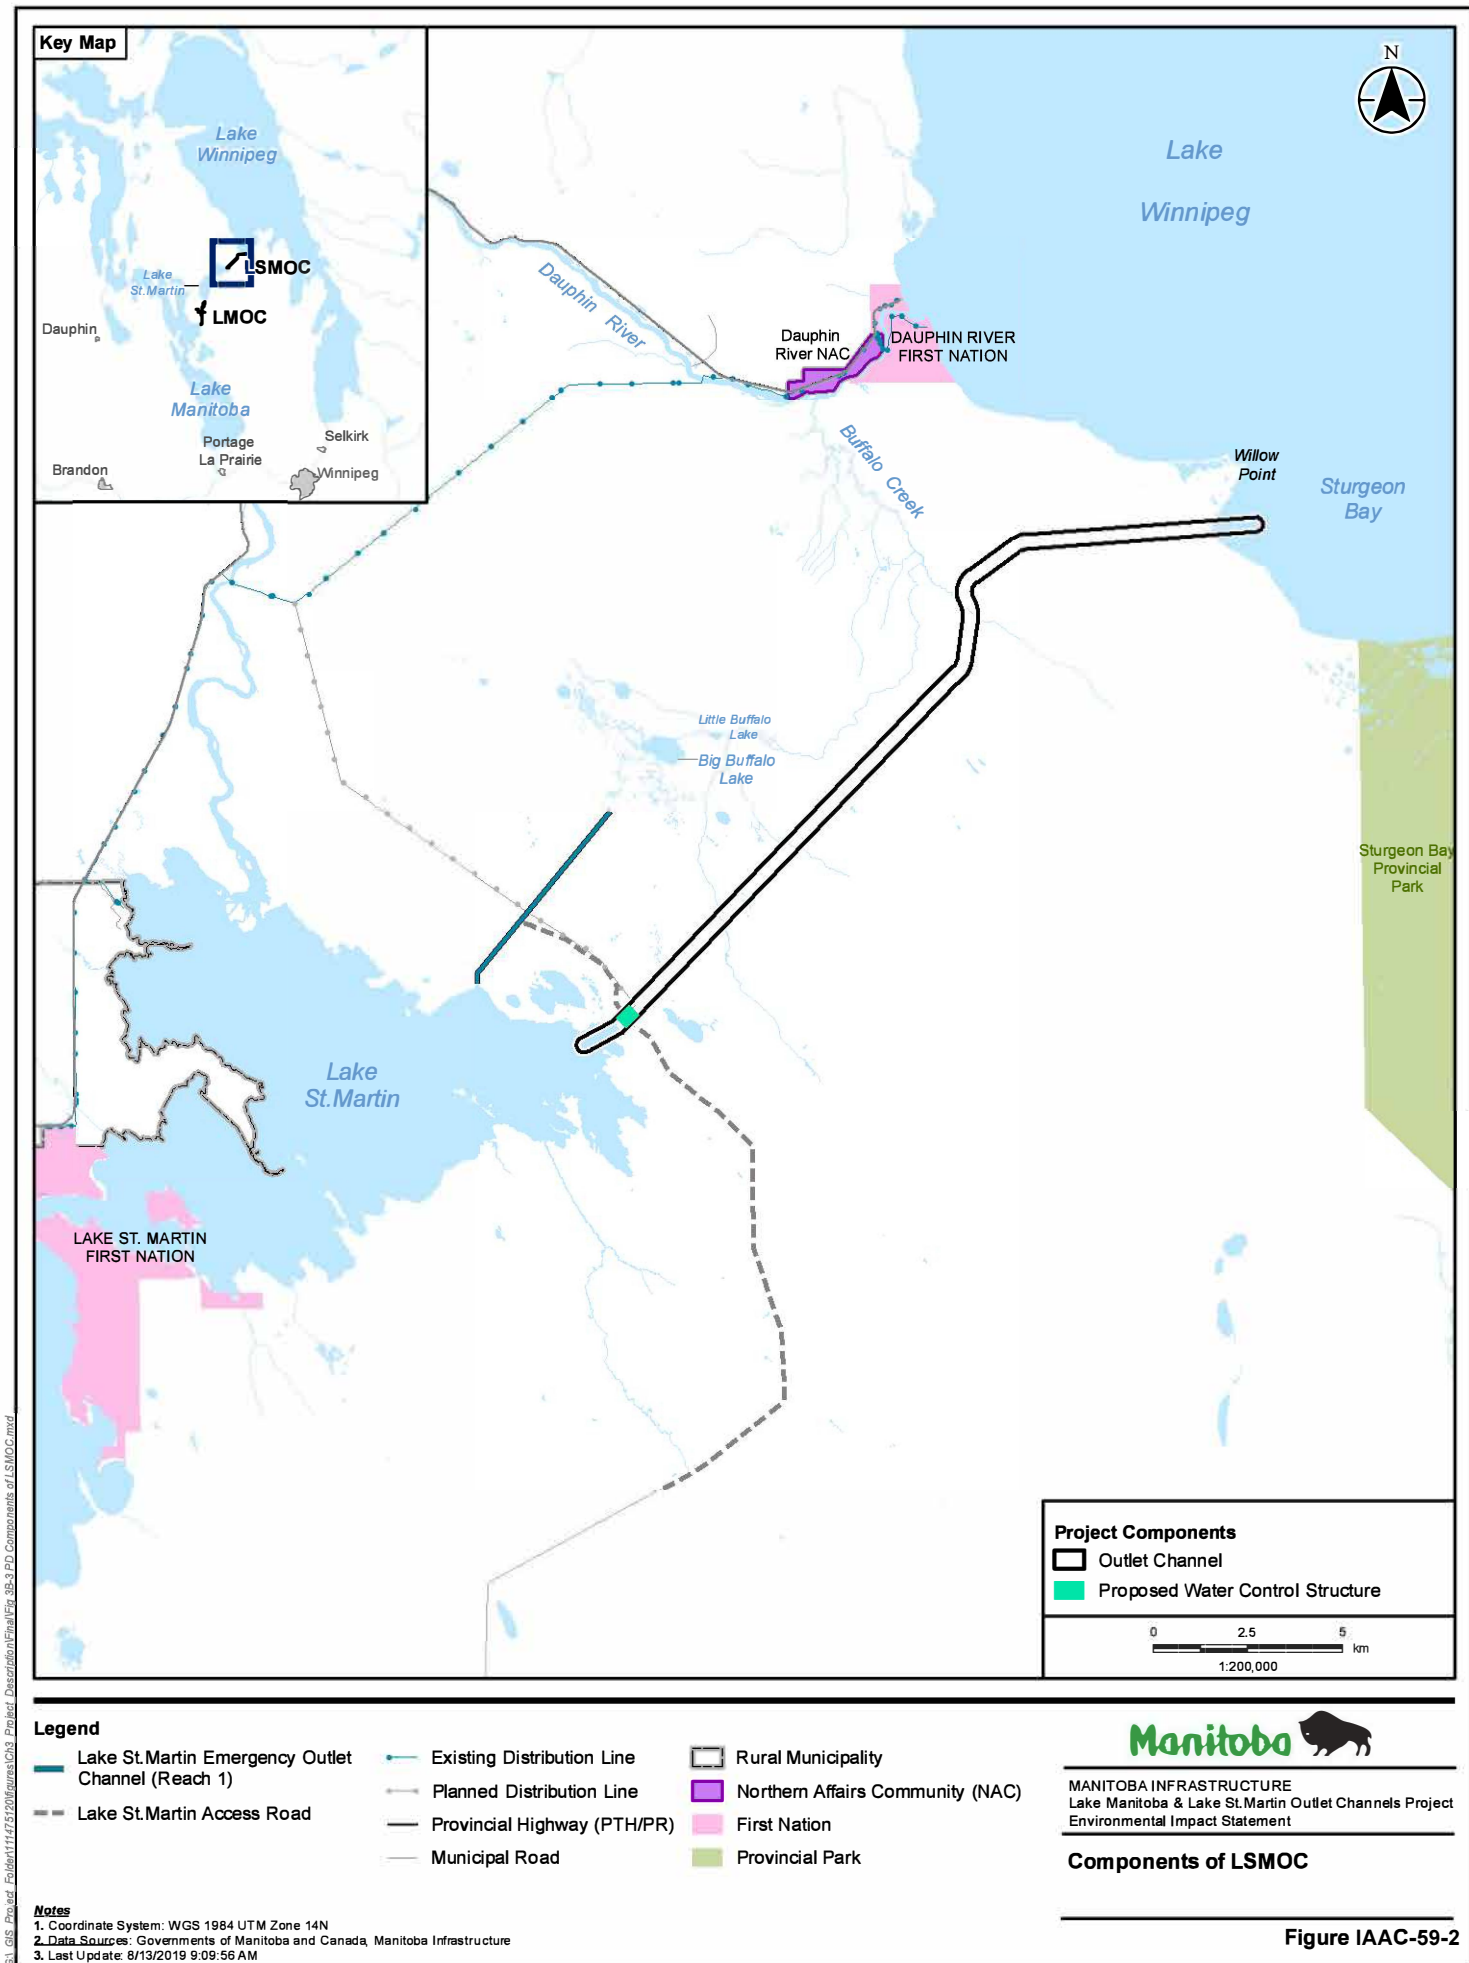
| Figure IAAC-59-1 Components of LMOC ..... | 5 |

Appendices IAAC-59-1 and IAAC-59-2 describe potential design failures for the Lake Manitoba Outlet Channel (LMOC) (Figure IAAC-59-1) and the Lake St. Martin Outlet Channel (LSMOC) (Figure IAAC-59-2).
