Whiteshell Reactor #1 Organic Coolant Leak Fact Sheet

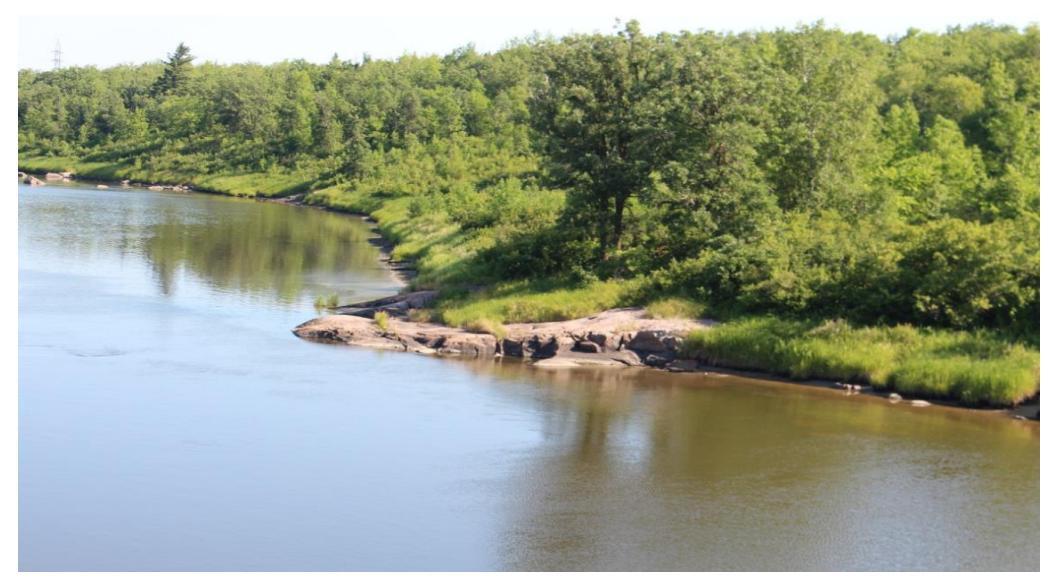
Winnipeg River, courtesy of CNL
