*Fisheries and Aquatic Habitat
Management Plan
Annual Report:
Jan 1, 2019 to Dec 31, 2019*

*Site C Clean Energy Project
March 31, 2020*

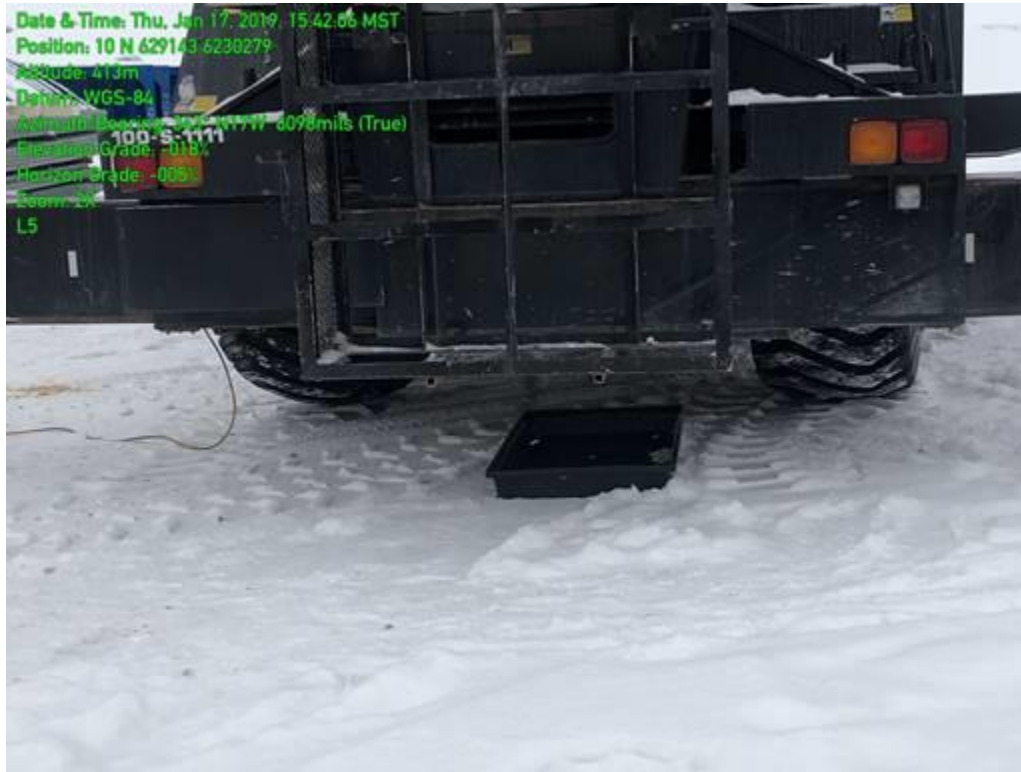
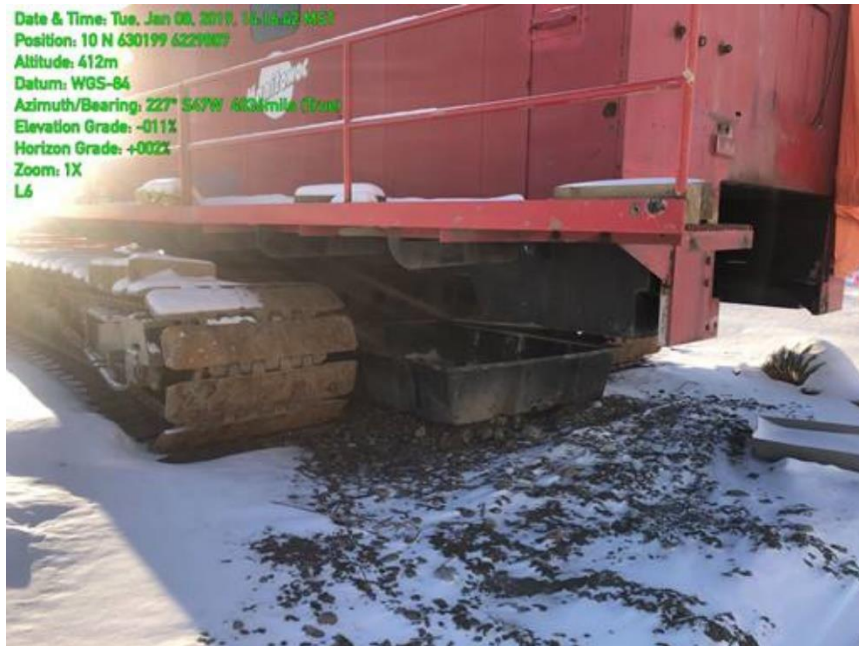
Figure 2. Crews ensure drip trays are placed under machinery parked less than 30 meters from the high-water mark at the diversion outlet cofferdam (top; January 8, 2019) and RSEM L5 (bottom; January 17, 2019).

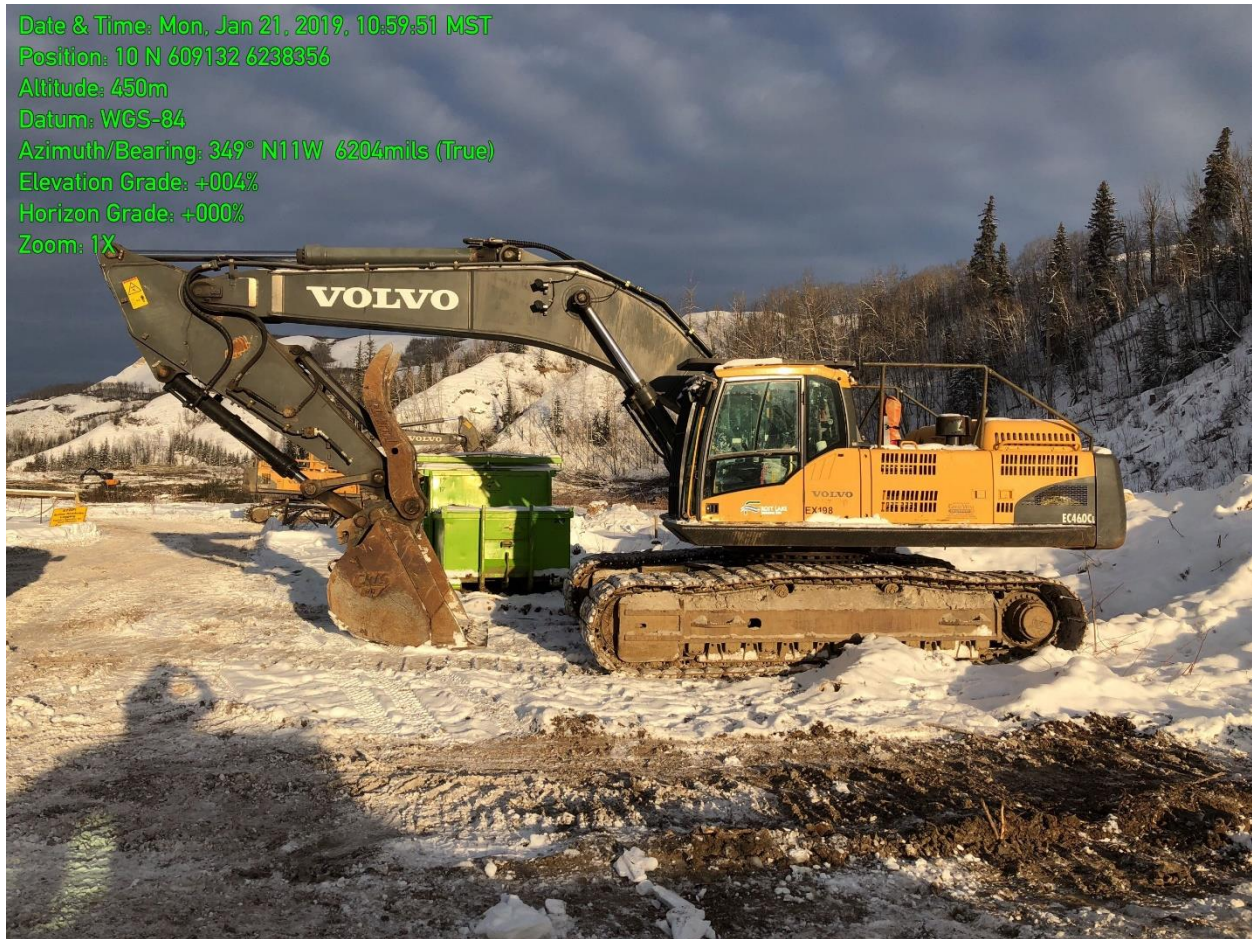
Figure 3. An excavator uses biodegradable hydraulic oil at Cache Creek during reservoir clearing activities (January 21, 2019).

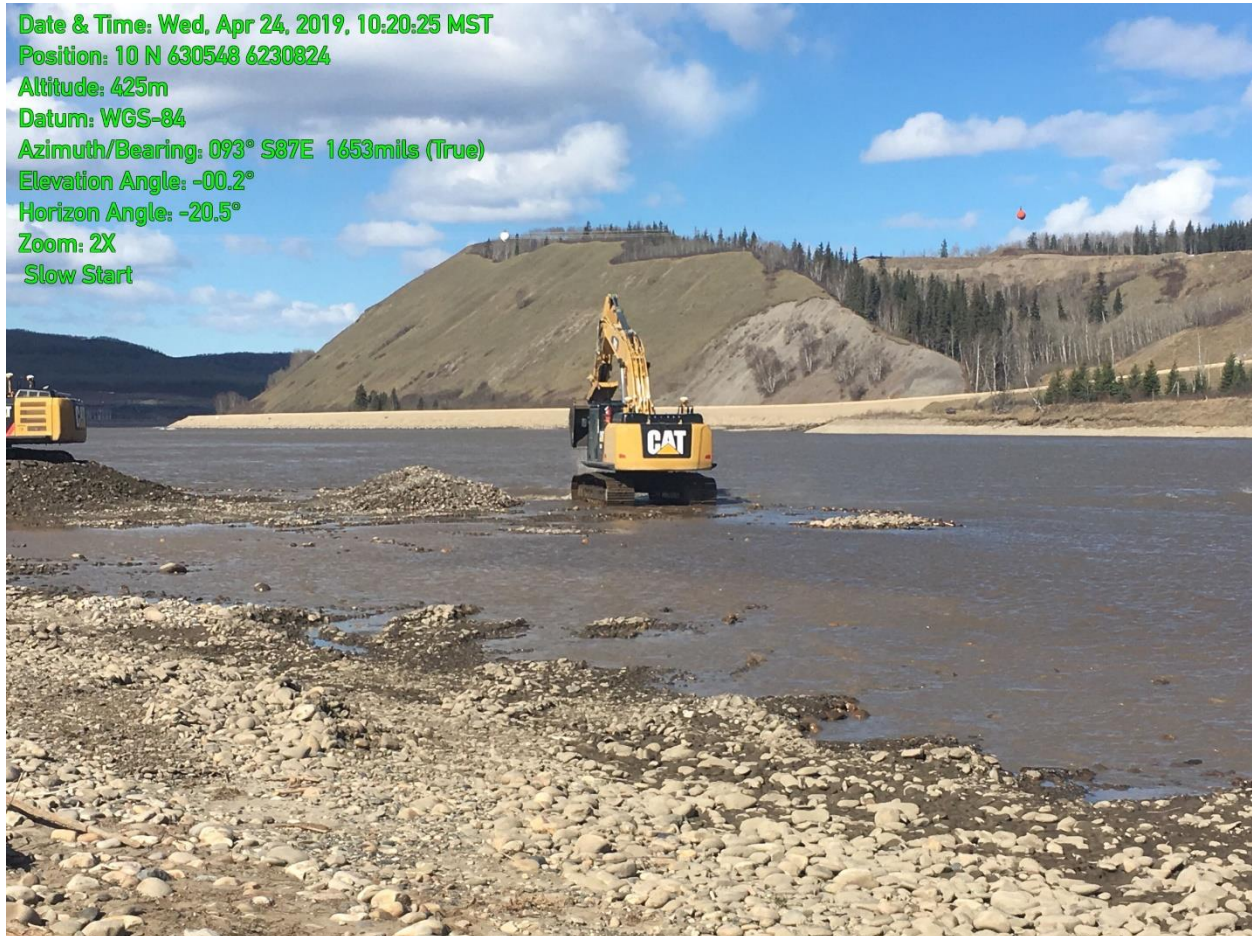
Figure 4. An excavator works to contour a bar in the Peace River at Site 108R to reduce potential for fish stranding. The excavator works in a slow, controlled and continuous manner to scare and exclude fish from the work area (April 24, 2019).

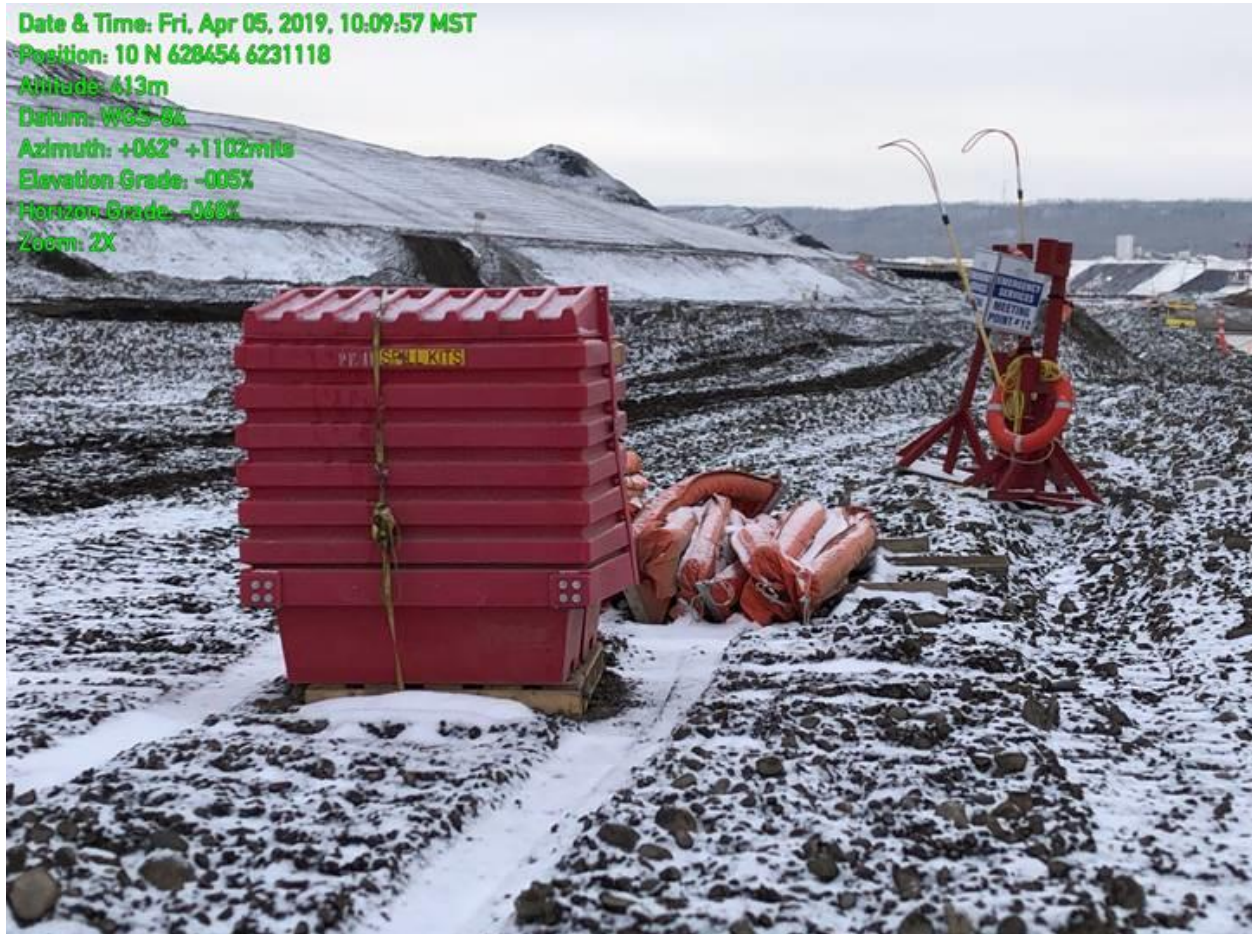
Figure 5. Absorbent and containment booms are on-site and available for deployment in the event of a spill at RSEM L5 (April 5, 2019).

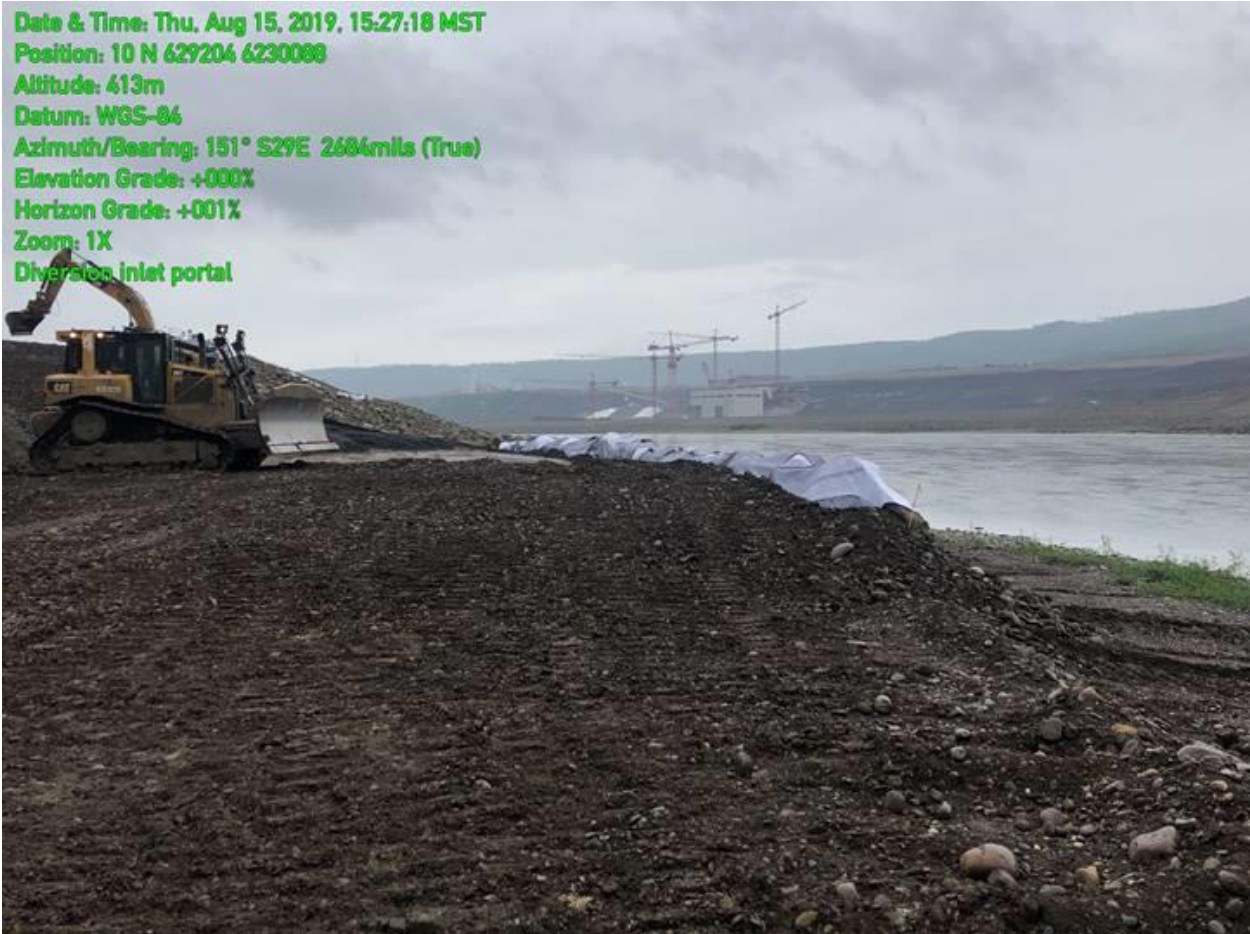
Figure 6. Debris and sediment are prevented from entering the Peace River at RSEM L5 (looking east) using rip rap and liner with mesh armouring (August 15, 2019).
