# ALDERON IRON ORE CORP.

ENVIRONMENTAL IMPACT STATEMENT KAMI IRON ORE MINE AND RAIL INFRASTRUCTURE, LABRADOR

# **Appendix P**

Additional Monitoring Station Details of Stream Gauging Stations S1, S2, S3, S4, and S5 and Hydrological Monitoring Results of Stream Gauging Stations

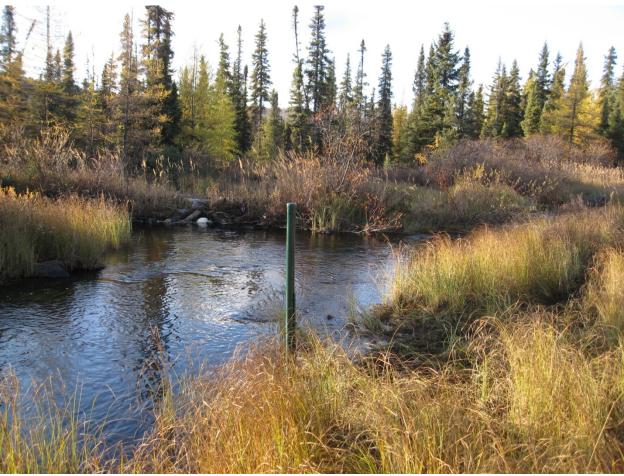
\*Looking downstream

Station *S1* is located at the exit of Narrow Lake approximately 10 m upstream of the access trail on the right bank. The coordinates (UTM NAD83) of the station are northing 5859719.680 and easting 632232.086.

Station *S1* contains a Levelogger installed in a stilling well for continuous water depth monitoring with a 10 minute interval. Station *S1* is also a water quality sampling location. This station was installed in Oct. 6, 2011. The Levelogger was installed with RV antifreeze about 20 cm below the channel bed on the right bank.

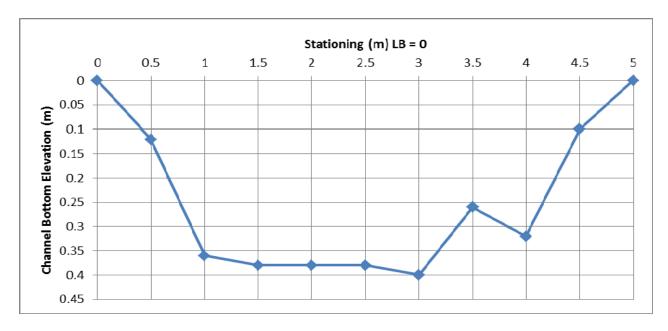
Channel profile starting at left bank looking downstream, units in m. Flat flood plain about 10 cm higher.

$$Q = 0.282 \text{ m}^3/\text{s}$$

- 14 m upstream of station to 11 m downstream of station
- Upstream Thalweg -15cm
- Downstream Thalweg -38 cm

Stream has bottom consisting mainly of gravel-cobbles-boulders.

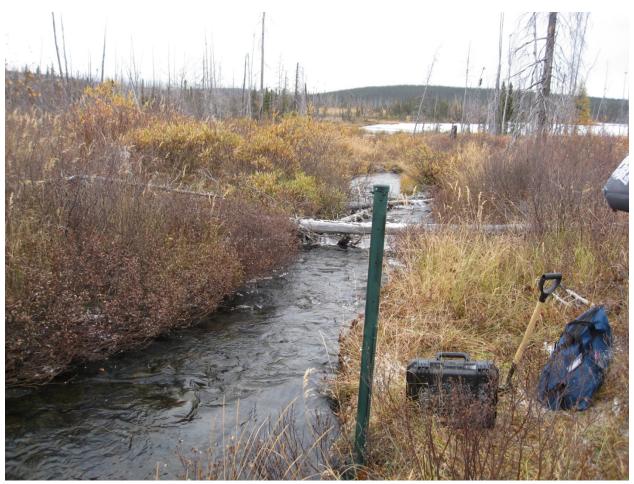
\*Looking downstream

Station S2 is located at the exit of Rose Lake and just upstream of Narrow Lake (approximately 150 m upstream). The coordinates (UTM NAD 83) of the station are northing 5856173.459 and easting 632802.882.

Station S2 contains a Levelogger (serial #22001599) and a Barologger (serial #11064953). Both instruments are installed in a stilling well for continuous water depth and atmospheric pressure monitoring with a 10 minute interval. Station S2 is also a water quality sampling location. This station was installed in Oct. 7, 2011. The Levelogger was installed with RV antifreeze on the right bank.

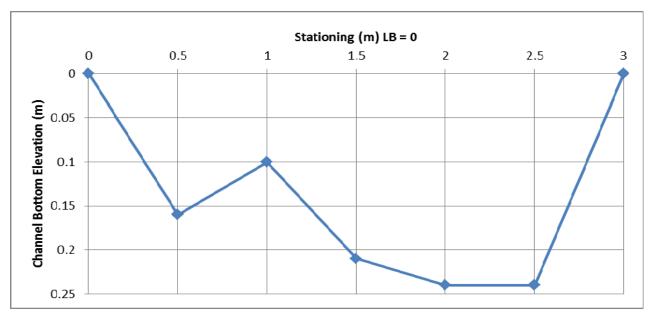
Channel profile starting at left bank looking downstream, units in m.

Flat flood plain about 40 cm higher.

$$Q = 0.0874 \text{ m}^3/\text{s}$$

- 5 m upstream of station to 7m downstream of station
- Upstream Thalweg -13cm

• Downstream Thalweg -17 cm

Stream has bottom consisting mainly of cobbles-boulders.

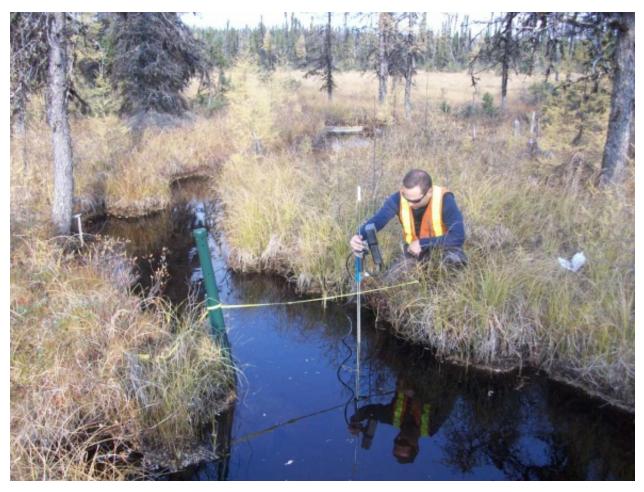
\*Looking upstream

Station S3 is located on a small tributary and approximately 150 m upstream of Molar Lake. The coordinates (UTM NAD83) of the station are northing 5851832.982 and easting 632431.028.

Station S3 contains a Levelogger (serial #22001511). The Levelogger is installed in a stilling well for continuous water depth monitoring with a 10 minute interval. Station S2 is also a water quality sampling location. This station was installed in Oct. 8, 2011. The Levelogger was installed with RV antifreeze on the right bank.

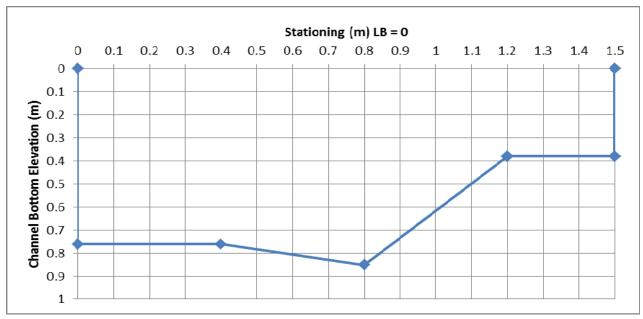
Channel profile starting at left bank looking downstream, units in m.

Flat flood plain about 35 cm higher.

$$Q = 0.0223 \text{ m}^3/\text{s}$$

- Very low slope channel, slope was not measured
- Stream is well defined with soft turf/moss on banks
- Bottom at cross section is sandy-cobble (mostly sand)
- Other reaches have boggy/organic bottom

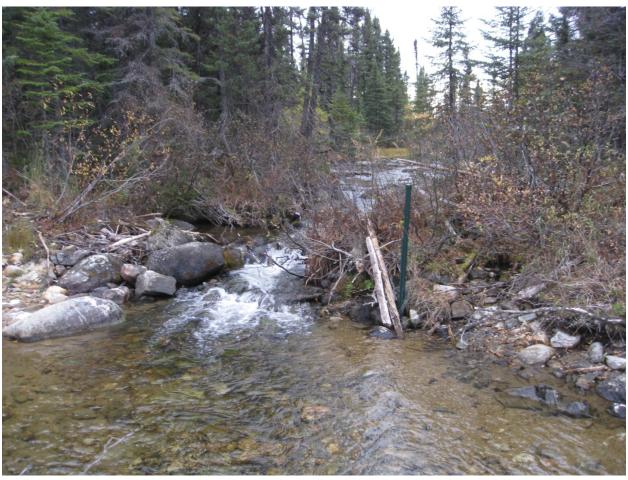
\*Looking upstream

Station *S4* is located in the stream that connects Molar Lake to Mills Lake adjacent to the access road bridge (upstream side). The coordinates (UTM NAD83) of the station are northing 5853070.825 and easting 634296.231.

Station *S4* contains a Levelogger (serial #22001617). The Levelogger is installed in a stilling well for continuous water depth monitoring with a 10 minute interval. Station S2 is also a water quality sampling location. This station was installed in Oct. 7, 2011. The Levelogger was installed with RV antifreeze on the left bank.

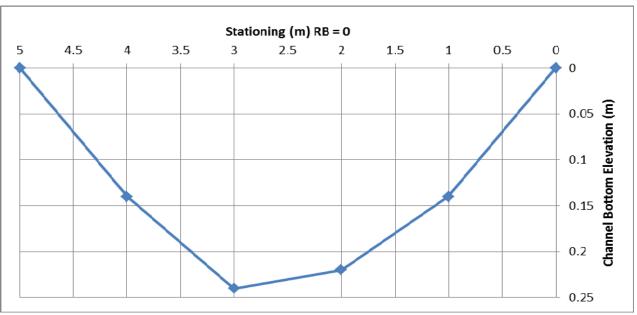
Channel profile starting @ right bank looking downstream, units in m.

Flat flood plain about 90 cm higher.

$$Q = 0.103 \text{ m}^3/\text{s}$$

Channel meandering obstructed the measurement of slope. Channel bottom is mainly gravel-cobbles-boulders.

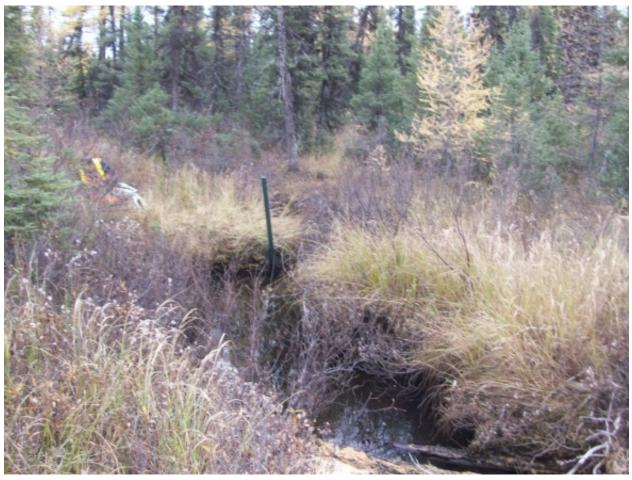
\*Looking downstream

Station *S5* is located in a tributary that feeds to the southern end of Long Lake (upstream side of lake). The coordinates (UTM NAD83) of the station are northing 5856368.709 and easting 637517.073.

Station *S5* contains a Levelogger (serial #21063654) and a Barologger (serial #11064951). Both instruments are installed in a stilling well for continuous water depth and atmospheric pressure monitoring with a 10 minute interval. Station *S5* is also a water quality sampling location. This station was installed in Oct. 8, 2011. The Levelogger was installed with RV antifreeze on the left bank.

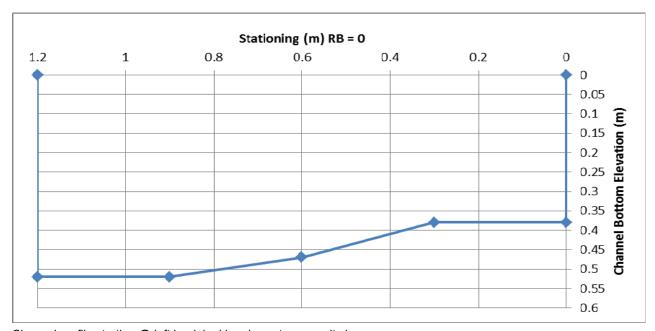
Channel profile starting @ left bank looking downstream, units in m.

Flat floodplain about 30 cm higher.

$$Q = 0.0047 \text{ m}^3/\text{s}$$

Channel slope was not measured. Meandering channel with bottom comprised of sand and boulders with lots of woody debris.

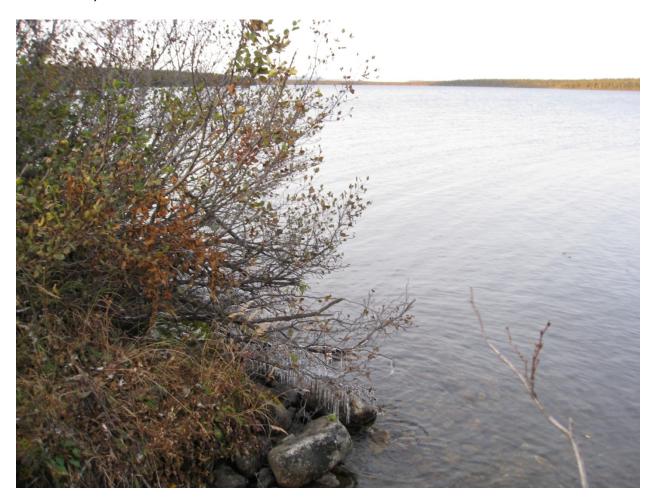
Station L1 is located near landing for snowmobiles next to two cottages on the Mills Lake shore. The coordinates (UTM NAD83) of the station are northing 5853238.290 and easting 634702.660.

Station L1 contains a Levelogger installed in a stilling well for continuous water depth monitoring with a 10 minute interval. Station L1 is also a water quality sampling location. This station was installed in Oct. 7, 2011. The Levelogger was installed with RV antifreeze on the lake.

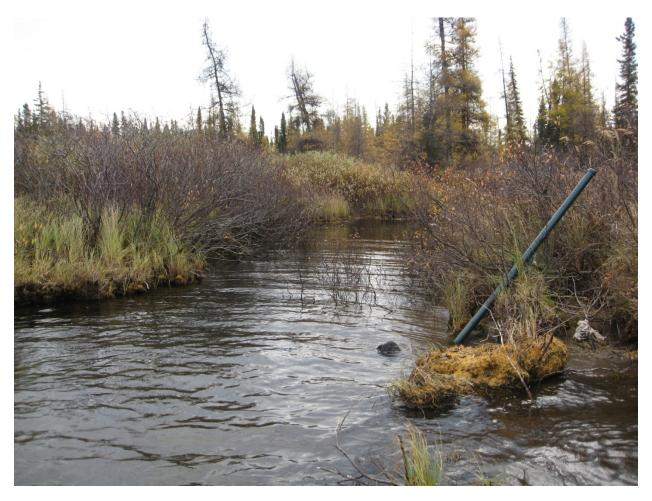
Station *L2* is located at the southern end of Long Lake at the mouth of a stream that feeds Long Lake (where station *S5* is installed). The coordinates (UTM NAD83) of the station are northing 5856468.955 and easting 637498.601.

Station *L2* contains a Levelogger installed in a stilling well for continuous water depth monitoring with a 10 minute interval. Station *L2* is also a water quality sampling location. This station was installed in Oct. 8, 2011. The Levelogger was installed with RV antifreeze on the lake.

Shallow embayment of long lake at south end with very shallow sandy bottom

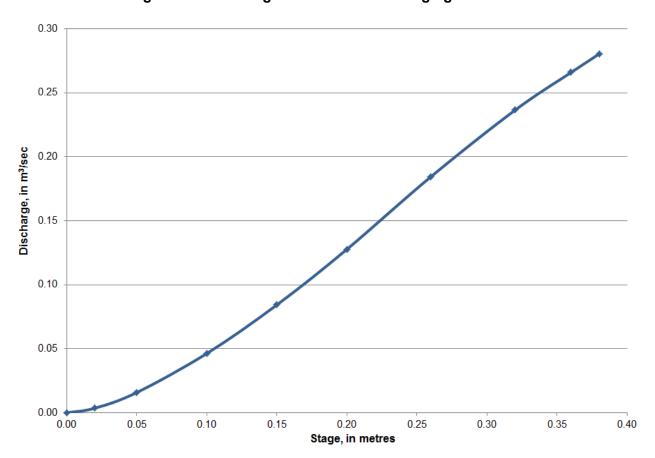
Figure 17C.1 Rating Curve of Stream Gauging Station S1

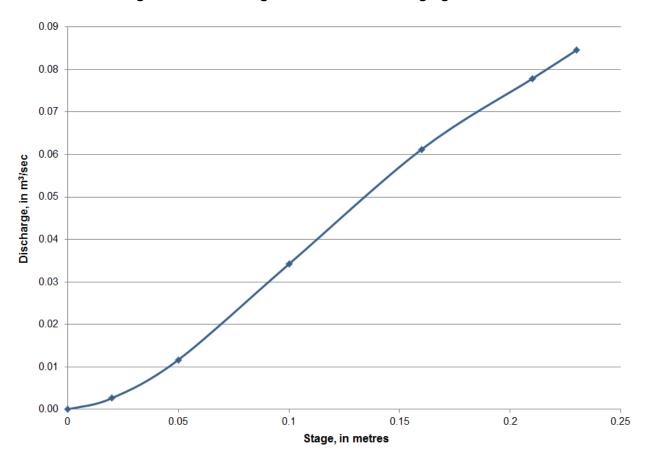
Figure 17C.2 Rating Curve of Stream Gauging Station S2

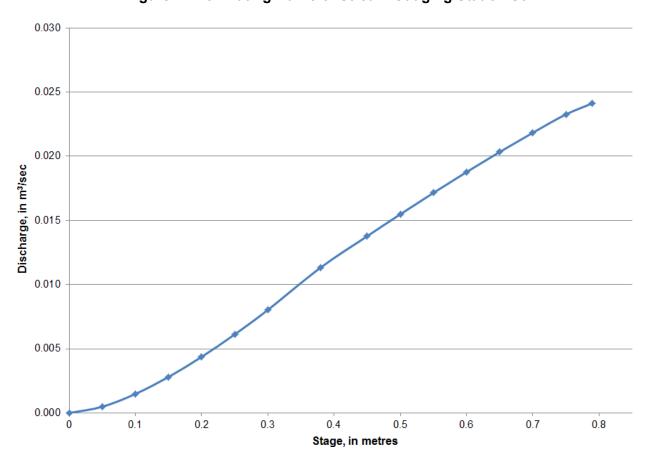
Figure 17C.3 Rating Curve of Stream Gauging Station S3

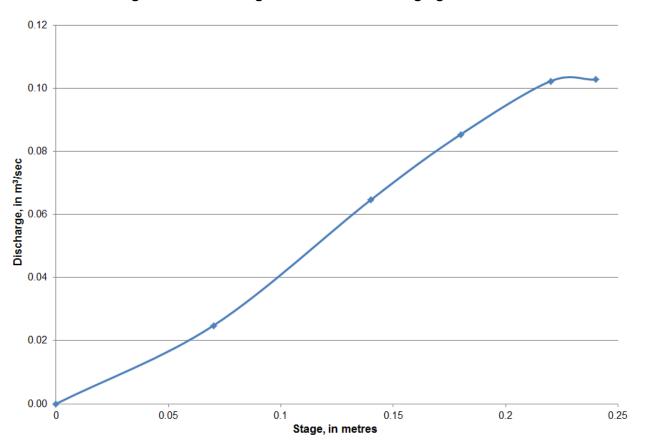
Figure 17C.4 Rating Curve of Stream Gauging Station S4

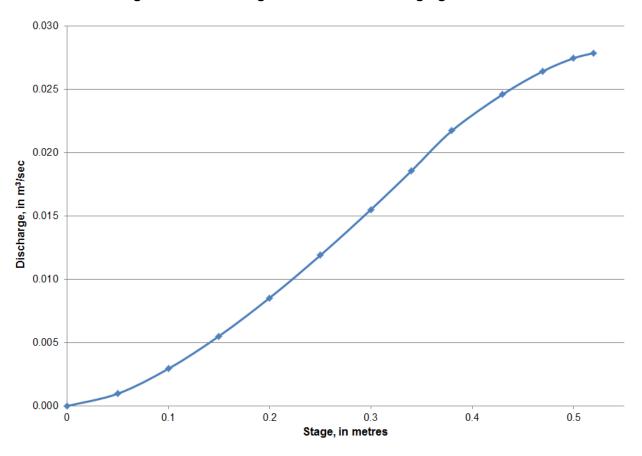
Figure 17C.5 Rating Curve of Stream Gauging Station S5

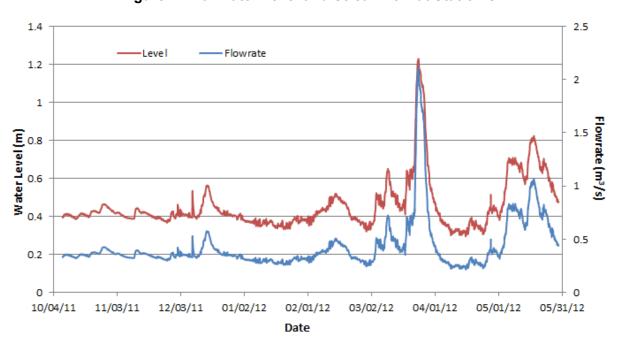
Figure 17C.6 Water Level and Streamflow at Station S1

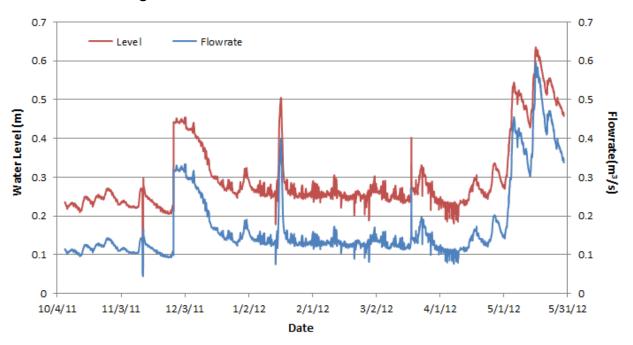
Figure 17C.7 Water Level and Streamflow at Station S2

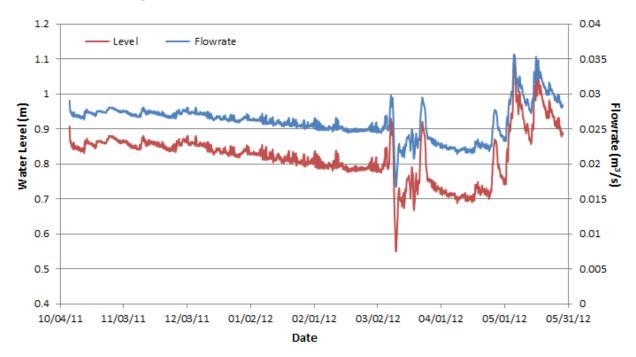
Figure 17C.8 Water Level and Streamflow at Station S3

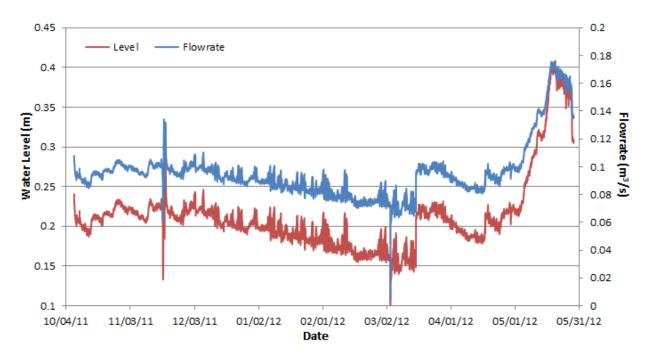
Figure 17C.9 Water Level and Streamflow at Station S4

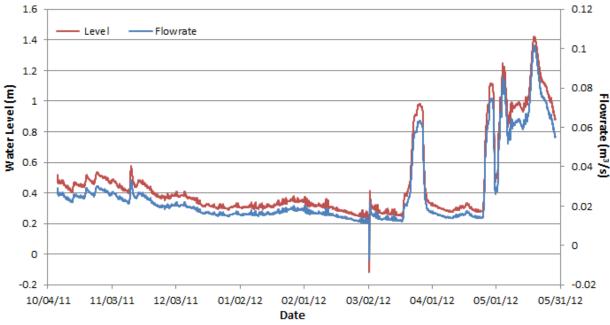
Figure 17C.10 Water Level and Streamflow at Station S5

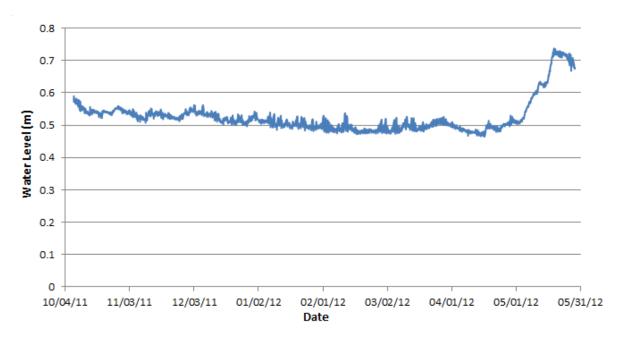
Figure 17C.11 Water Level at Station *L1*

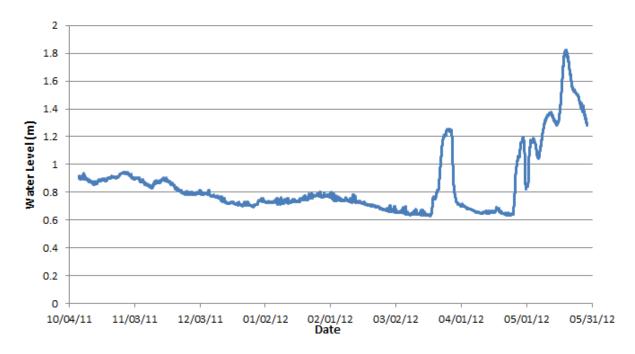
Figure 17C.12 Water Level at Station *L2*
